# 2024 Annual River Crossing Report

**Environment Act Licences No. 2684 RRR, 2669 E RR & 2716 RR**

**Environment and Climate Change**

April 2025

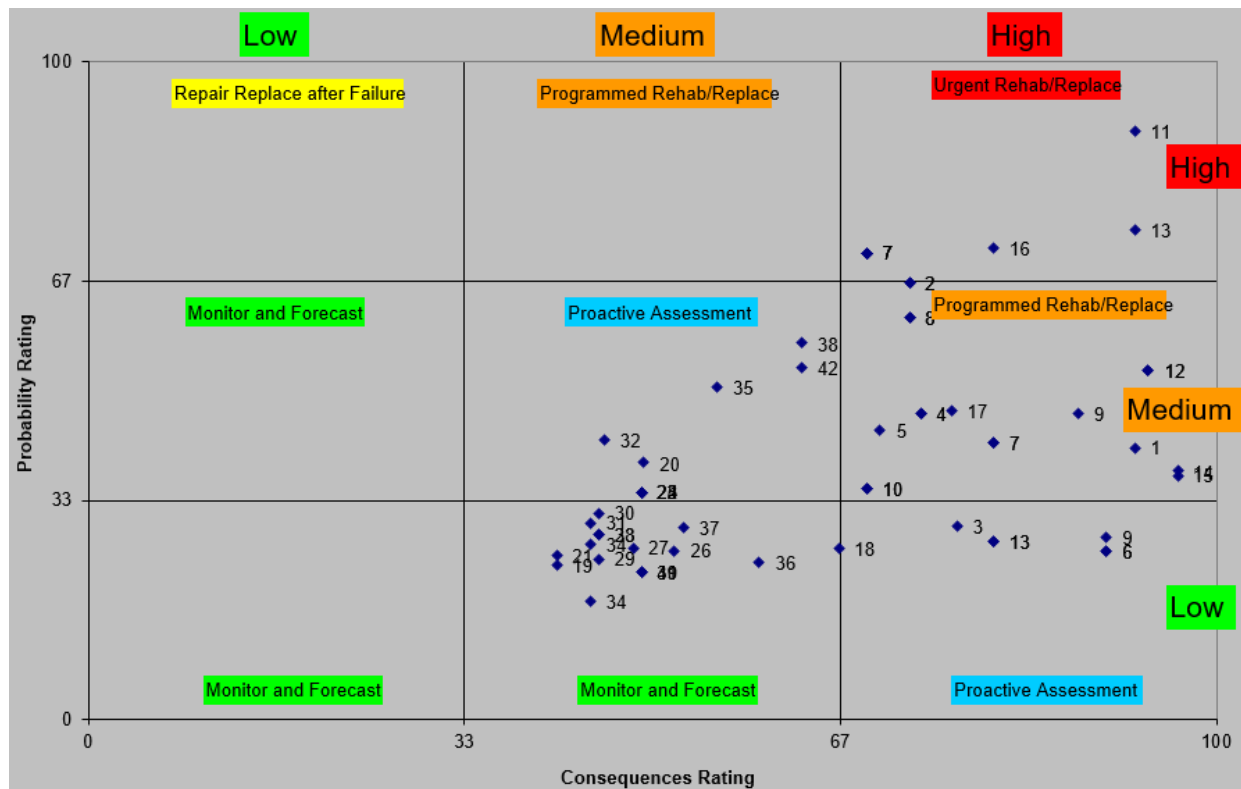
**Figure 1:** Wastewater Sewer River Crossing Inventory: 2006 Risk Ratings

A risk matrix was created to prioritize pipes for physical condition assessments, (see Figure 1) which would then initiate future inspection, repair, maintenance and/or replacement of the assets.

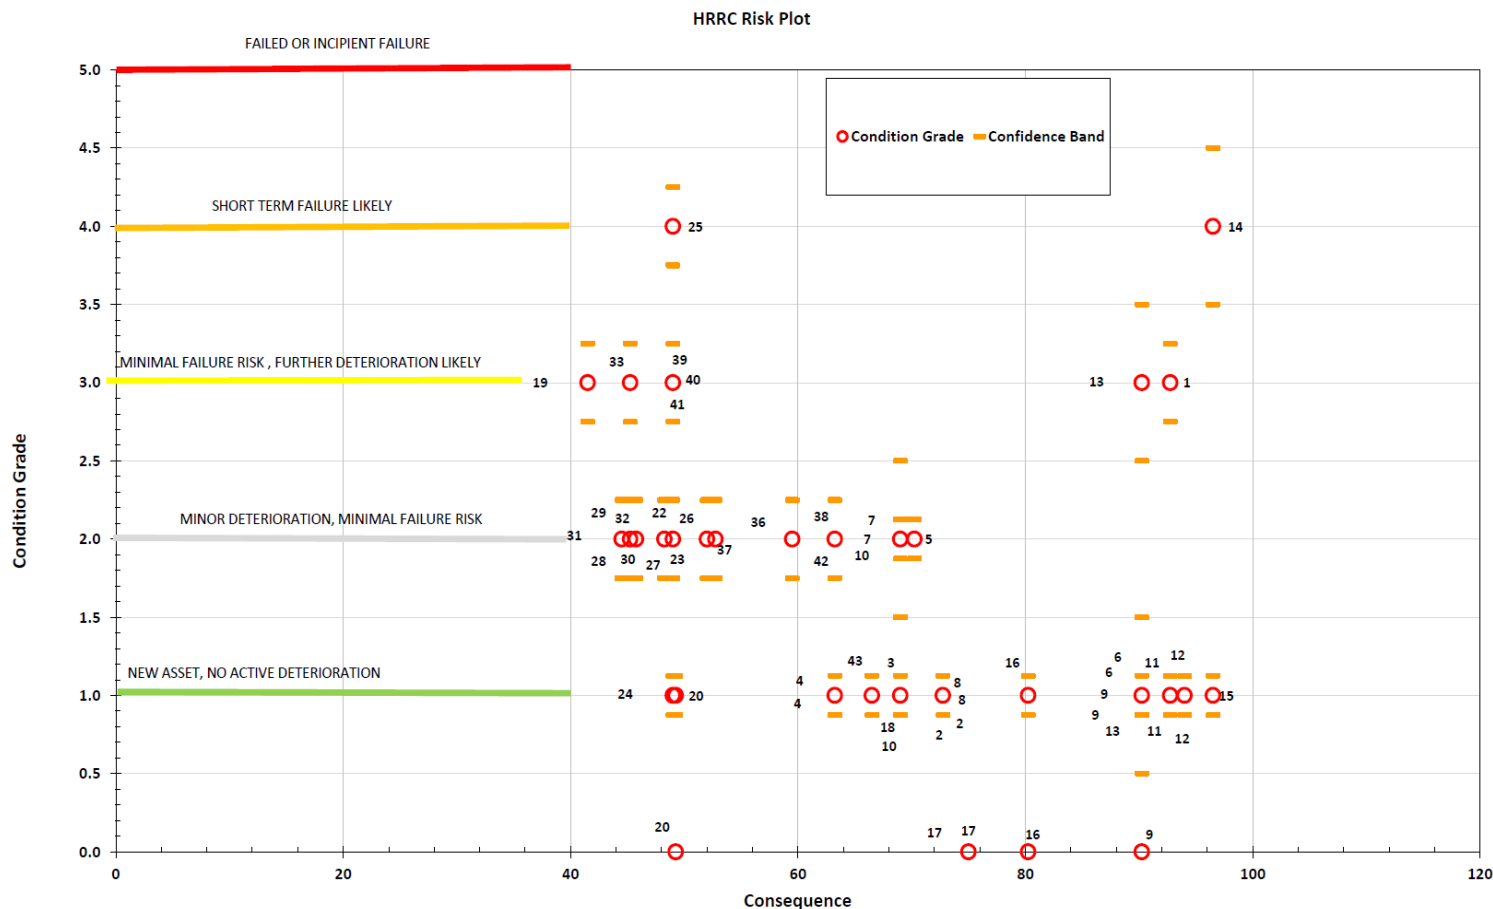
Figure 2: 2024 High Risk River Crossing Risk Matrix

In December of 2024, AECOM updated the 2006 Risk Matrix to include pipe condition data obtained through inspections. Figure 2 below shows the updated 2024 Risk Matrix. Points in the graph below refer to crossing sites as listed in Table 1.

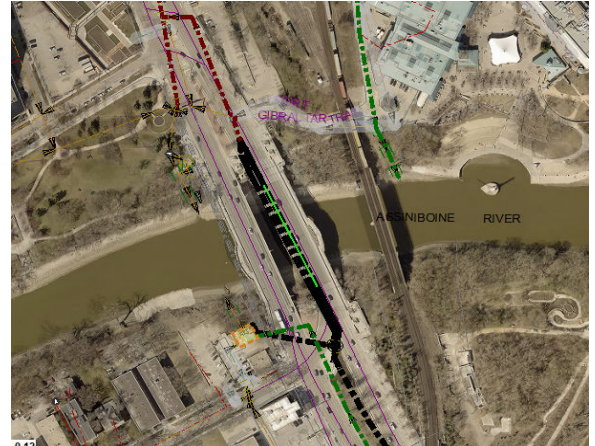
Inspection and condition assessment of the Old Forts Bridge Force Mains, suggest that the pipe are in good condition.

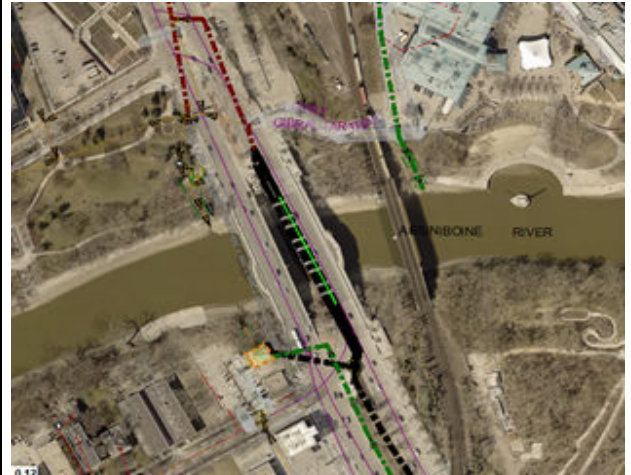
condition.  
The lowest reported wall thickness was 88% RW.
