Re: Notice of Alteration for the Repairs to the Municipal Lagoon Licence No. 2809

Rosser Lagoon – Notice of Alteration Placement of Riprap on Lagoon Dikes October 27, 2015

**Regarding: Rosser Lagoon Secondary Cell – Erosion Repair
Erosion Design Detail and Cost Estimate**

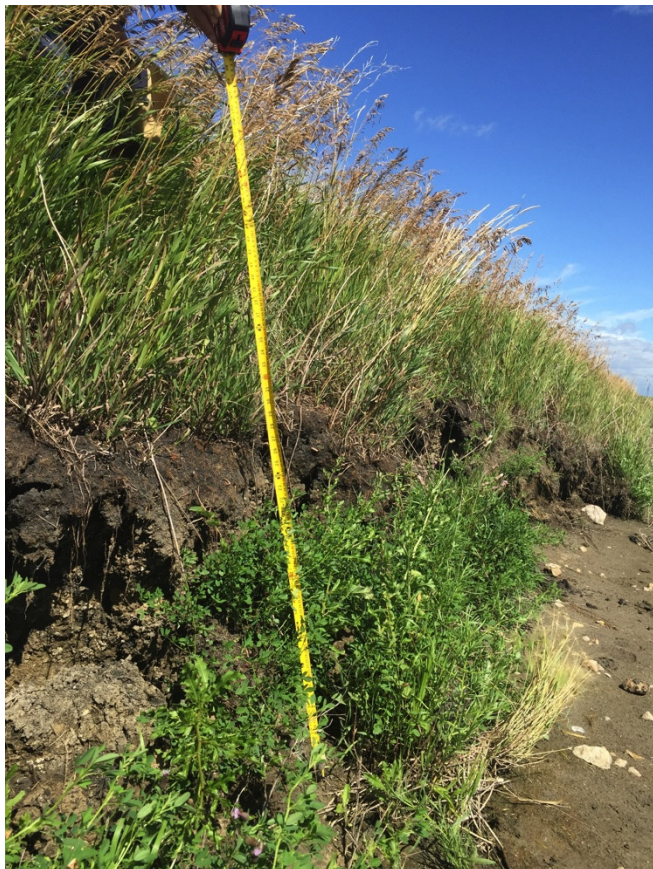
Figure 1 Erosion Secondary Cell

The lagoon operators have observed that the slopes of the secondary cell have been subject to erosion as shown on Figure 1 and wish to proceed with repair of the erosion and placement of riprap to protect the slopes.

During the site visit, it was observed that various parts of the berm in the secondary cell are eroded. Pursuant to Clause 20 of Licence No. 2809, the municipality will be required to repair the dyke and place rip rap on the interior dyke surfaces from 0.6 meters above the high water mark to at least 0.6 meters below the low water mark in accordance with the licence.

The secondary cell of the R.M. of Rosser Lagoon was constructed without perimeter riprap for erosion control and has experienced considerable sloughing and localized erosion at the interface with the lagoon contents since it was originally constructed. AECOM recommends that a riprap erosion blanket be installed to repair the existing slope and prevent future erosion. The work would consist of placing a minimum 300mm thick layer of riprap around the entire perimeter of the secondary cell. A non-woven geotextile would be installed between the existing ground and the proposed riprap layer to prevent the loss of bank material through the riprap layer. AECOM completed a topographic survey at the site, which was used to determine the overall quantities of material required to complete the work.

20. The Licencee shall, if, in the opinion of the Director, significant erosion of the interior surfaces of the dykes occurs, repair the dyke and place riprap on the interior dyke surfaces from 0.6 metres above the high water mark to at least 0.6 metres below the low water mark to protect the dykes from wave action. ☐

The proposed design involves the placement of geotextile and rock riprap over the slope from the lagoon bottom elevation to 0.6 m above the design high level. The project is expected to require 5200 square metres of geotextile and 2400 cubic metres of rock riprap. AECOM estimated the cost of the work to be \$339,040.

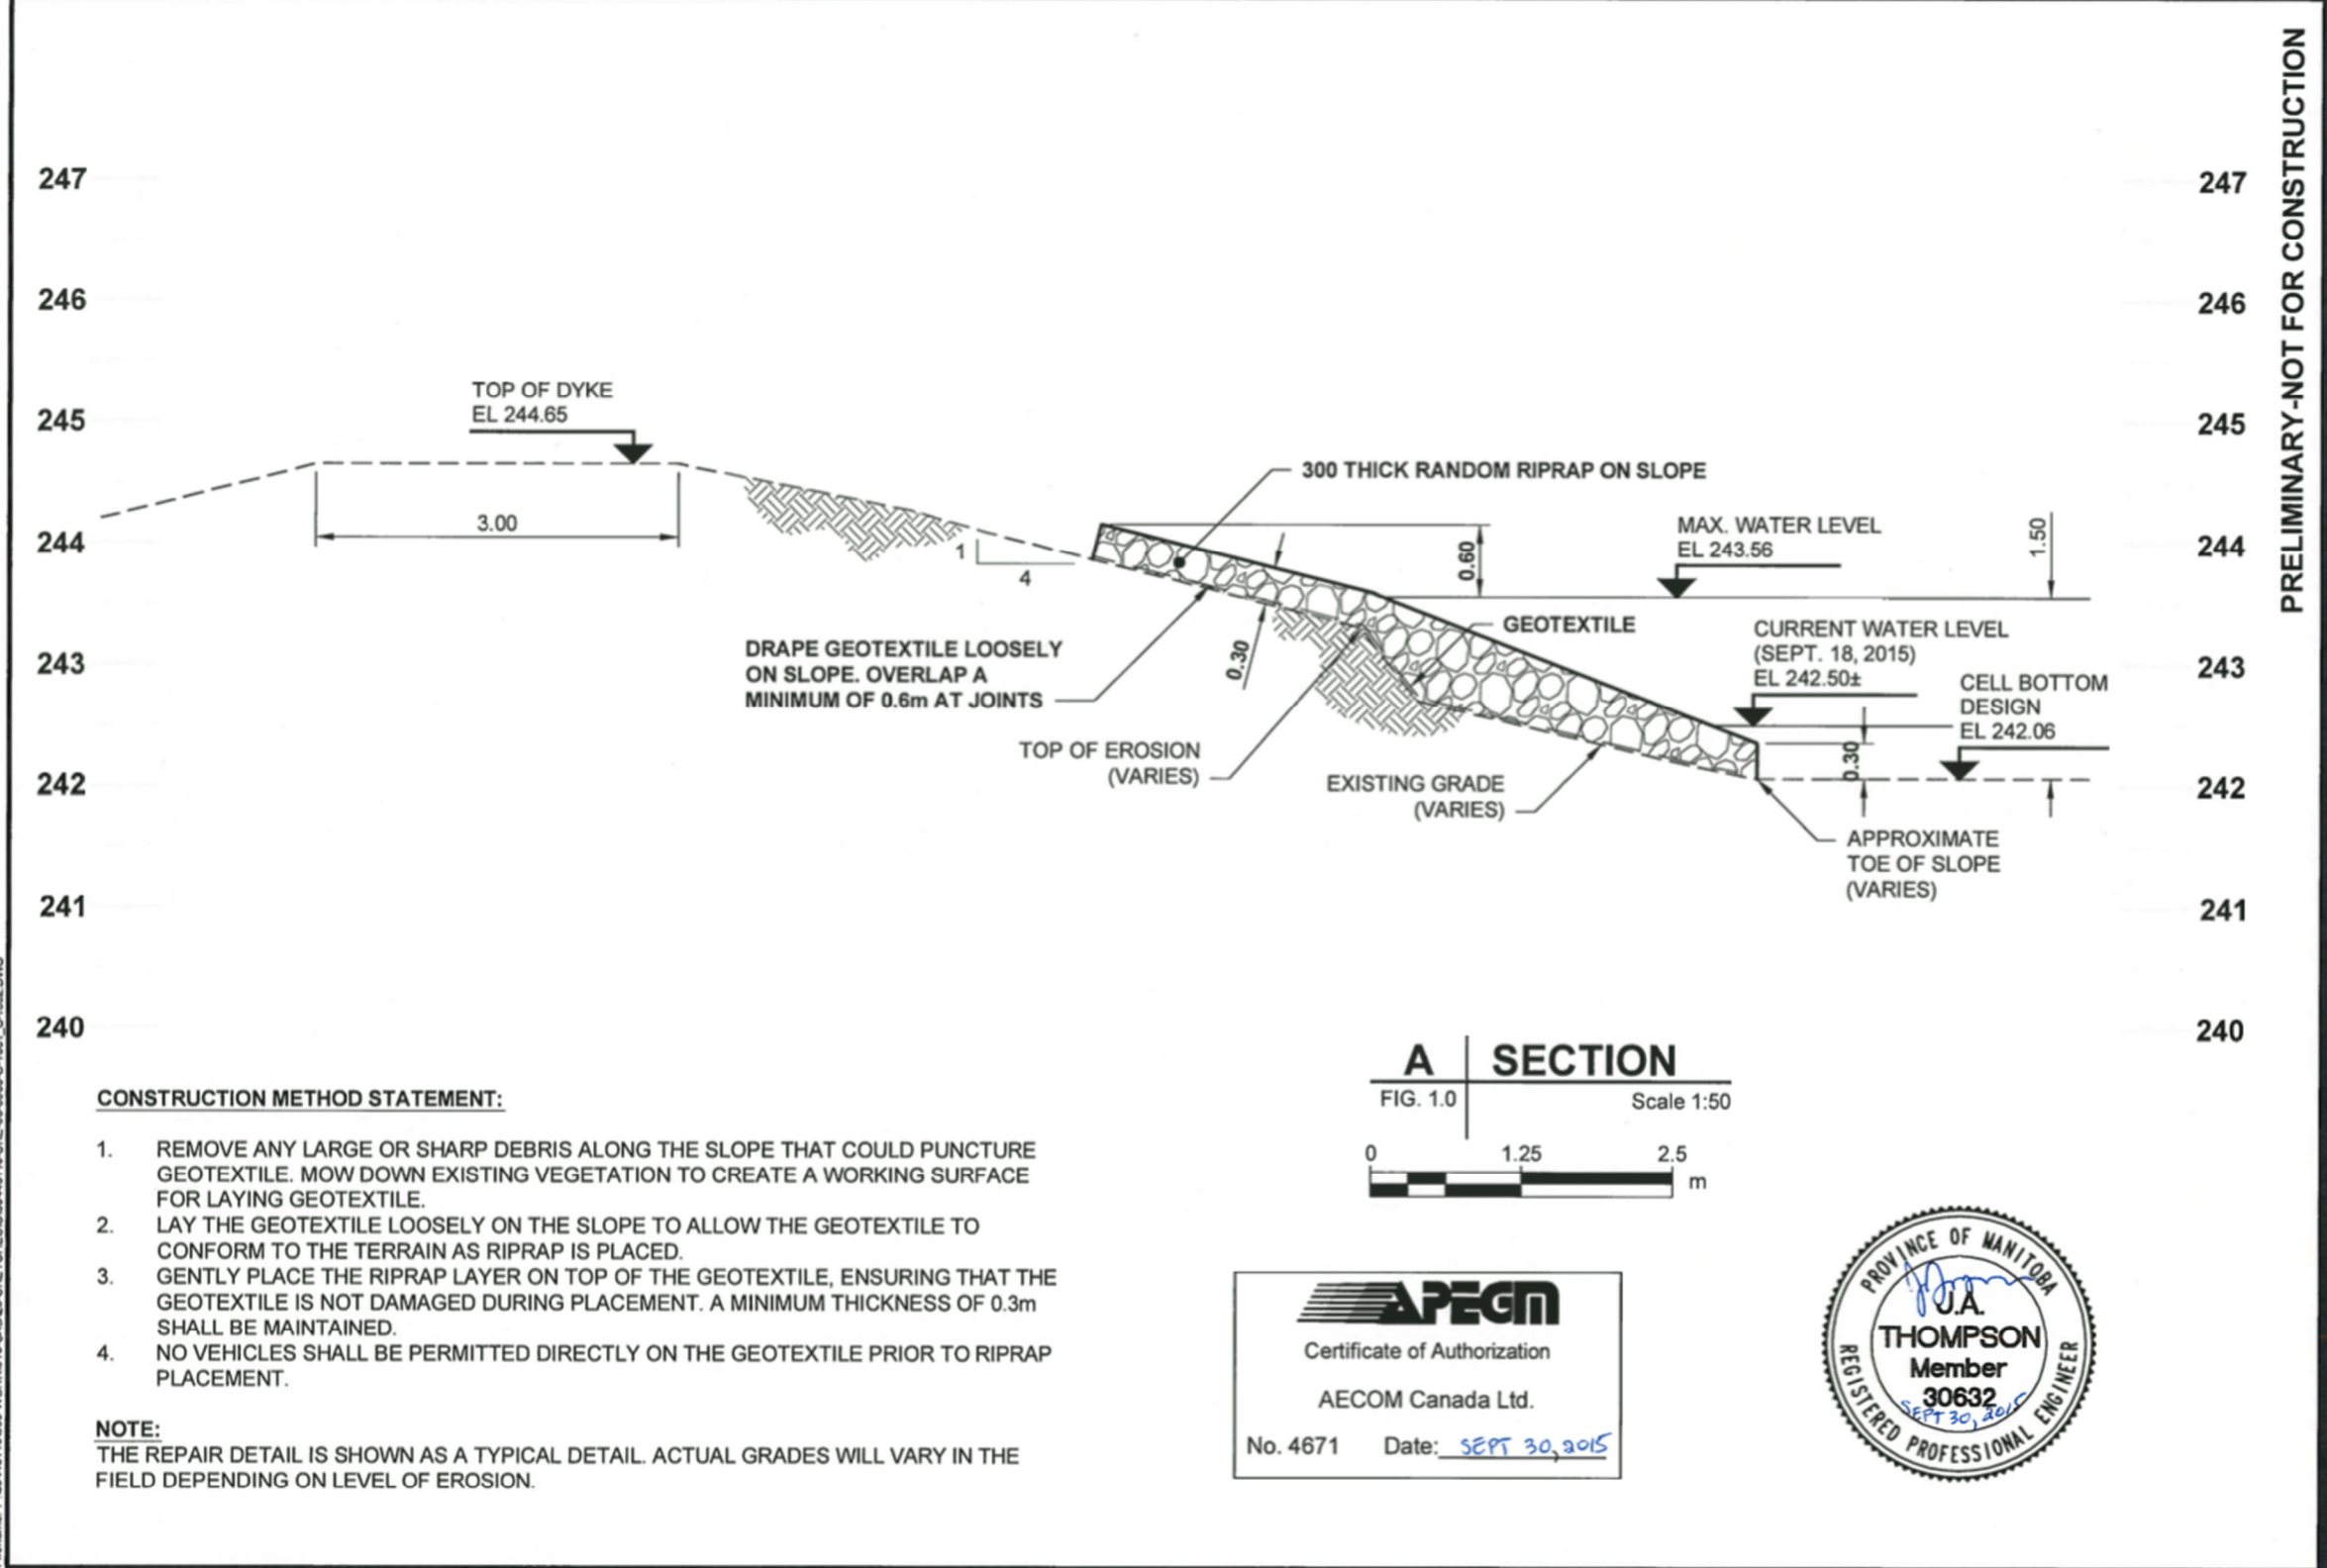
TYPICAL RIPRAP REPAIR DETAIL

NOTE:
 THE REPAIR DETAIL IS SHOWN AS A TYPICAL DETAIL. ACTUAL GRADES WILL VARY IN THE FIELD DEPENDING ON LEVEL OF EROSION.

1. REMOVE ANY LARGE OR SHARP DEBRIS ALONG THE SLOPE THAT COULD PUNCTURE GEOTEXTILE. MOW DOWN EXISTING VEGETATION TO CREATE A WORKING SURFACE FOR LAYING GEOTEXTILE.
2. LAY THE GEOTEXTILE LOOSELY ON THE SLOPE TO ALLOW THE GEOTEXTILE TO CONFORM TO THE TERRAIN AS RIPRAP IS PLACED.
3. GENTLY PLACE THE RIPRAP LAYER ON TOP OF THE GEOTEXTILE, ENSURING THAT THE GEOTEXTILE IS NOT DAMAGED DURING PLACEMENT. A MINIMUM THICKNESS OF 0.3m SHALL BE MAINTAINED.
4. NO VEHICLES SHALL BE PERMITTED DIRECTLY ON THE GEOTEXTILE PRIOR TO RIPRAP PLACEMENT.
