# **Bipole III Transmission Project Construction Environmental Protection Plan**

**Construction Section N2 Environmentally Sensitive Site Locations**

**Bipole III Transmission Project Construction Environmental Protection Plan Construction Section C1 Environmentally Sensitive Site Locations**

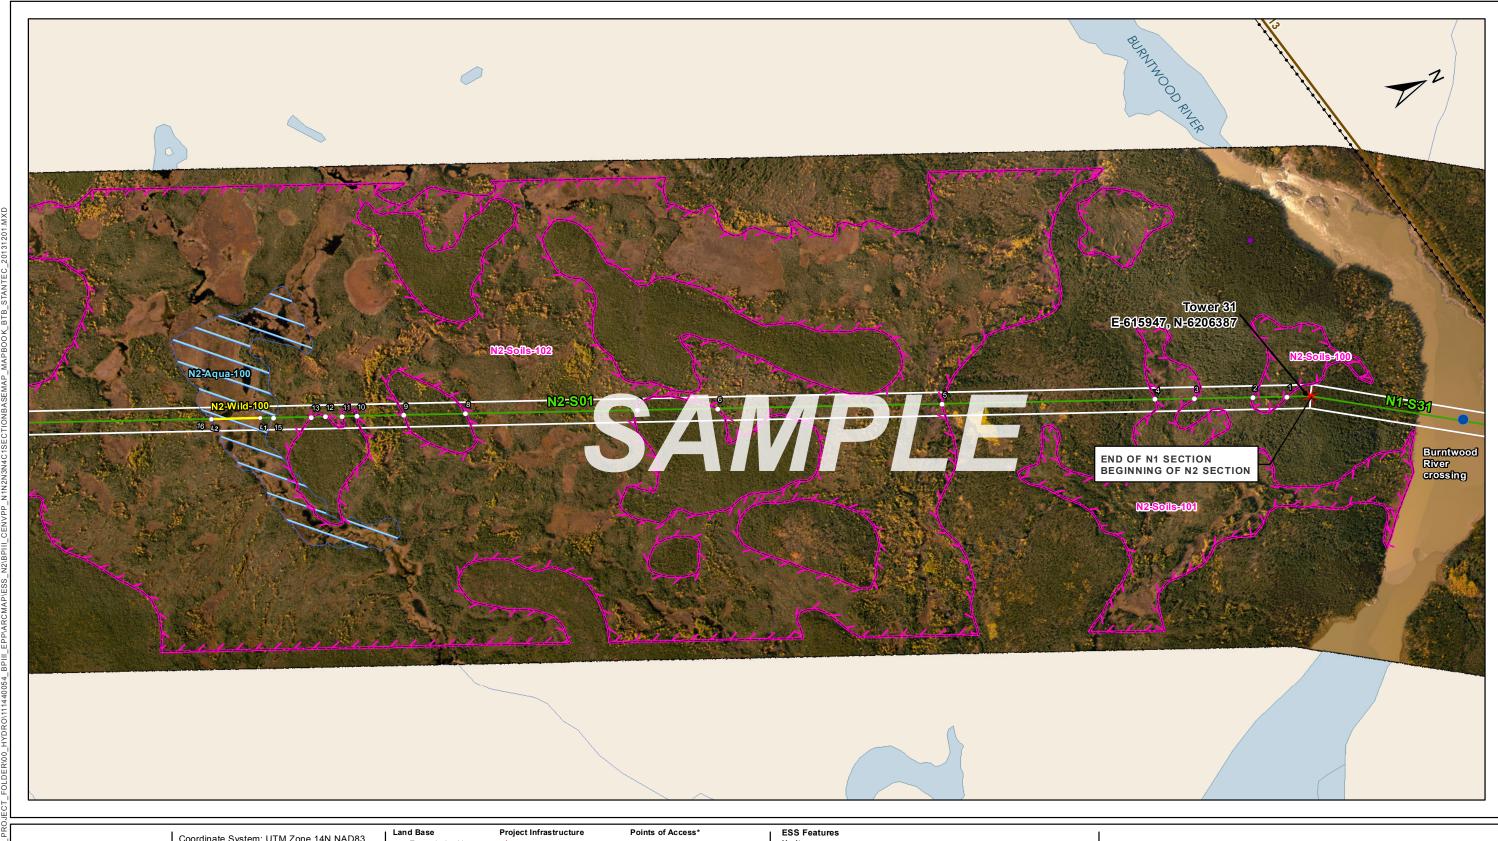
## MAP NUMBER: 61 1

ESS Group: Permafrost <sup>2</sup>

Sec-Seg ID	ESS ID	<b>ESS Name</b>	Location	Start	Stop	UTM Zone	Distance	_
N2-S01	N2-Soils-100	Permafrost	Sito: 1 to )	E- 615921 N- 6206328		14N	95 m	
N2-S01	N2-Soils-102	Permafrost	Site: 13 to 14	E- 614820 N- 6203884	E- 614309 N- 6202749	14N	1244 m

Melting or loss of permafrost due to disturbance of the active layer

Sec-Seg ID	ESS ID	ESS Name	Location	Start	Ston	UTM Zone	Distance
N2-S01		Unnamed tributary of Burntwood River	Sita: 15 to 16	E- 614778 N- 6203790	E- 614707 N- 6203634	14N	171 m

Increased erosion and sedimentation, rutting of floodplains, loss of riparian vegetation

Sec-Seg ID	ESS ID	ESS Name	Location	Start	Ston	UTM Zone	Distance
N2-S01	N2-Wild-100	Waterfowl Sensitivity Area	Site: L1 to L2	E- 614763 N-6203757	E-614708 N-6203636	14N	132 m

Higher risk of wire collision, disturbance during breeding and nesting, risk of wire collision is localized to the right-of-way while construction disturbance can effect colonies up to 400 meters away

- · Carry out construction activities on frozen ground to minimize surface damage and rutting
- Use existing trails, roads or cut lines whenever possible as access routes

• Riparian Buffers shall be a minimum of 30m and increase in size based on slope of land entering waterway. Within these buffers shrub and herbaceous understory veg will be maintained along with trees that do not violate MH Veg Clearance Requirements. Use existing trails, roads or cut lines whenever possible as access routes

- Adhere to reduced risk timing windows for protection of birds (August 1- April 30)
- Maintain applicable setback during nesting and breeding timing window
- Conduct priority assessment for bird diverters and other measures prior to transmission line stringing
- Install bird diverters or other measures at high priority sites

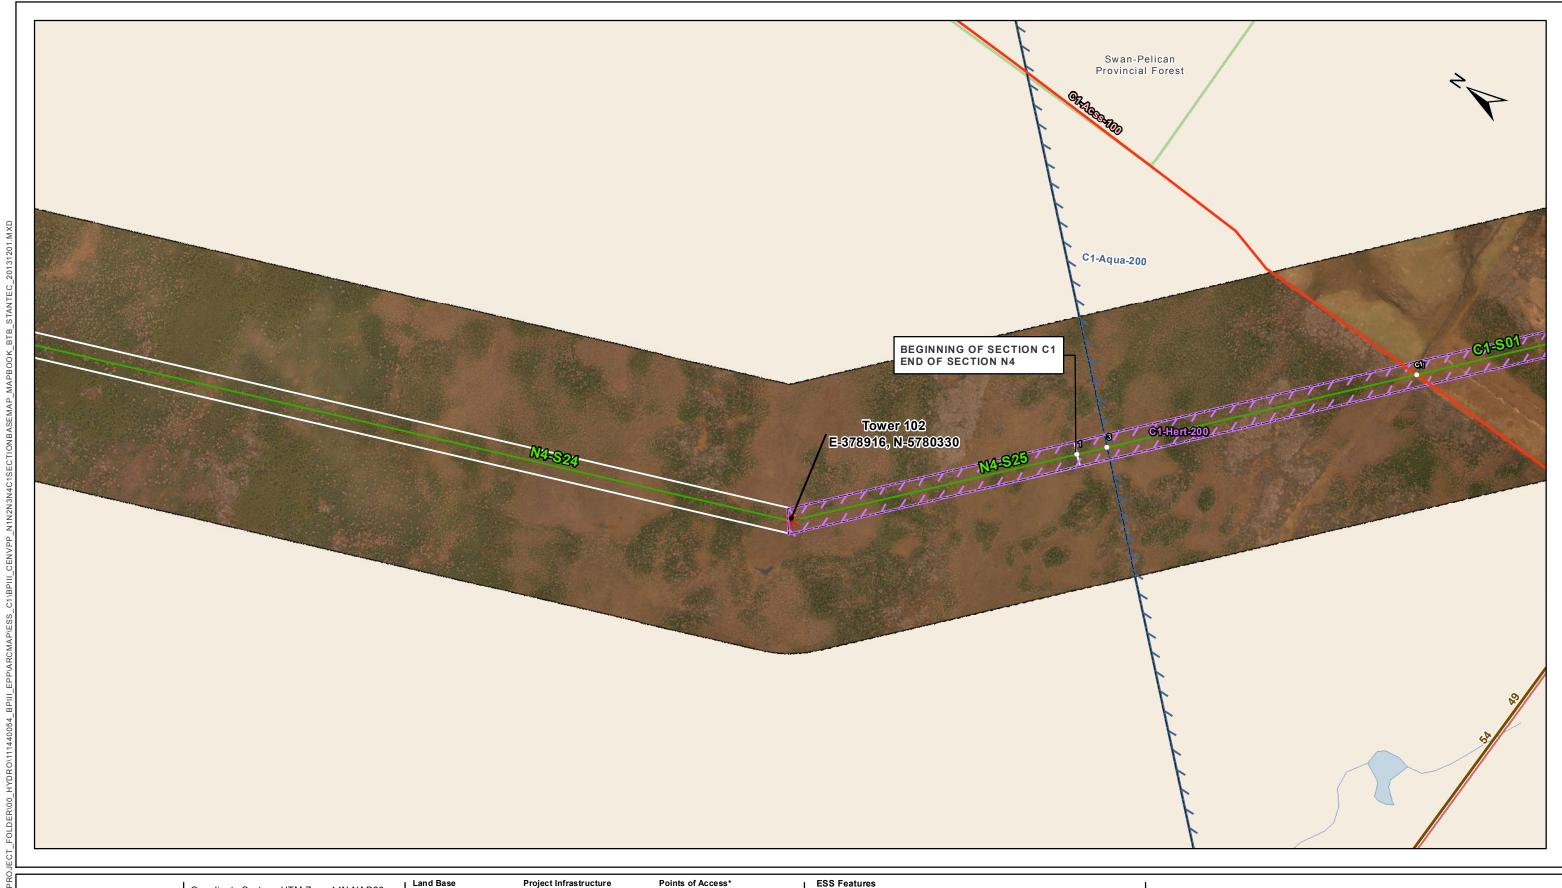
Sec-Seg ID	ESS ID	ESS Name	Location	Start	Stop	UTM Zone	Distance
C1-S01	C1-Hert-200	Plant Gathering Area	Site: 1 to 2	E-379494 N-5779807	E-396683 N-5764303	14N	23149 m

Potential for presence of important architectural heritage resources

Sec-Seg ID	ESS ID	ESS Name	Location	Start	Stop	UTM Zone	Distance
C1-S01		Artesian areas with uncertain water quality	Site: 3 to 4		E-382245 N-5777326	14N	3624 m

Potential increase in salinity of soils and surface water in case where aquifer is saline and groundwater discharges to the surface; also, wetting the surficial environment (ground saturation)

Sec-Seg ID	ESS ID	ESS Name	Location	Easting	Northing	UTM Zone
C1-S01	C1-Acss-100	Access route to traplines	Site: C1	380179	5779190	14N

Loss of historic road due to construction of access road to ROW and activities associated with the ROW Loss of cultural value associated with historic events

- Carry out construction activities on frozen or dry ground to minimize surface damage, rutting and erosion
- Minimize surface disturbance around the site to the extent possible
- Remove trees by low-disturbance methods
- No Herbicide to be applied during construction
- Confine vehicle traffic to established trails to the extent possible

- Qualified driller with appropriate experience will be contracted to work in areas affected by artesian conditions
- Emergency response plans for sealing/grouting and pumping will be implemented as required
- Follow up inspections of installed foundations will be undertaken to monitor for excess moisture

- · Carry out construction activities on frozen or dry ground to minimize surface damage, rutting and erosion
- Avoid surface damage to and obstruction of access route
- Inspect excavated materials or surface disturbance for heritage resources and report any finds to Environmental Inspector
- If any heritage resources are discovered, Archaeologist to conduct site investigation and recommend any additional mitigation measures

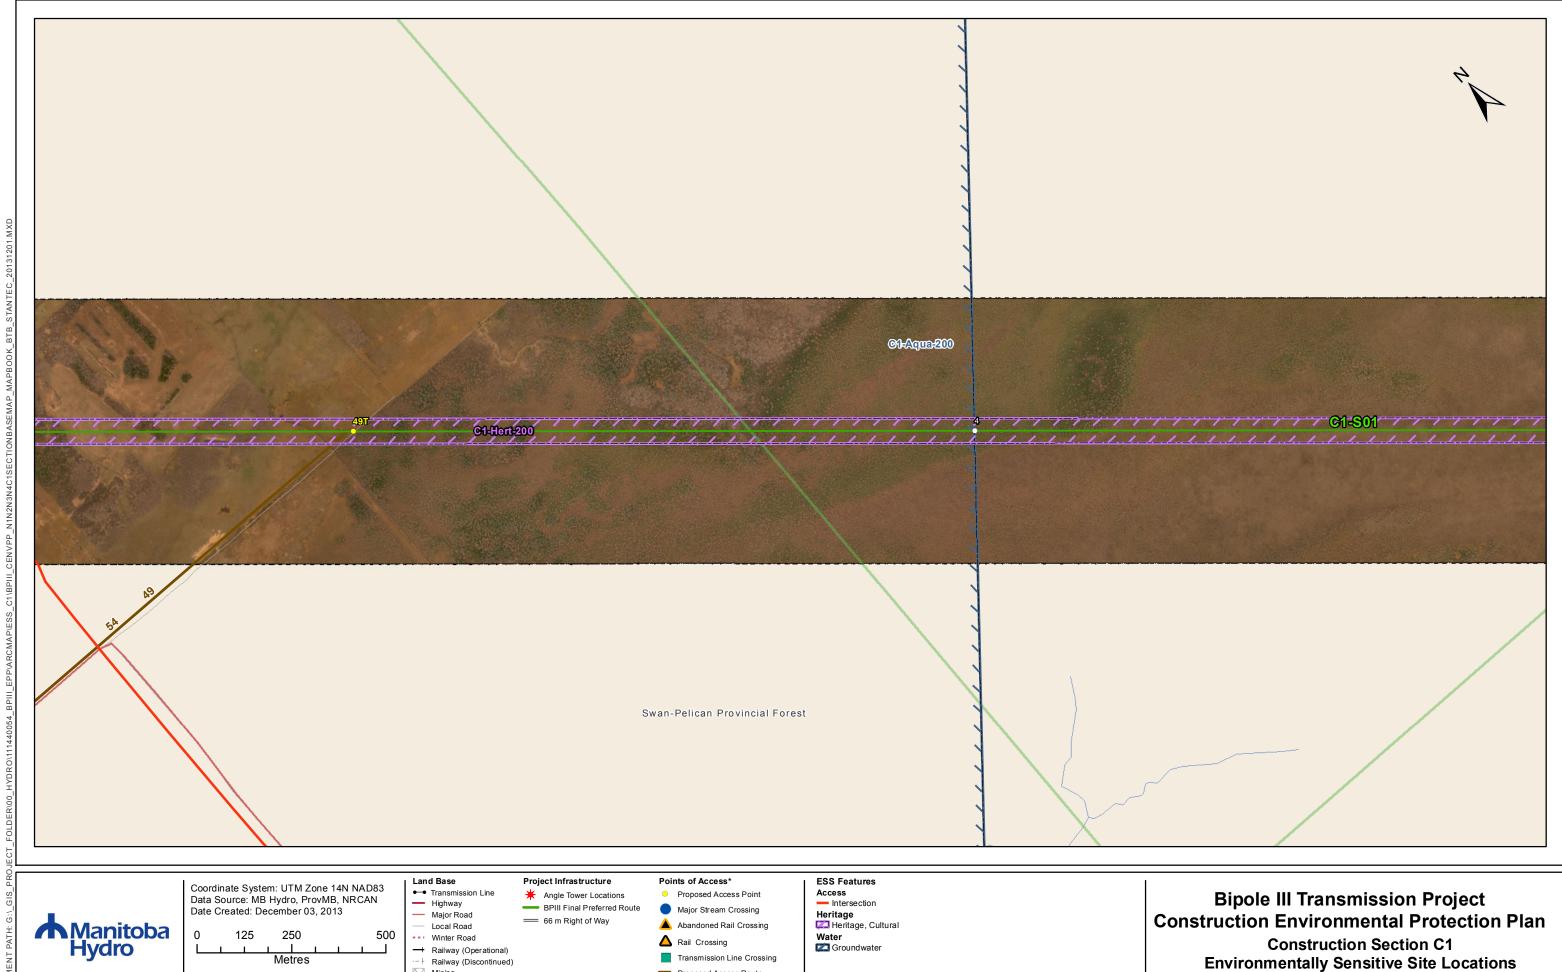
Map 208

Sec-Seg ID	ESS ID	ESS Name	Location	Start	Stop	UTM Zone	Distance
C1-S01	C1-Hert-200	Plant Gathering Area	Site: 1 to 2	E-379494 N-5779807	E-396683 N-5764303	14N	23149 m

Potential for presence of important architectural heritage resources

Sec-Seg ID	ESS ID	ESS Name	Location	Start	Stop	UTM Zone	Distance
C1-S01	C1-Aqua- 200	Artesian areas with uncertain water quality	Site: 3 to 4	E-379554 N-5779753	E-382245 N-5777326	14N	3624 m

Potential increase in salinity of soils and surface water in case where aquifer is saline and groundwater discharges to the surface; also, wetting the surficial environment (ground saturation)

- Carry out construction activities on frozen or dry ground to minimize surface damage, rutting and erosion
- Minimize surface disturbance around the site to the extent possible
- Remove trees by low-disturbance methods
- No Herbicide to be applied during construction
- Confine vehicle traffic to established trails to the extent possible

- Qualified driller with appropriate experience will be contracted to work in areas affected by artesian conditions
- Emergency response plans for sealing/grouting and pumping will be implemented as required
- Follow up inspections of installed foundations will be undertaken to monitor for excess moisture

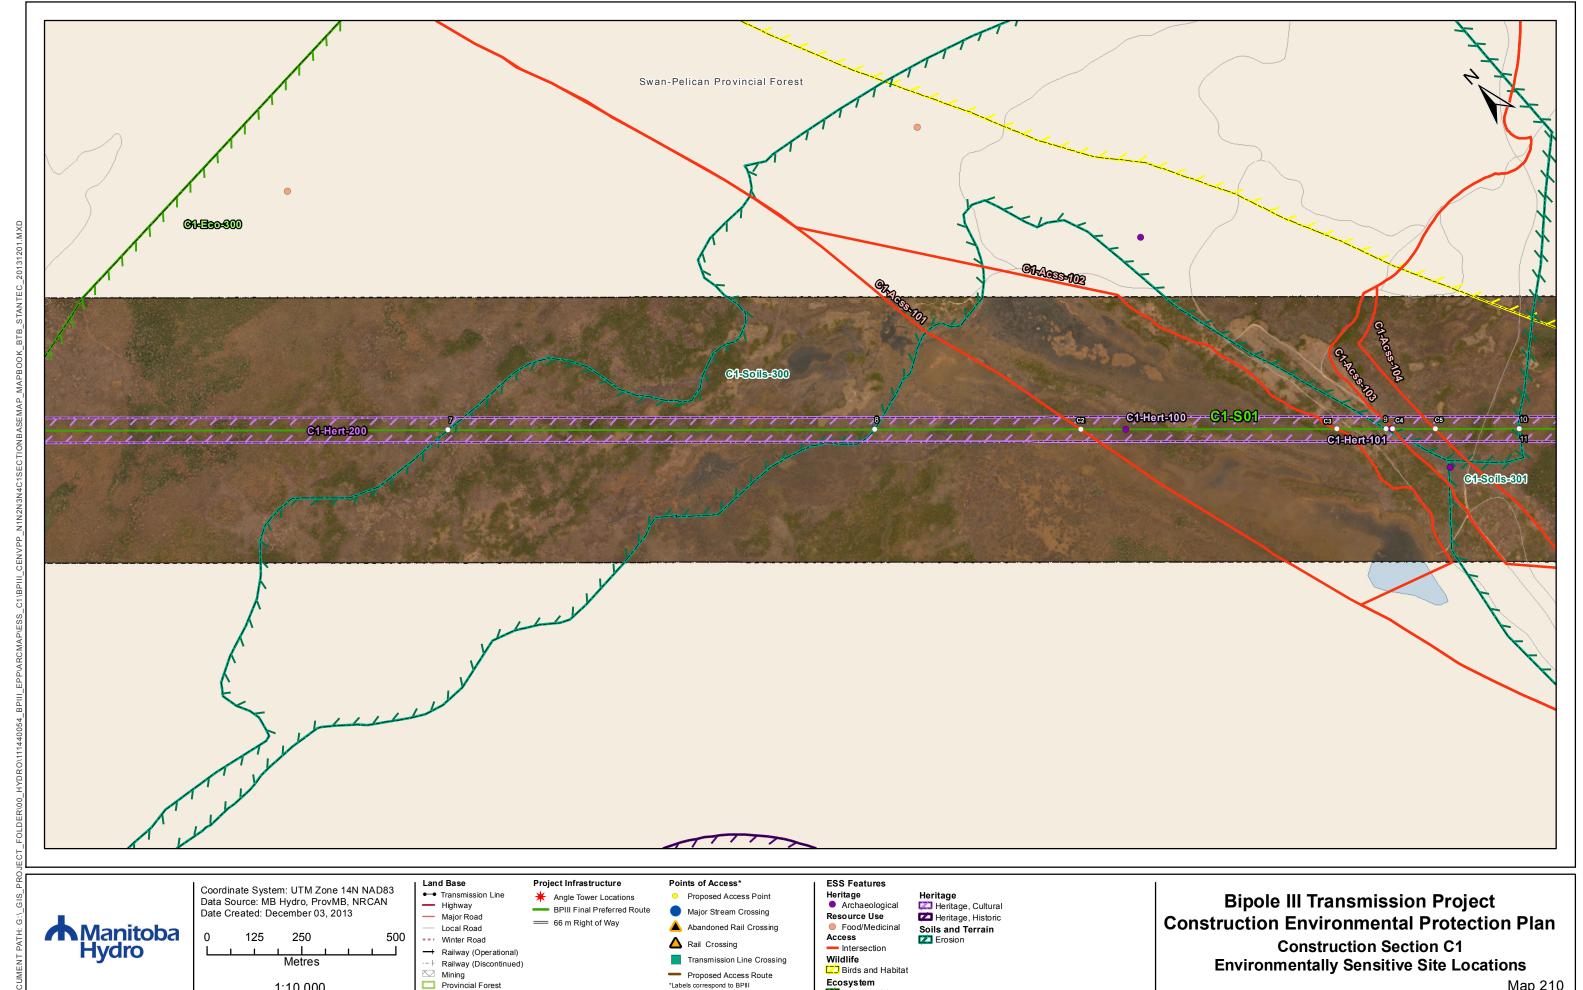
MAP NUMBER: 210 cont'd

Sec-Seg ID	ESS ID	ESS Name	Location	Start	Stop	UTM Zone	Distance
C1-S01	C1-Hert-200	Plant Gathering Area	Site: 1 to 2	E-379494 N-5779807	E-396683 N-5764303	14N	23149 m

Potential for presence of important architectural heritage resources

Sec-Seg ID	ESS ID	ESS Name	Location	Easting	Northing	UTM Zone
C1-S01	C1-Hert-100	Historical Trail	Site: C1	388314	5771855	14N

Potential disturbance to heritage Resources

Sec-Seg ID	ESS ID	ESS Name	Location	Start	Stop	UTM Zone	Distance
C1-S01	C1-Eco-300	Species of Concern	Site: 5 to 6	E-386187 N-5773771	E-393457 N-5767213	14N	9791 m

Potential loss of previously known plants of conservation concern from clearing, construction, maintenance and decommissioning activities

Sec-Seg ID	ESS ID	ESS Name	Location	Easting	Northing	UTM Zone
C1-S01	C1-Acss-101	Access Route	Site: C2	388316	5771850	14N
C1-S01	C1-Acss-102	Access Route	Site: C3	388819	5771396	14N
C1-S01	C1-Acss-103	Access Route	Site: C4	388928	5771298	14N
C1-S01	C1-Acss-104	Access Route	Site: C5	389012	5771223	14N

Potential disturbance of access; disruption of social cohesion

Sec-Seg ID	ESS ID	ESS Name	Location	Start	Stop	UTM Zone	Distance
C1-S01	C1-Soils-300	Wind Erosion Risk	Site 7 to 8		E-387910 N-5772216	14N	1129 m
C1-S01	C1-Soils-300	Wind Erosion Risk	Sita. 0 to 10	E-388916 N-5771309	E-389177 N-5771073	14N	352 m
C1-S01	C1-Soils-301	Wind Erosion Risk	Site: 11 to 12	E-389177 N-5771073	E-390222 N-5770131	14N	1408 m

Loss of topsoil due to wind erosion (eg creep, saltation, suspension) on disturbed surfaces

- Carry out construction activities on frozen or dry ground to minimize surface damage, rutting and erosion
- Minimize surface disturbance around the site to the extent possible
- Remove trees by low-disturbance methods
- No Herbicide to be applied during construction
- Confine vehicle traffic to established trails to the extent possible

- · Carry out construction activities on frozen or dry ground to minimize surface damage, rutting and erosion
- Identify and flag prior to start of work
- Conduct site investigation with Archaeologist post clearing and prior to construction
- Minimize surface disturbance around the site to the extent possible
- Inspect excavated materials or surface disturbance for heritage resources and report any finds to Environmental Inspector
- Implement additional mitigation from site investigation

- · Carry out construction activities on frozen or dry ground to minimize surface damage, rutting and erosion
- Use existing access roads and trails to the extent possible
- Remove trees by low-disturbance methods
- Confine vehicle traffic to established trails to the extent possible
- Stabilize sites immediately after construction and re-vegetate disturbed areas in accordance with site Rehabilitation Plan

- Carry out construction activities on frozen or dry ground to minimize surface damage, rutting and erosion
- Avoid surface damage to and obstruction of access route
- Inspect excavated materials or surface disturbance for heritage resources and report any finds to Environmental Inspector
- If any heritage resources are discovered, Archaeologist to conduct site investigation and recommend any additional mitigation measures

- Carry out construction activities on frozen ground to minimize surface damage, rutting and erosion
- Use existing trails, roads or cut lines whenever possible as access routes
- Identify and flag prior to start of work
- Avoid dry soil conditions with high and severe wind erosion risk to the extent possible
- Maintain shrub and herbaceous vegetation to the extent possible
- Remove trees by hand or other low-disturbance methods
- Confine vehicle traffic to established trails to the extent possible
- Implement erosion protection before commencing construction in accordance with Erosion/Sediment Control Plan

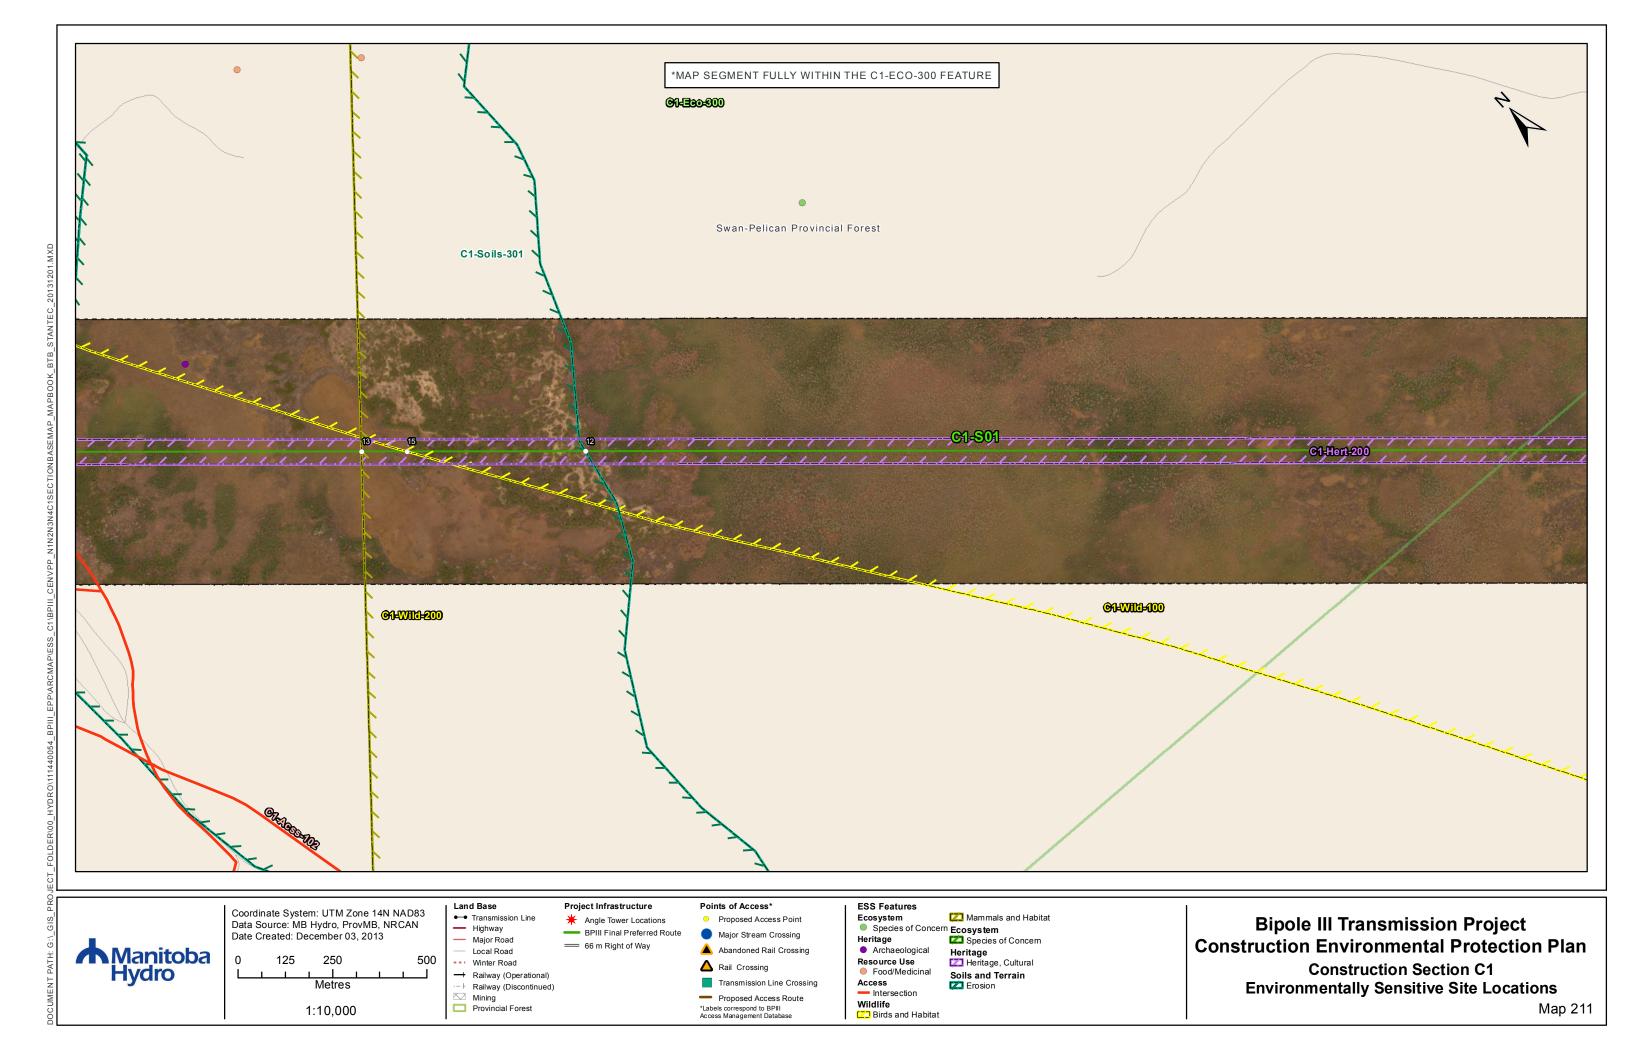
MAP NUMBER: 211 cont'd

Sec-Seg ID	ESS ID	ESS Name	Location	Start	Ston	UTM Zone	Distance
C1-S01		Bird migration route identified by community		E-389871 N-5770447	E-395171 N-5765667	14N	7137 m

Change in bird migration route due to transmission line

Sec-Seg ID	ESS ID	ESS Name	Location	Start	Stop	UTM Zone	Distance
C1-S01	C1-Eco-300	Species of Concern	Site: 5 to 6	E-386187 N-5773771	E-393457 N-5767213	14N	9791 m

Potential loss of previously known plants of conservation concern from clearing, construction, maintenance and decommissioning activities

Sec-Seg ID	ESS ID	ESS Name	Location	Start	Stop	UTM Zone	Distance
C1-S01	C1-Hert-200	Plant Gathering Area	Site: 1 to 2	E-379494 N-5779807	E-396683 N-5764303	14N	23149 m

Potential for presence of important architectural heritage resources

Sec-Seg ID	ESS ID	ESS Name	Location	Start	Stop	UTM Zone	Distance
C1-S01	C1-Soils-301	Wind Erosion Risk	Site: 11 to 12	E-389177 N-5771073	E-390222 N-5770131	14N	1408 m

Loss of topsoil due to wind erosion (eg creep, saltation, suspension) on disturbed surfaces

Sec-Seg ID	ESS ID	ESS Name	Location	Start	Ston	UTM Zone	Distance
C1-S01	C1-Wild-200	Moose Sensitive Area	Site: 13 to 14	E-389782 N-5770528	E-395210 N-5765631	14N	7311 m

Potential disturbance to and loss of sensitive moose habitat

- Adhere to reduced risk timing windows for protection of birds (August 1- April 30)
- Maintain applicable setback during nesting and breeding timing window
- · Conduct priority assessment for bird diverters and other measures prior to transmission line stringing
- Install bird diverters or other measures at high priority sites

- · Carry out construction activities on frozen or dry ground to minimize surface damage, rutting and erosion
- Use existing access roads and trails to the extent possible
- Remove trees by low-disturbance methods
- Confine vehicle traffic to established trails to the extent possible
- Stabilize sites immediately after construction and re-vegetate disturbed areas in accordance with site Rehabilitation Plan

- Carry out construction activities on frozen or dry ground to minimize surface damage, rutting and erosion
- Minimize surface disturbance around the site to the extent possible
- Remove trees by low-disturbance methods
- No Herbicide to be applied during construction
- Confine vehicle traffic to established trails to the extent possible

- Carry out construction activities on frozen ground to minimize surface damage, rutting and erosion
- Use existing trails, roads or cut lines whenever possible as access routes
- Identify and flag prior to start of work
- · Avoid dry soil conditions with high and severe wind erosion risk to the extent possible
- Maintain shrub and herbaceous vegetation to the extent possible
- Remove trees by hand or other low-disturbance methods
- Confine vehicle traffic to established trails to the extent possible
- Implement erosion protection before commencing construction in accordance with Erosion/Sediment Control Plan

- Manitoba Hydro will not support development of designated motorized recreational trail use within areas described above if requested
- No shear blading to clear the ROW in the sensitive range Selective cutting methods to be used leaving low shrub and herb plant communities on the ROW

- Slash piles will be stockpiled every 200m-400m during clearing, adjacent to centerline trail, these piles will be placed on centerline trail post construction

- Annual ground inspection of towers to occur late in winter season to avoid creating packed snow trails that facilitate predator use of the ROW
- Selective cutting to remove danger trees only on portions of the ROW to reduce line of site for hunters and predators and facilitate wildlife movement across the ROW

- Any access trails used to access the ROW for construction that will not be needed for future maintenance will be
  decommissioned on completion of construction Any culverts or road improvements will be removed and the first 100
  m from of the trail dug up to the extent possible Available slash < 1 m in height will also be evenly distributed over
  the access trail to reduce the possibility of use be ATV traffic</li>
