FISH MOVEMENTS AND TURBINE PASSAGE AT SELECTED MANITOBA HYDRO GENERATING STATIONS

2005 – 2006 INTERIM REPORT

Prepared
for
Manitoba Hydro

North/South Consultants Inc. and Normandeau Associates Inc.

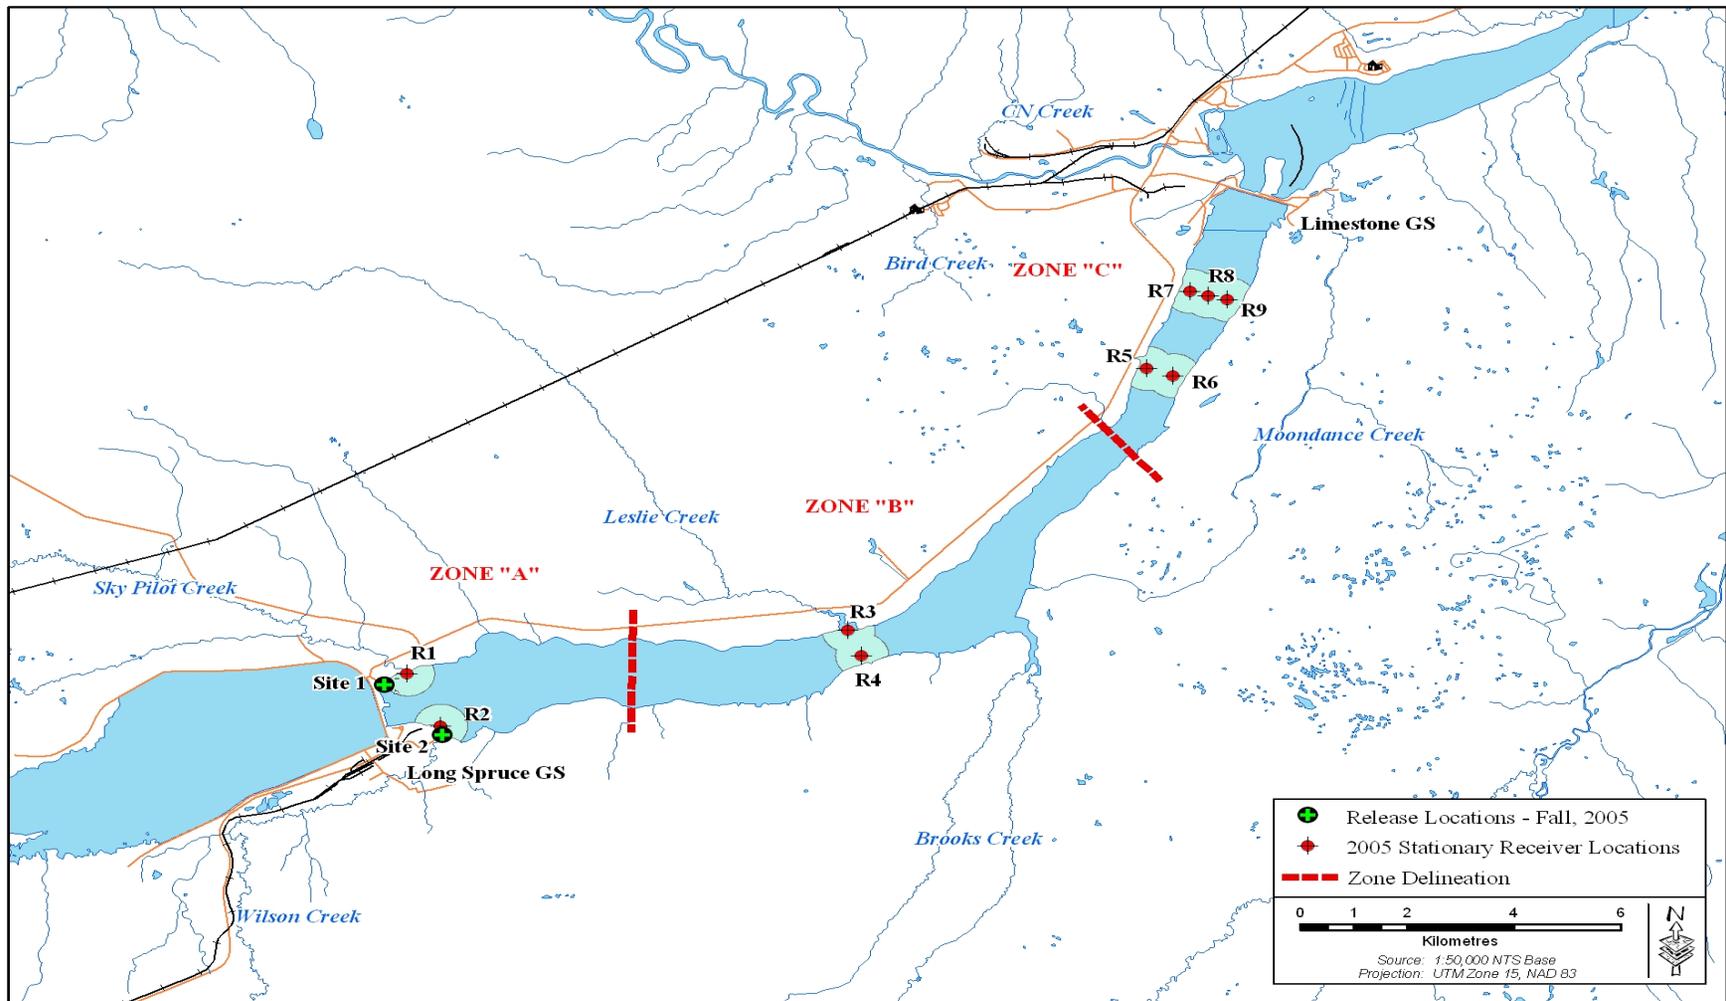
Figure 1. Locations of release sites of fish, stationary acoustic receivers, and estimated minimum range of detection of receivers in the Limestone GS forebay, fall 2005.

During fall, 2005, movements of acoustic-tagged fish were monitored using nine stationary VR2 receivers positioned throughout the Limestone forebay (Figure 1). All receivers were removed from the Nelson River on 1 and 2 November, 2005, to prevent being lost or damaged over winter.

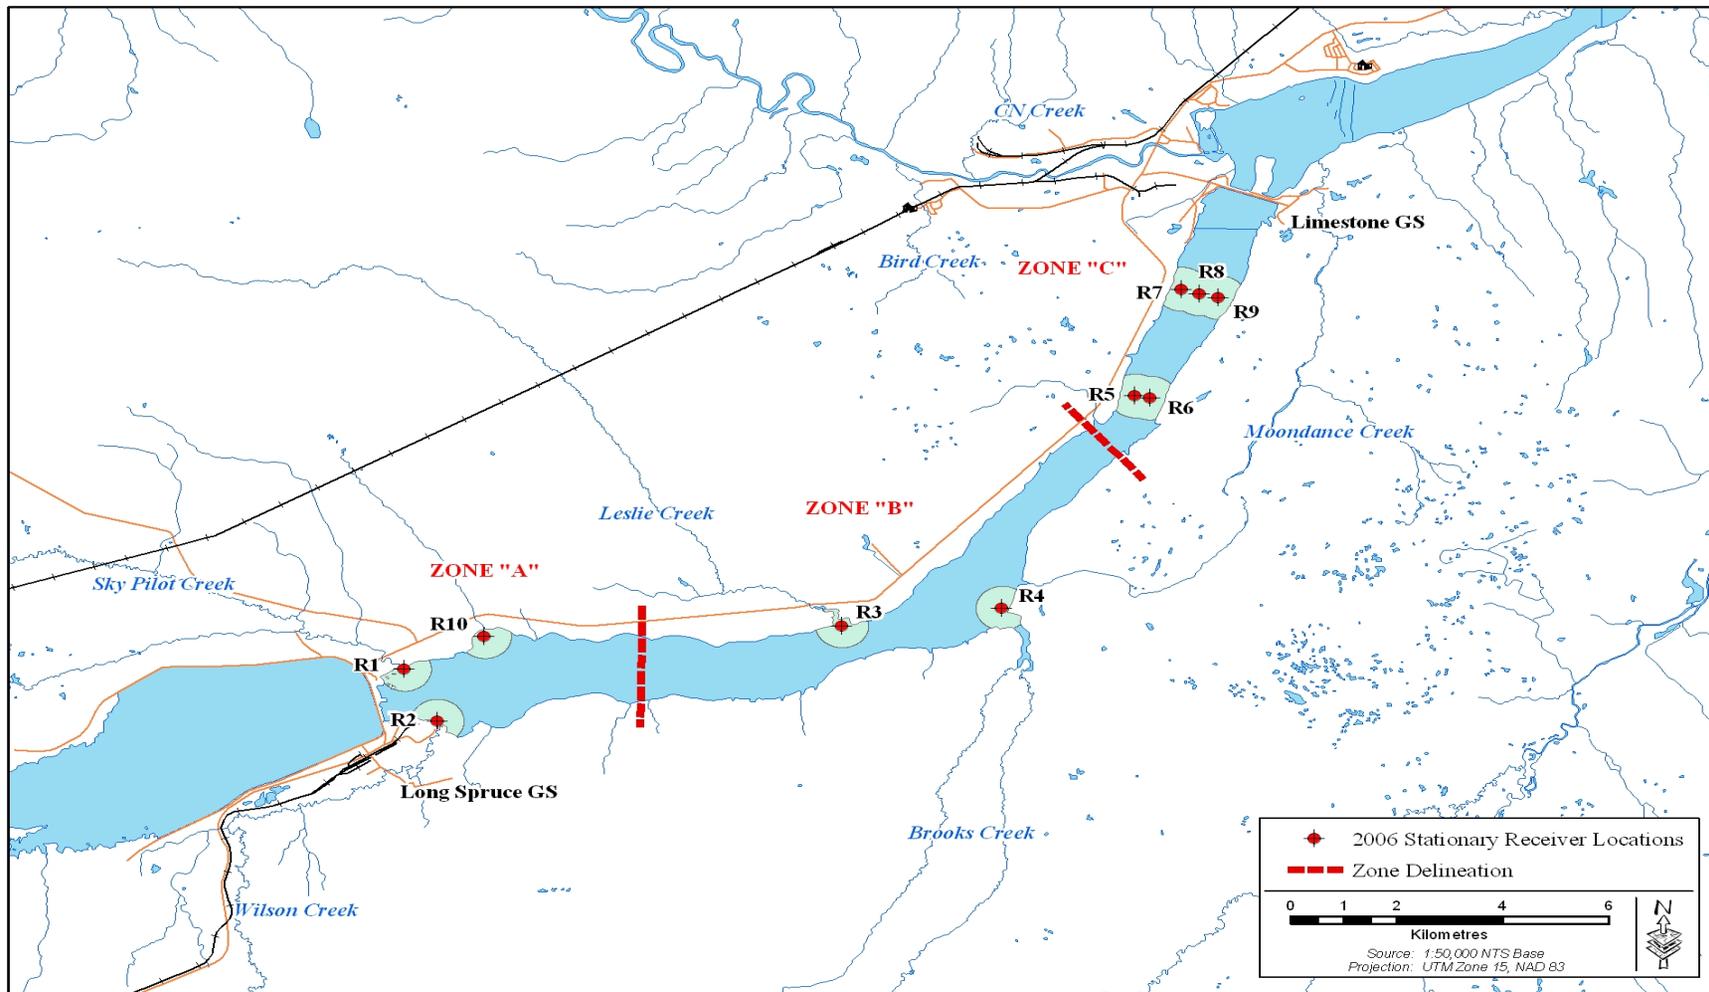
Figure 2. Locations of stationary acoustic receivers and their estimated minimum range of detection (green shading) in the Limestone GS forebay, May to November, 2006.

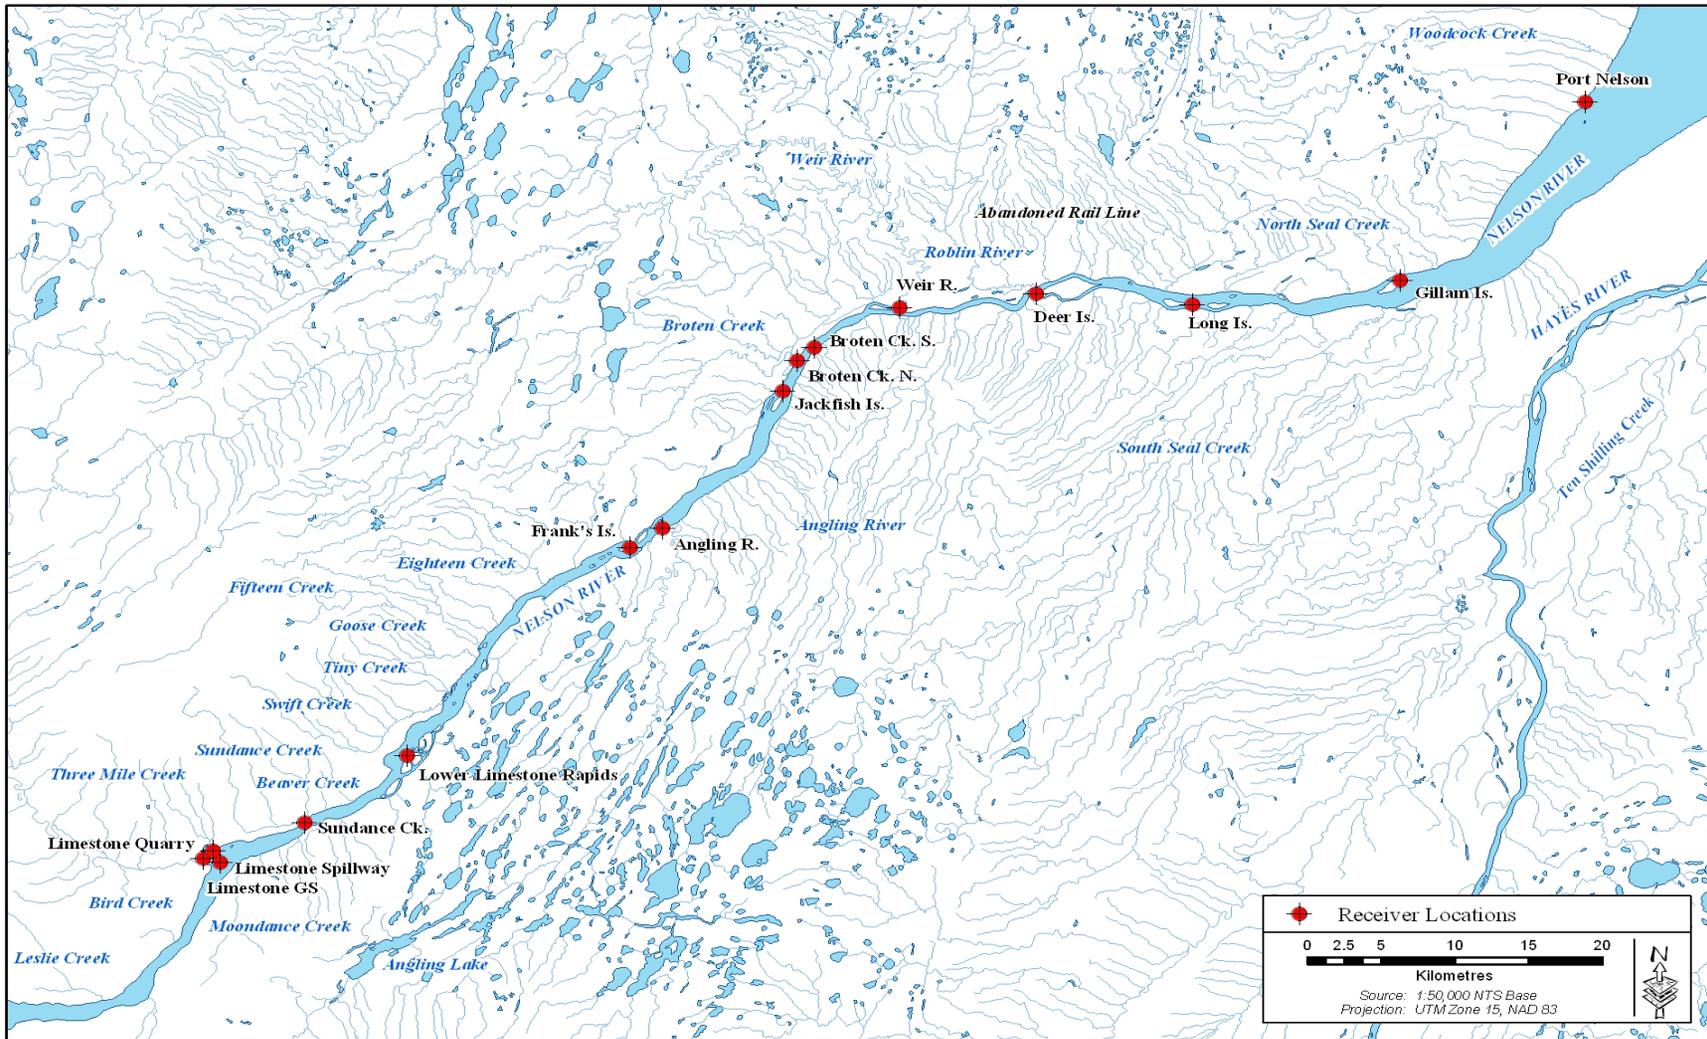
Figure 3. Locations of stationary acoustic receivers downstream of the Limestone GS, May to November, 2006.

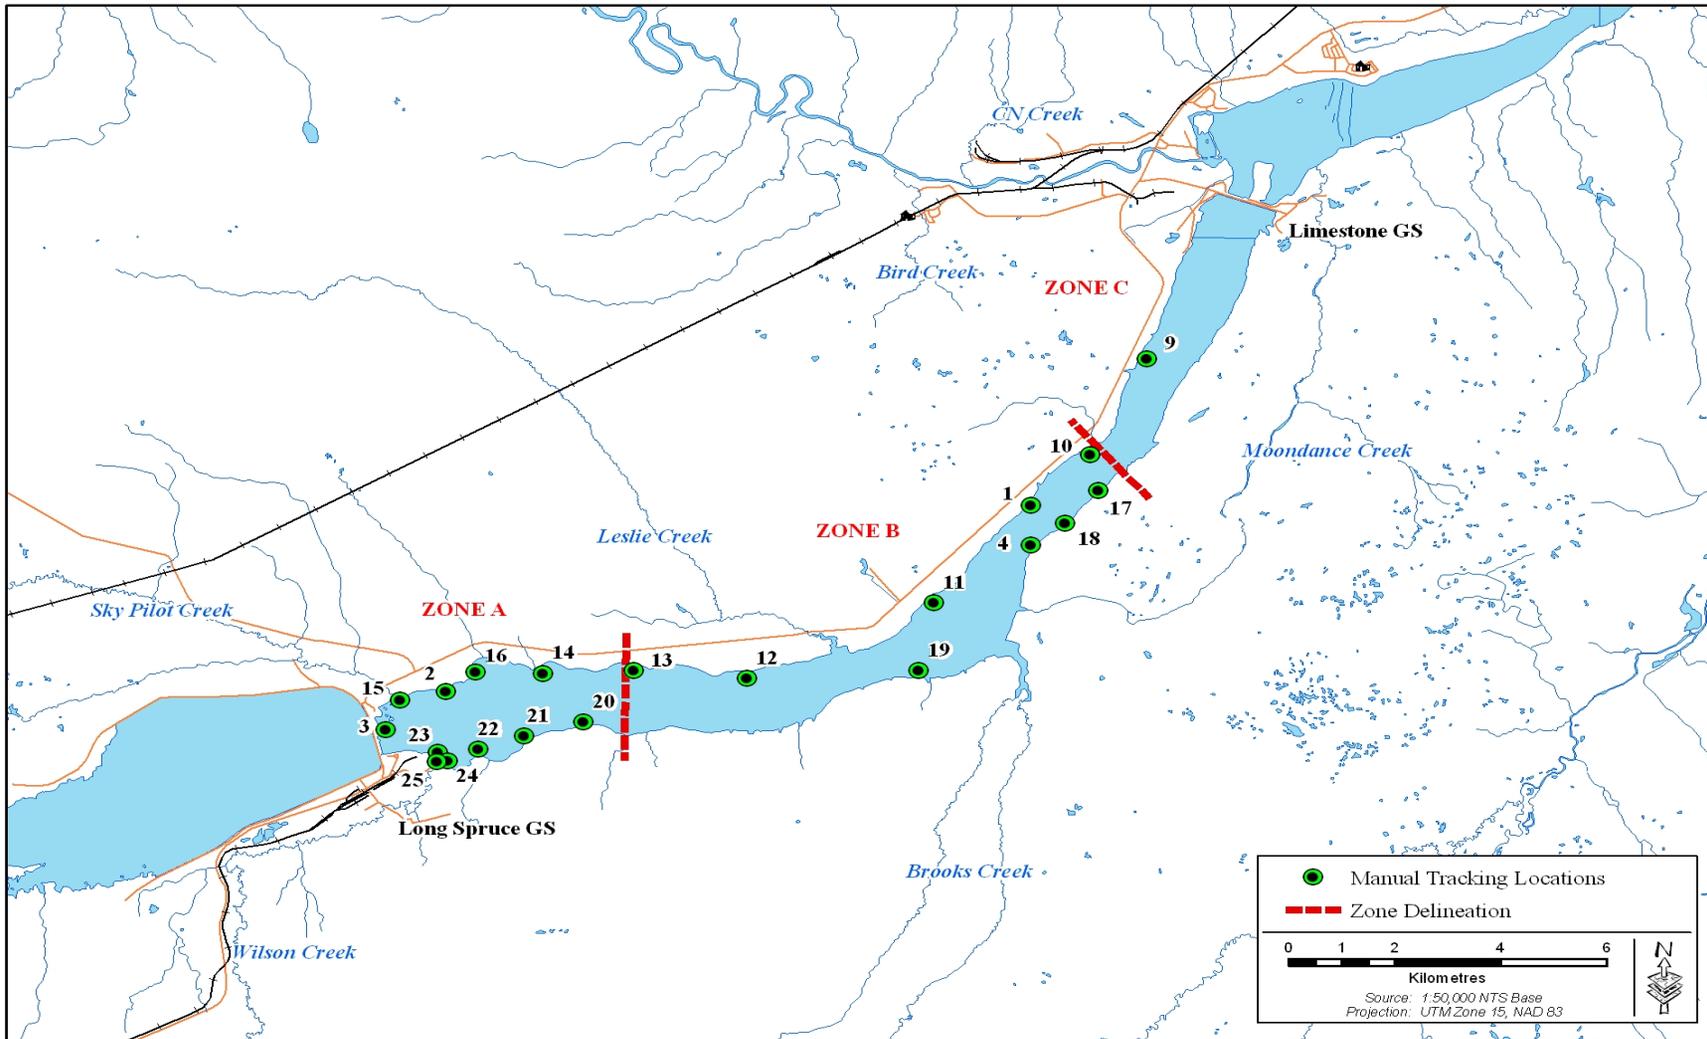
Figure 4. Manual tracking (VR60) locations in the Limestone forebay during the open-water season in 2006.

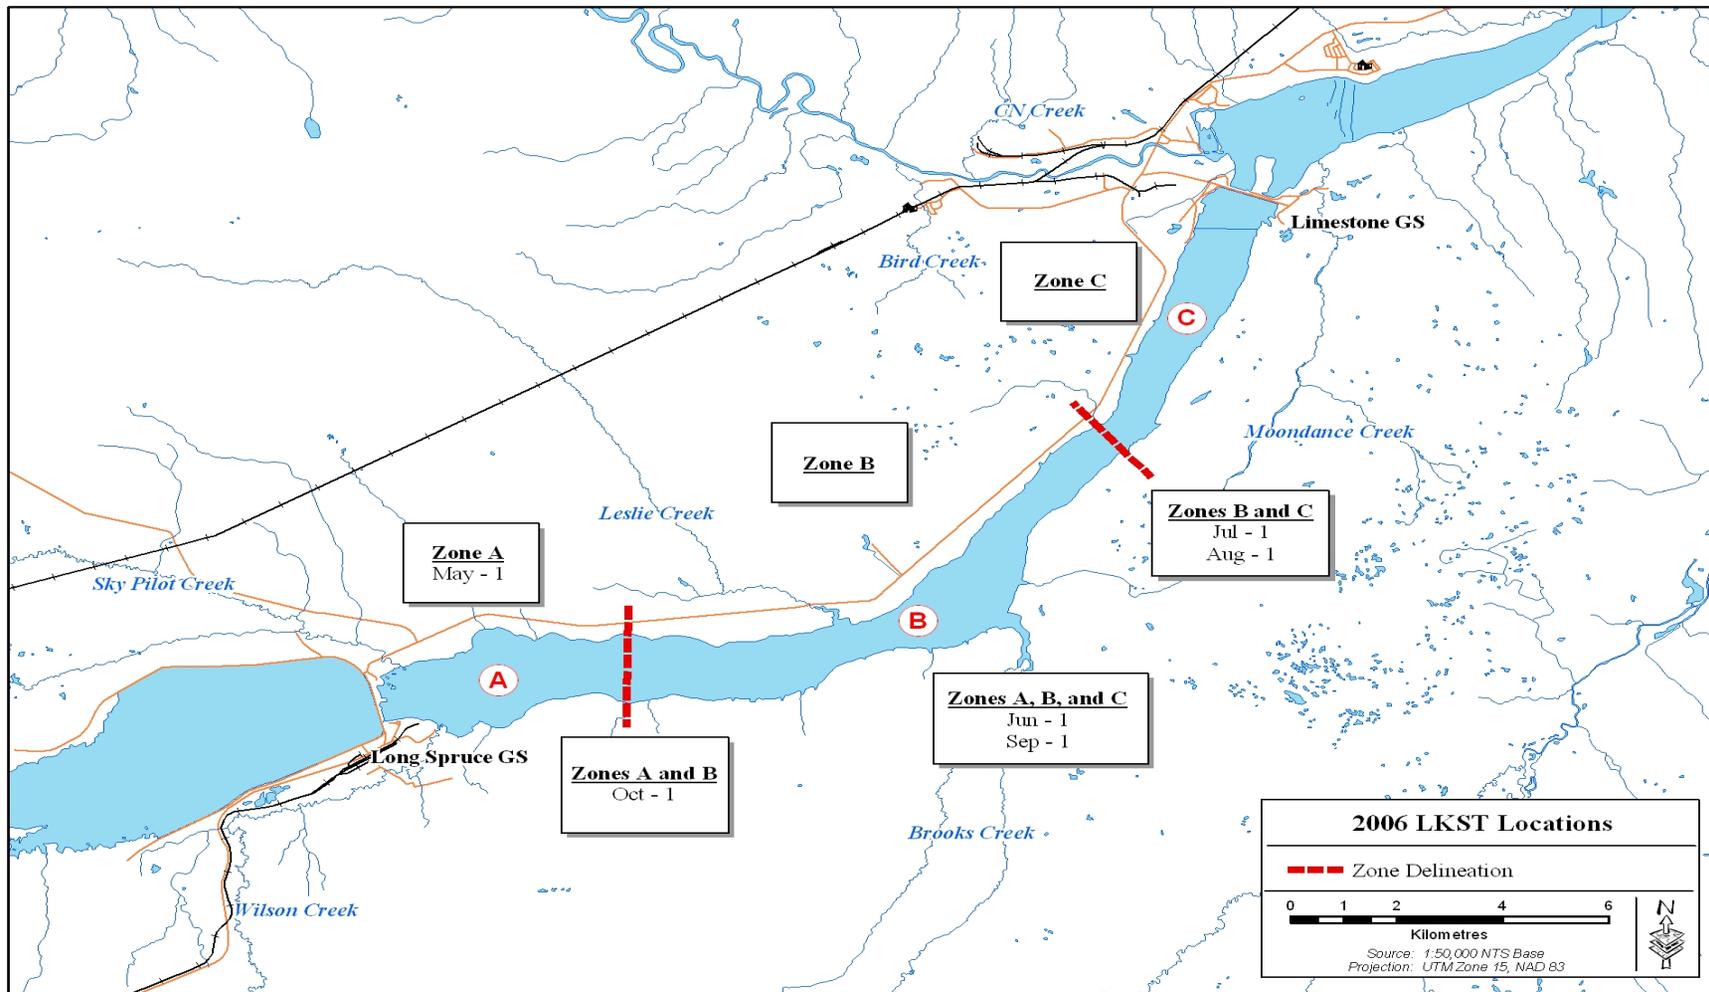
Figure 5. Monthly relocation data, by zone, for the acoustic-tagged lake sturgeon in the Limestone forebay during the open-water season in 2006.

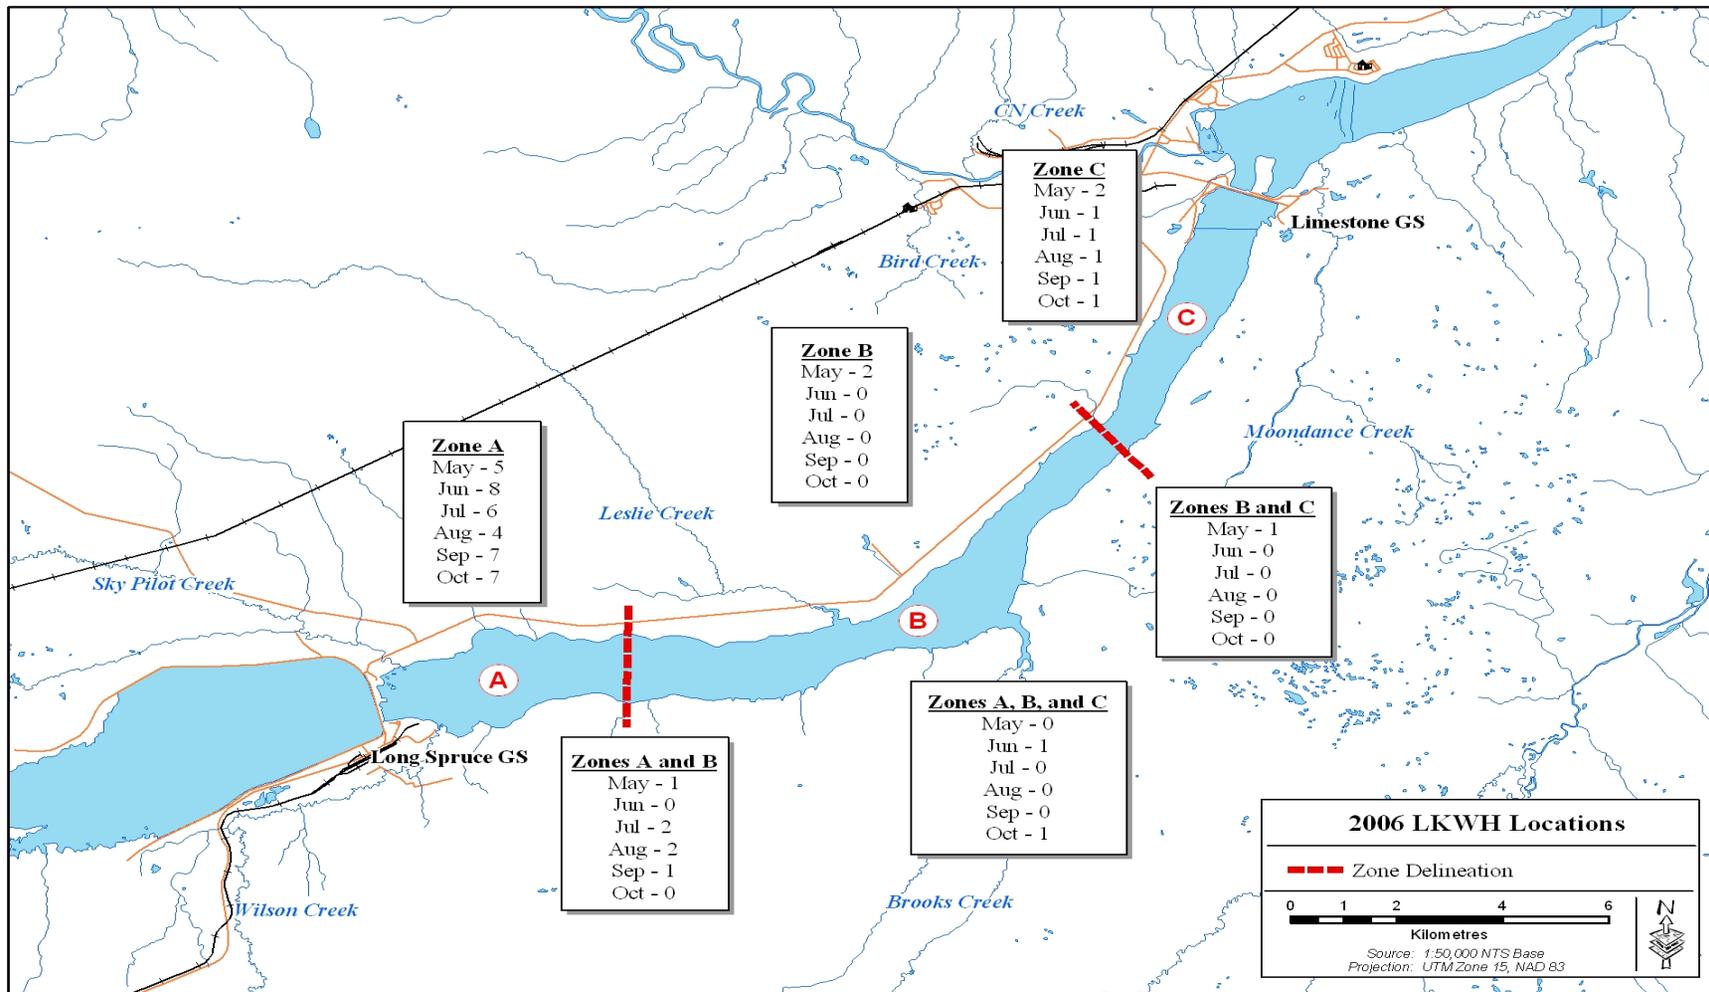
Figure 6. Monthly relocation data, by zone, for acoustic-tagged lake whitefish in the Limestone forebay during the open-water season in 2006.

As of November, 2006, at least twelve (60%) of the acoustic-tagged lake whitefish remain in the forebay. Overall, lake whitefish were most often found in Zone A, and six lake whitefish did not move downstream of Zone A throughout the entire open-water season (tables 2 and 3; Figure 6).

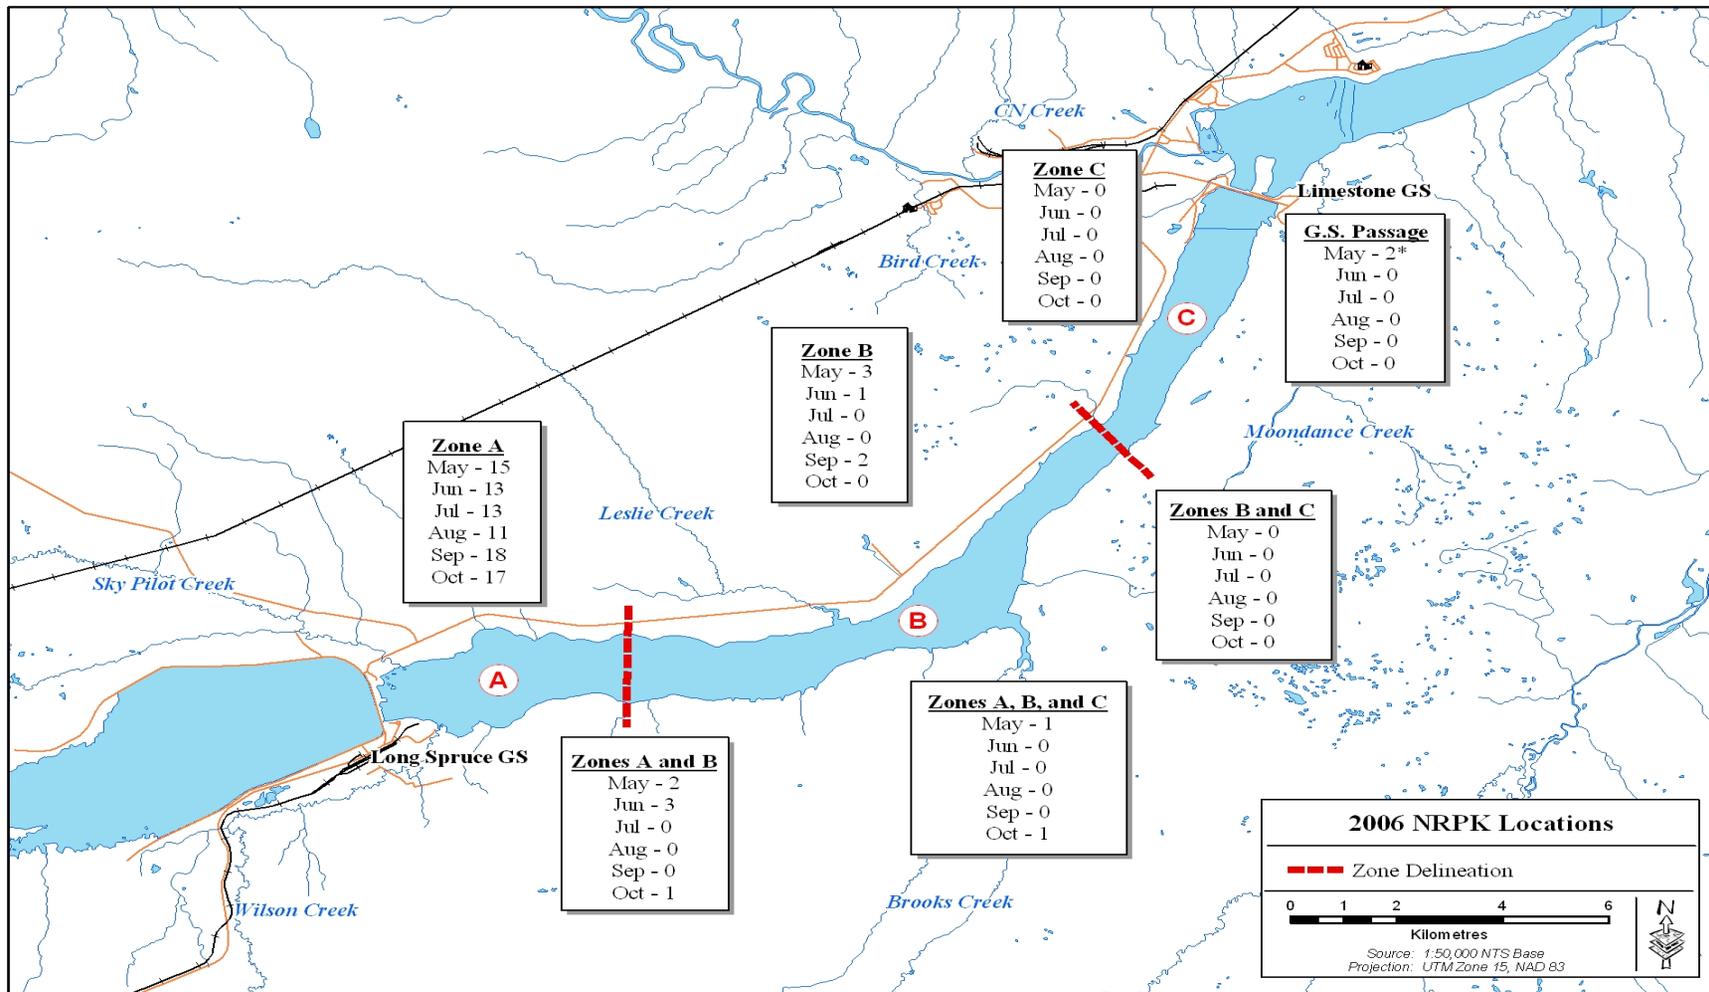
Figure 7. Monthly relocation data, by zone, for acoustic-tagged northern pike in the Limestone forebay during the open-water season in 2006.

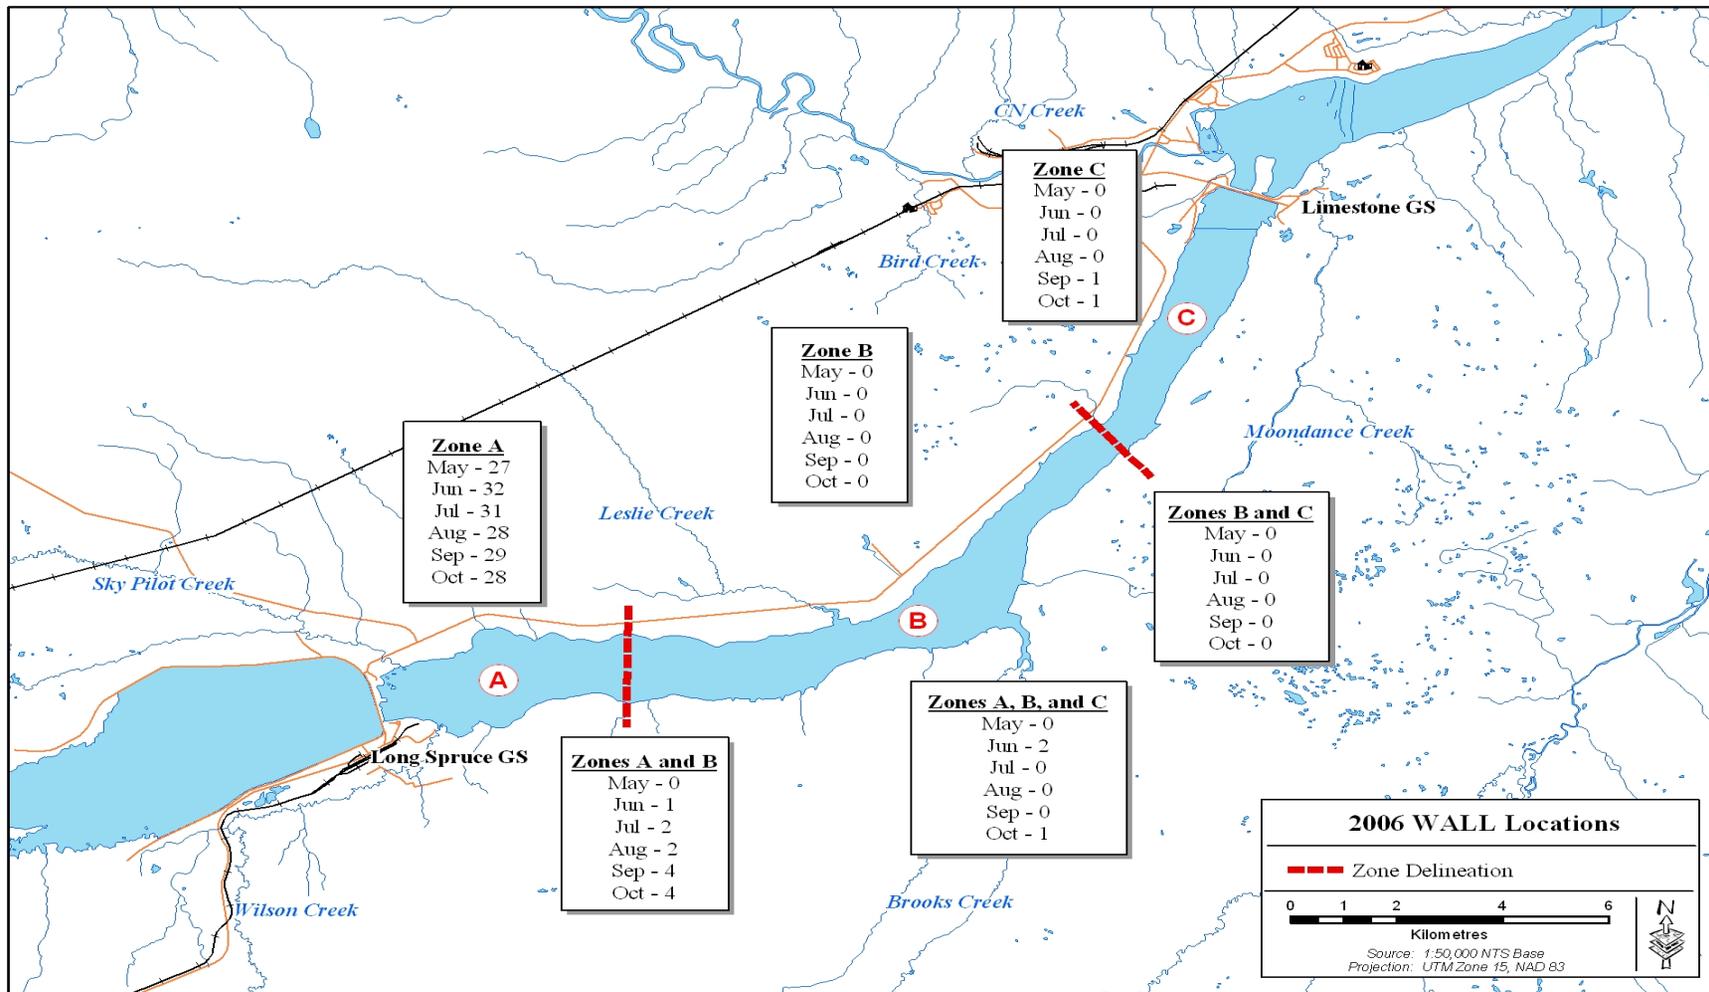
Figure 8. Monthly relocation data, by zone, for acoustic-tagged walleye in the Limestone forebay during the open-water season in 2006.

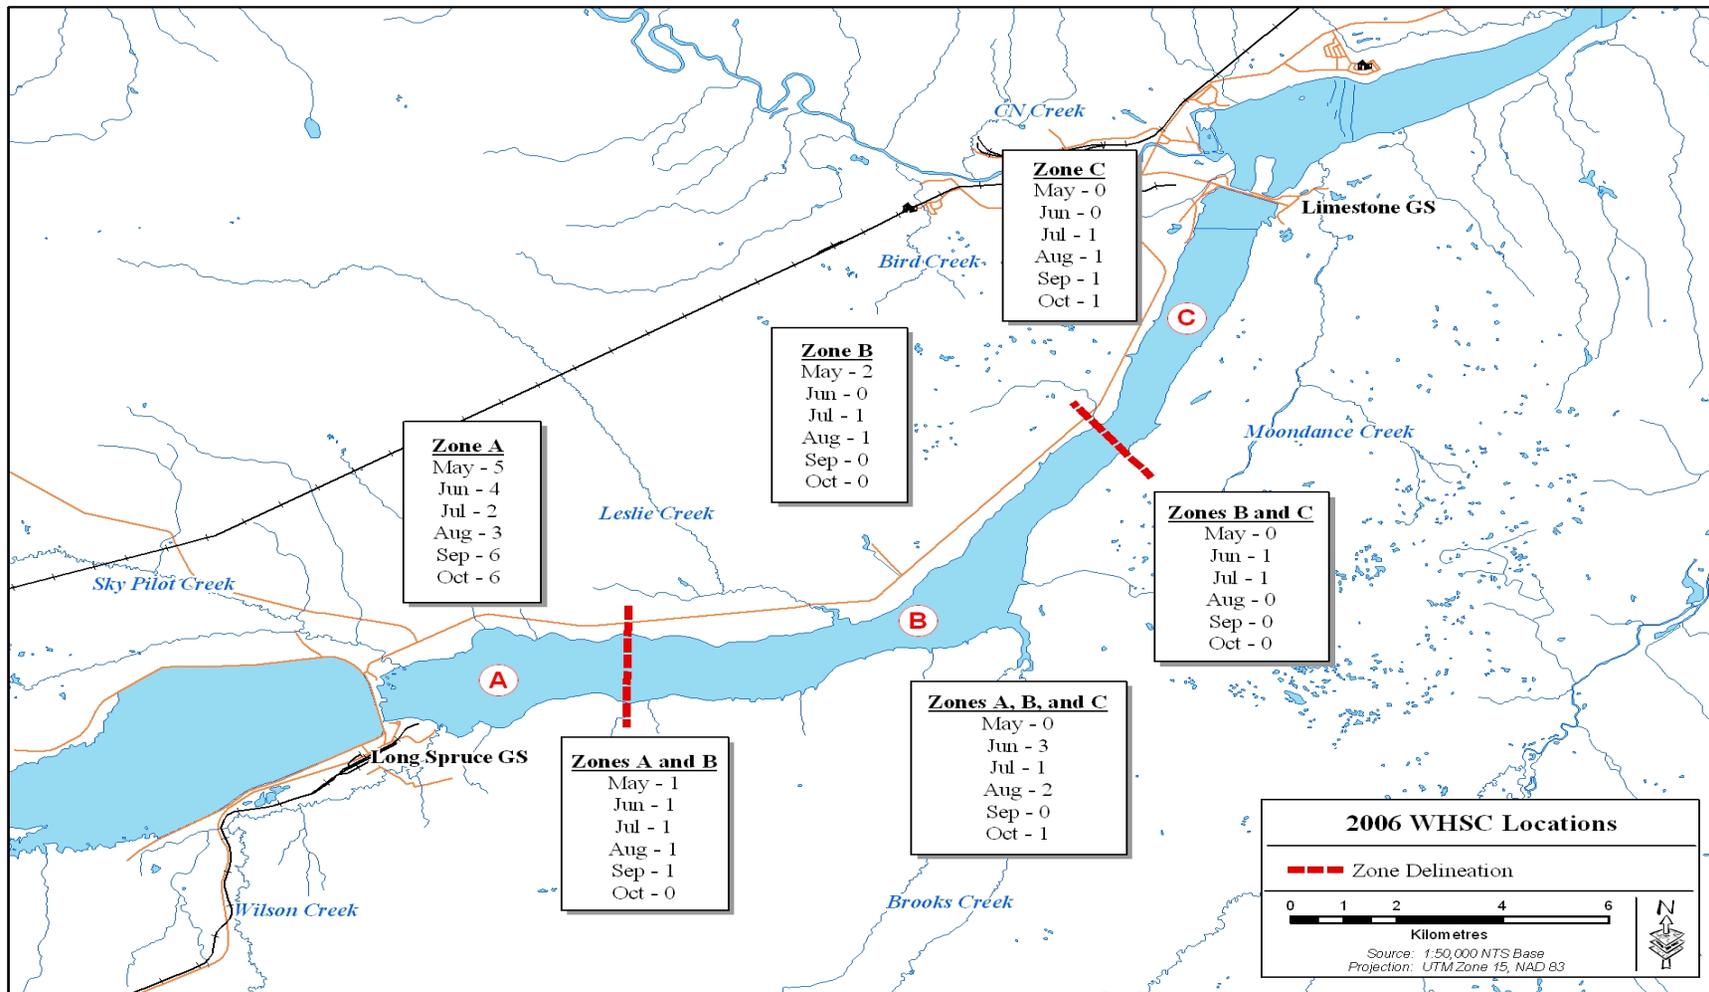
Figure 9. Monthly relocation data, by zone, for acoustic-tagged white sucker in the Limestone forebay during the open-water season in 2006

White sucker were found to move throughout the forebay during fall, 2005, including the middle and lower regions. During spring 2006, nine of the eleven white sucker were initially relocated in Zone A (Table 2; Figure 9). Of these nine fish, six moved throughout the middle and lower reaches throughout the season, resulting in a distribution in fall, 2006, similar to that of 2005. The data appear to indicate that white sucker have a preference for the upper forebay in spring, with a tendency to be distributed throughout the forebay during summer and fall (Figure 9).

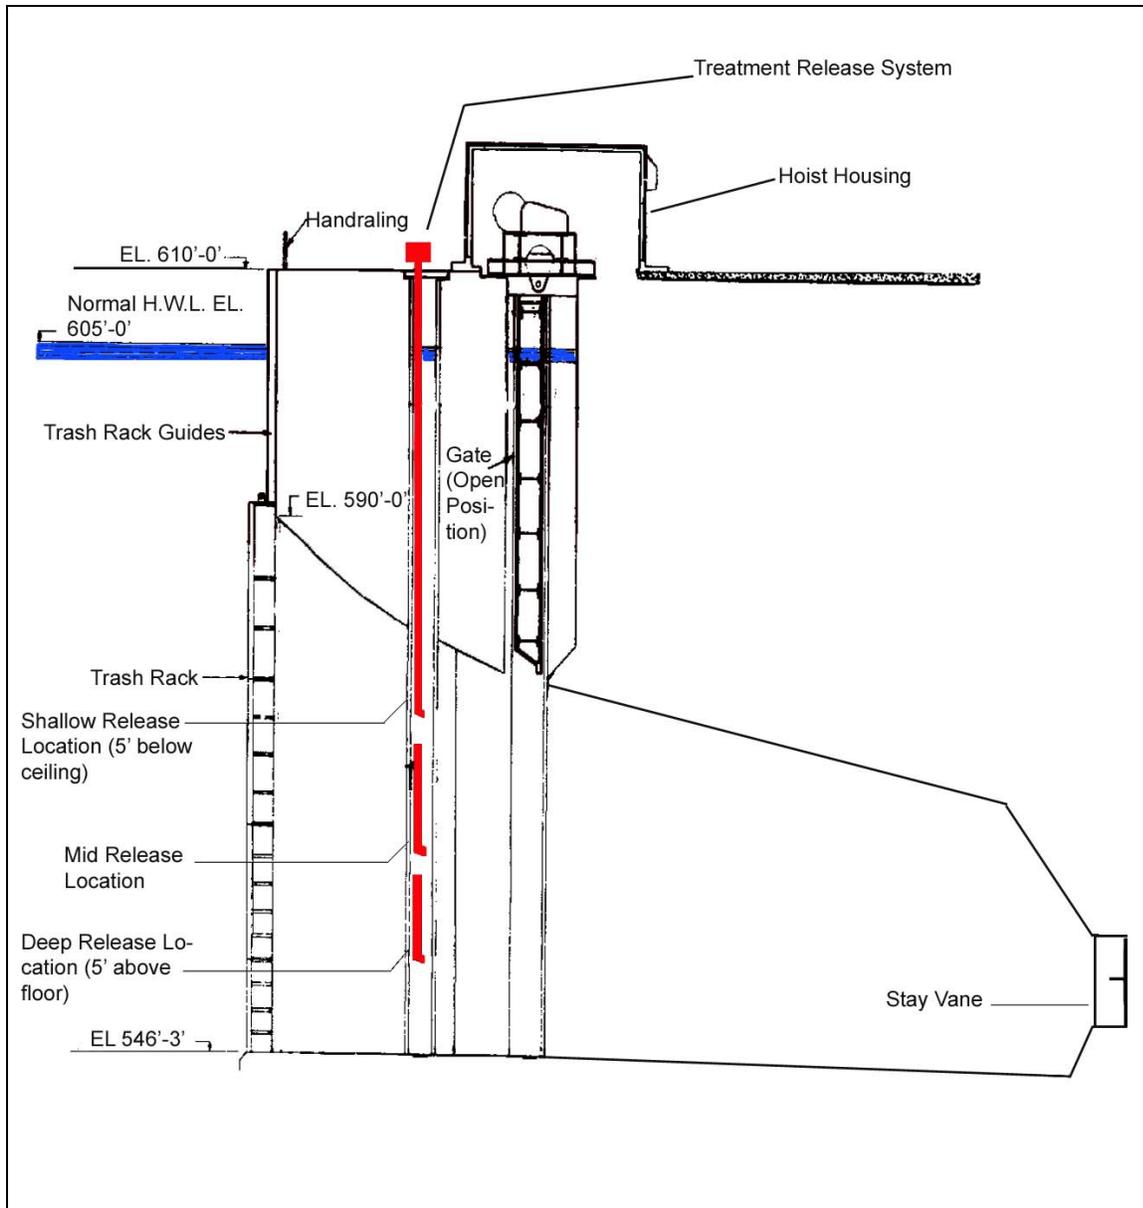
Figure 2-1

Cross-section of the Kelsey GS head works and intake with schematic of treatment fish release system and locations.

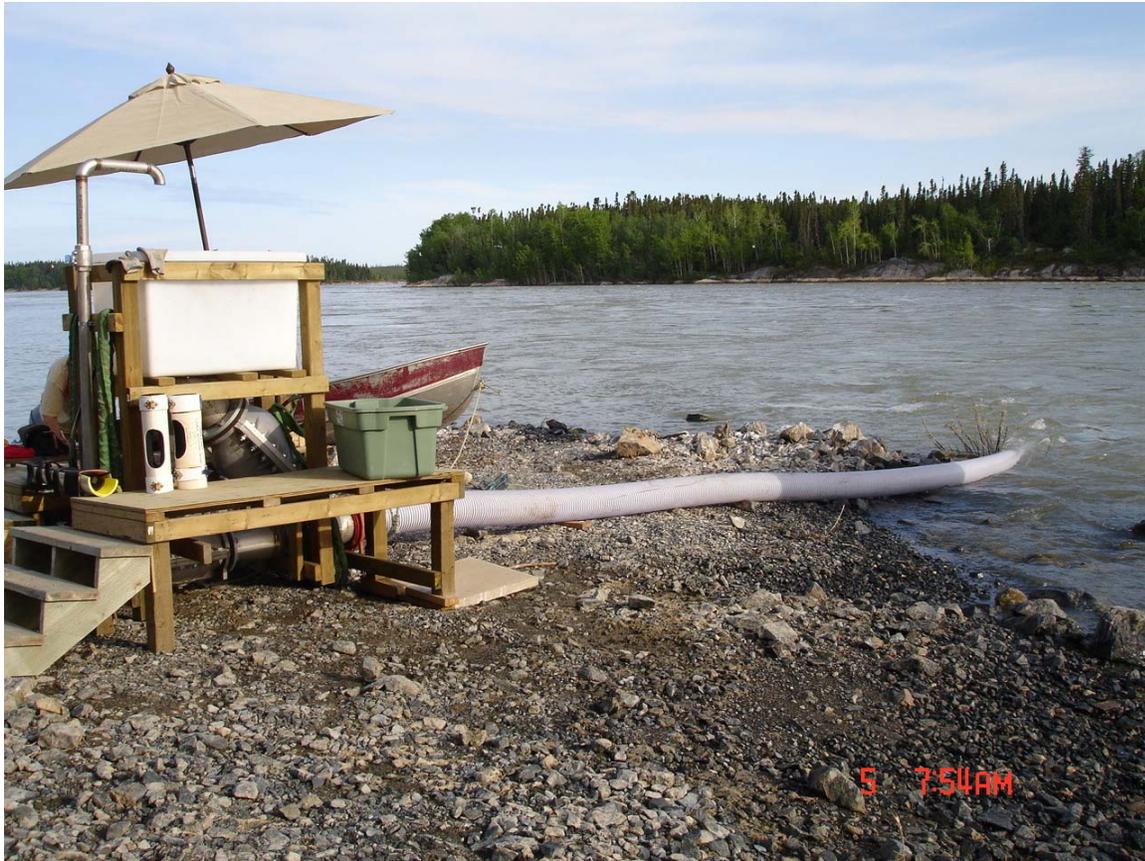
Figure 2-2

Control site and release hose extending into Nelson River.

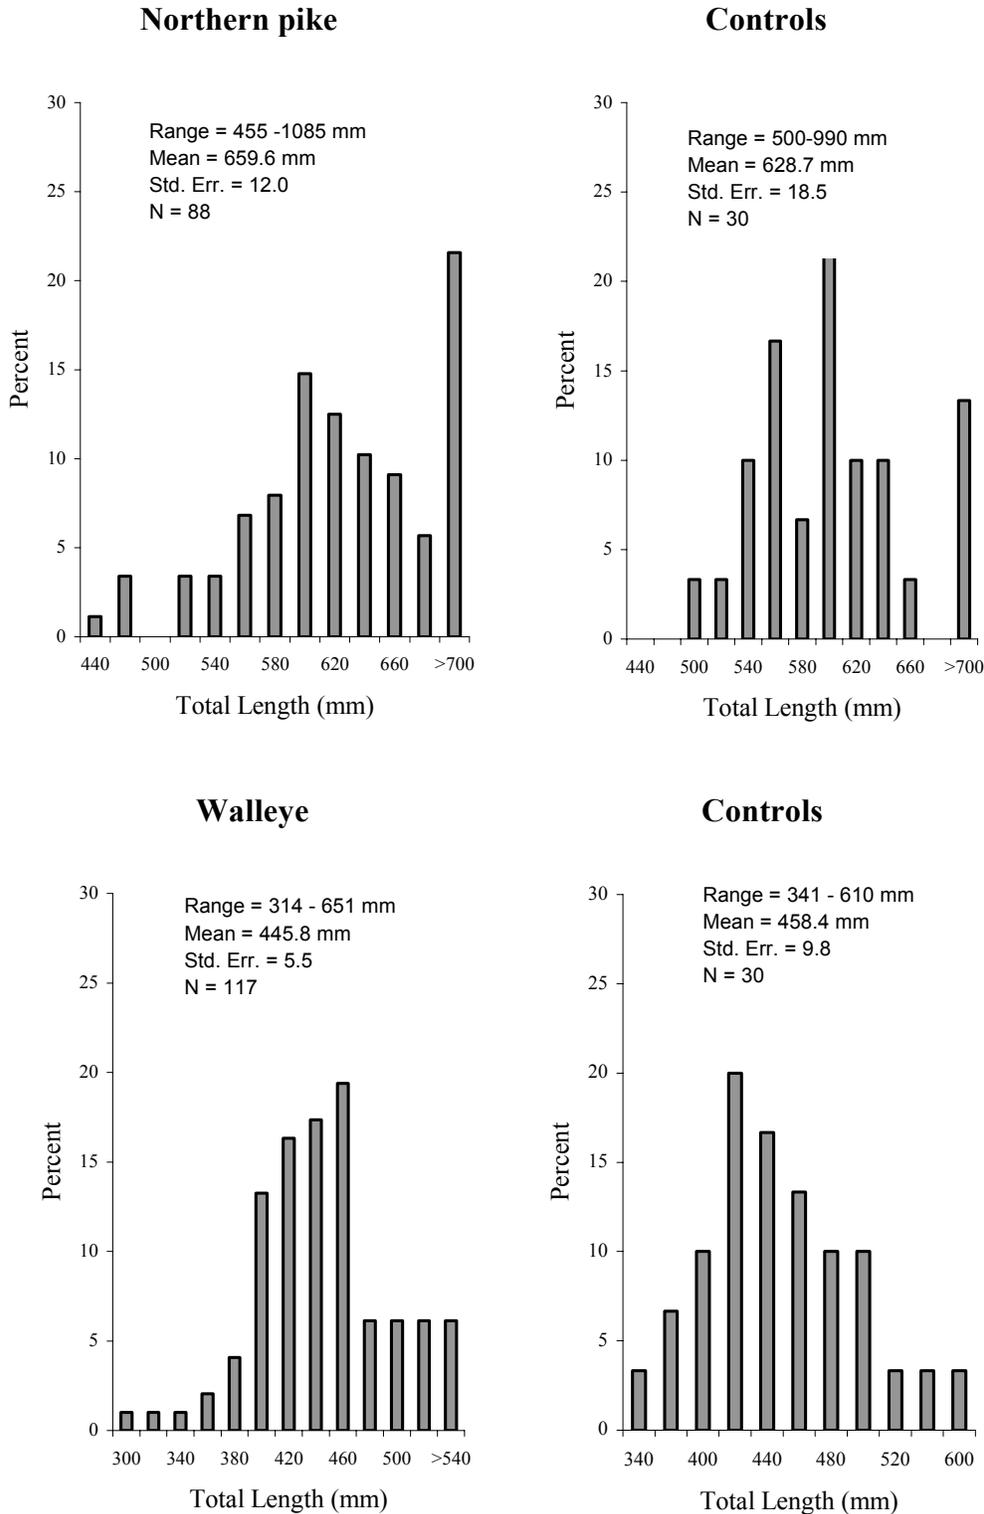
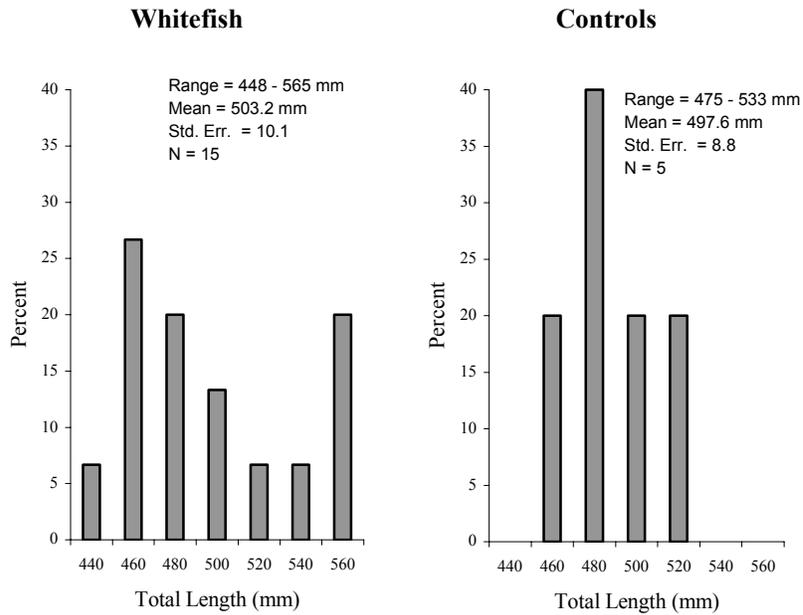
Figure 2-4

Total length (mm) frequency distribution of treatment and control northern pike and walleye released through Kelsey GS, June 2006.

Total length (mm) frequency distribution of treatment and control lake whitefish released through the Kelsey GS, June 2006.

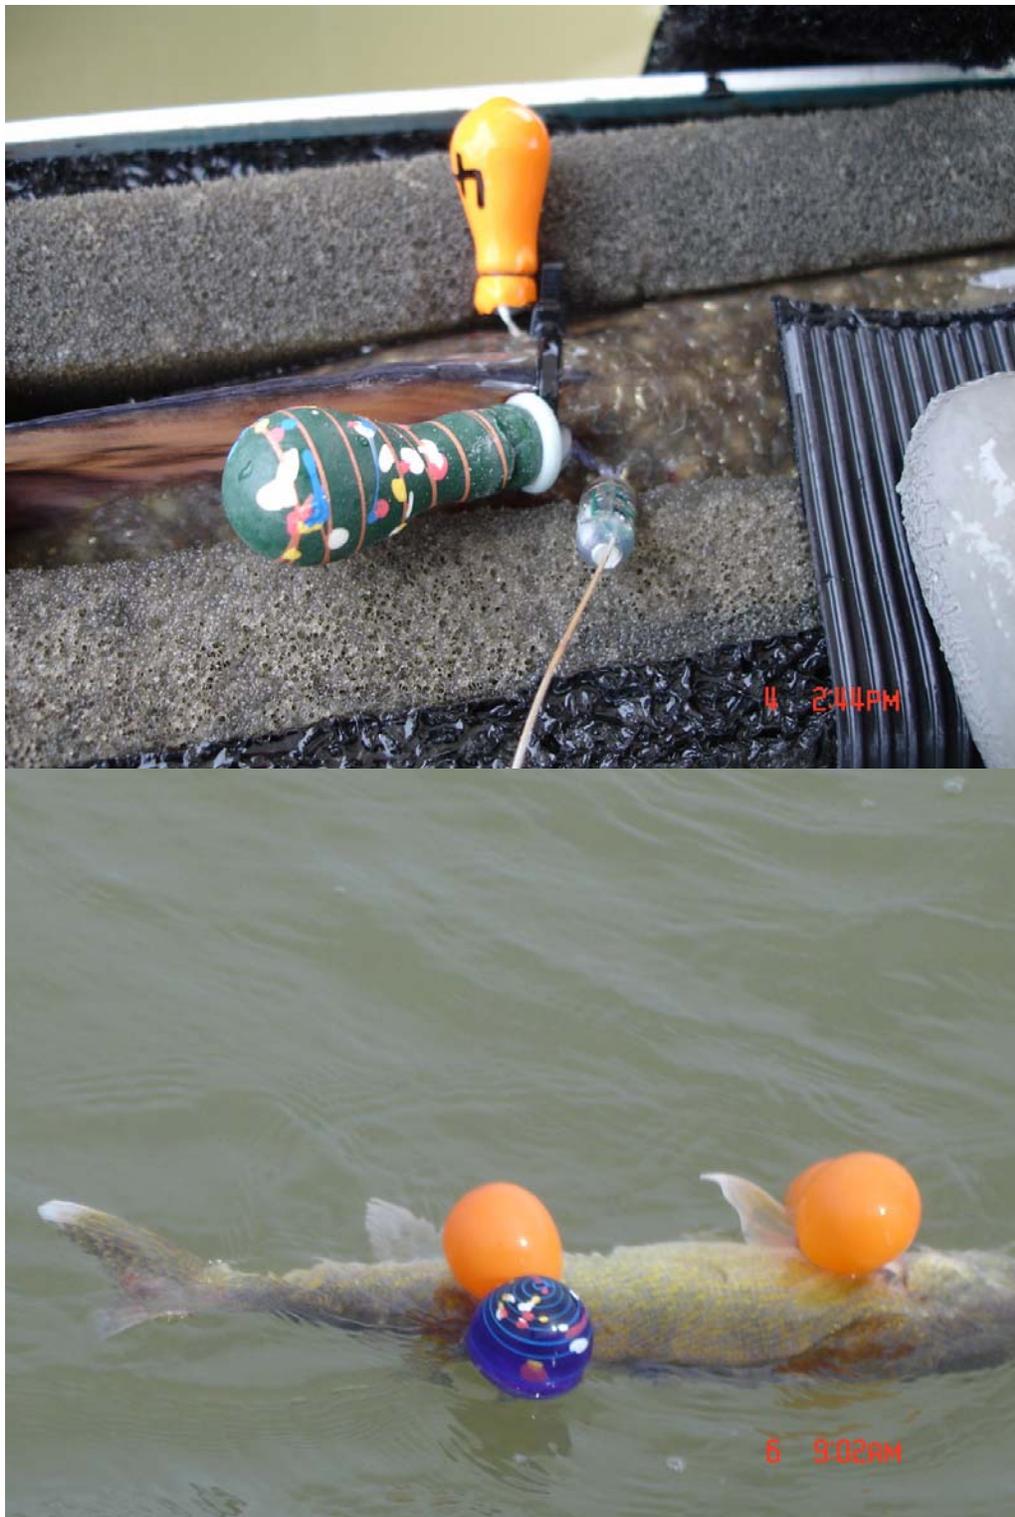
Figure 2-5

HI-Z balloon tagged fish. Upper photo uninflated; lower photo inflated balloons.

HI-Z tags were activated by injecting a small amount of water into the balloons which caused the tag to inflate in approximately 2 to 4 minutes. All treatment fish were released through an induction apparatus (Figure 2-7) that consisted of a holding basin attached to a 20.32 cm (8 inch) diameter flexible hose which led to a rigid 20.32 cm (8 inch) PVC pipe. This pipe was U-bolted onto a steel frame that could be raised or lowered to the desired release depth (Figure 2-8). The release hose was continuously supplied with river water to ensure fish were transported quickly to the desired release point. Control fish were released through the same induction apparatus attached to a 20.32 cm (8 inch) diameter flexible hose approximately 15 m (50 ft) long that released fish into the tailrace downstream of the turbulent eddies (Figure 2-2). Treatment fish were introduced into turbine Unit 2 at 3 depths, shallow (1.5 m below ceiling),
