FISH MOVEMENTS AND TURBINE PASSAGE AT SELECTED MANITOBA HYDRO GENERATING STATIONS

2005 – 2006 INTERIM REPORT

Prepared
for
Manitoba Hydro

North/South Consultants Inc. and Normandeau Associates Inc.

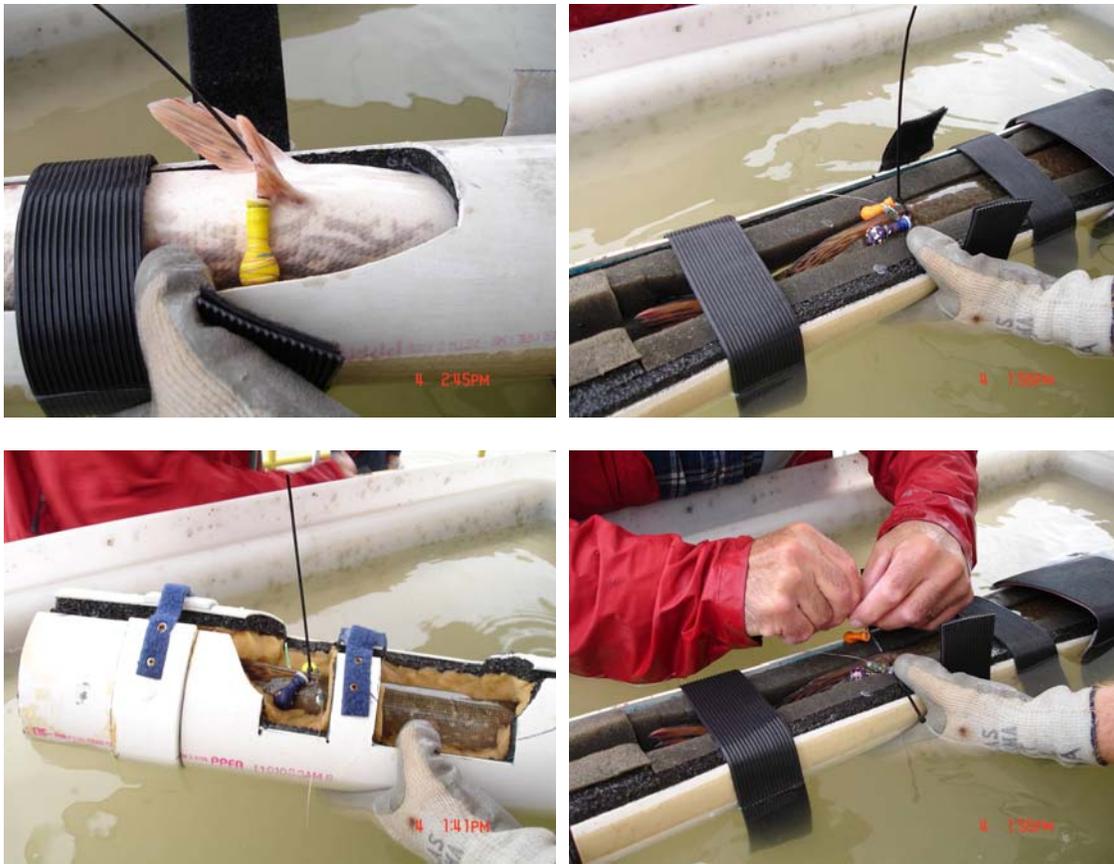
Figure 2-6

HI-Z tag attachment to adult fish while in restraint device at the Kelsey GS.

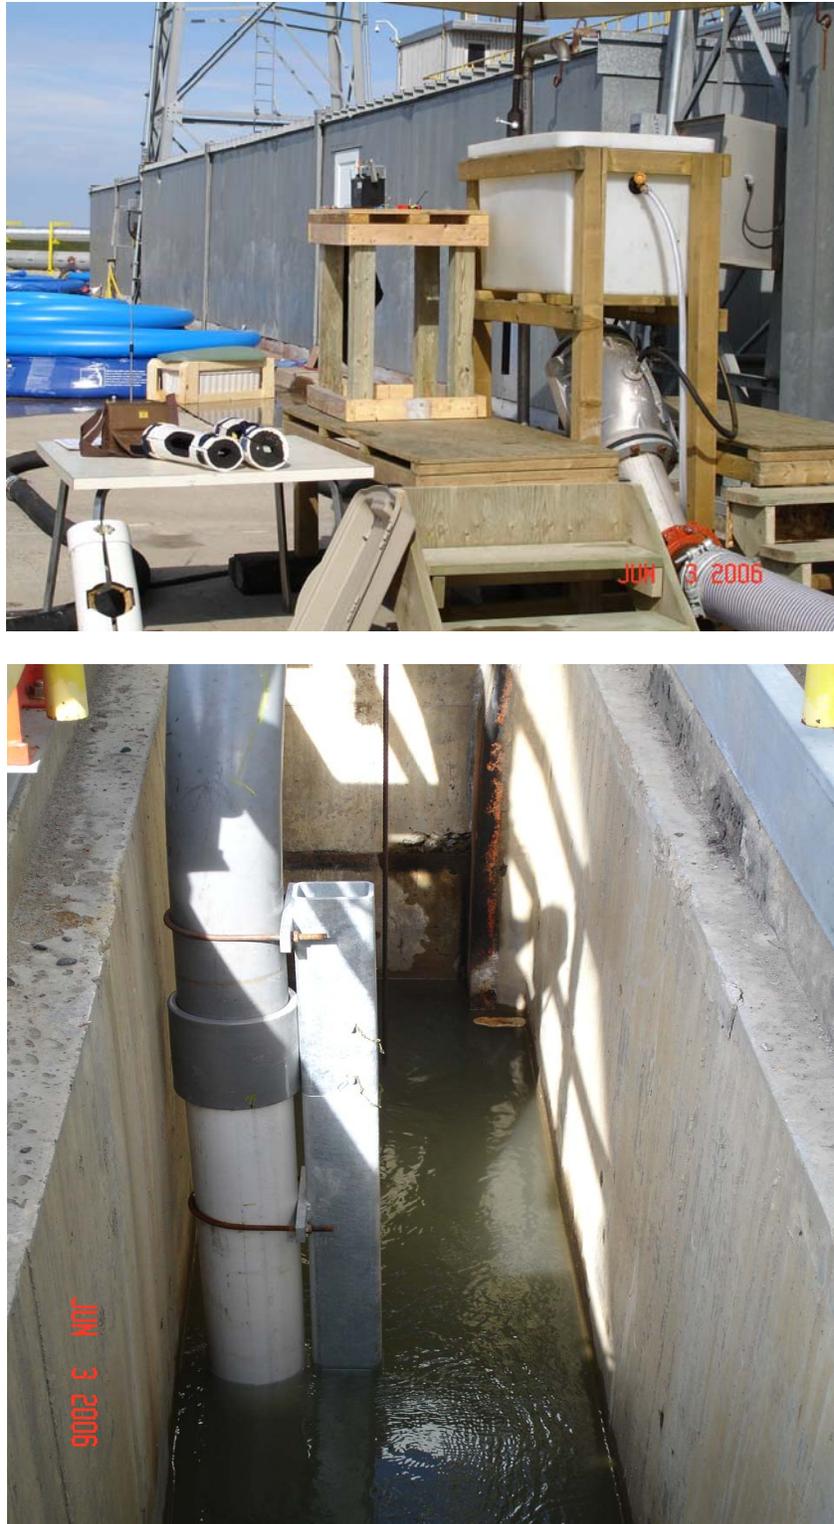
Figure 2-7

Induction apparatus (upper) and release pipe (lower) for introducing fish into turbine Unit 2 intake at the Kelsey GS.

HI-Z tags were activated by injecting a small amount of water into the balloons which caused the tag to inflate in approximately 2 to 4 minutes. All treatment fish were released through an induction apparatus (Figure 2-7) that consisted of a holding basin attached to a 20.32 cm (8 inch) diameter flexible hose which led to a rigid 20.32 cm (8 inch) PVC pipe. This pipe was U-bolted onto a steel frame that could be raised or lowered to the desired release depth (Figure 2-8). The release hose was continuously supplied with river water to ensure fish were transported quickly to the desired release point. Control fish were released through the same induction apparatus attached to a 20.32 cm (8 inch) diameter flexible hose approximately 15 m (50 ft) long that released fish into the tailrace downstream of the turbulent eddies (Figure 2-2). Treatment fish were introduced into turbine Unit 2 at 3 depths, shallow (1.5 m below ceiling),

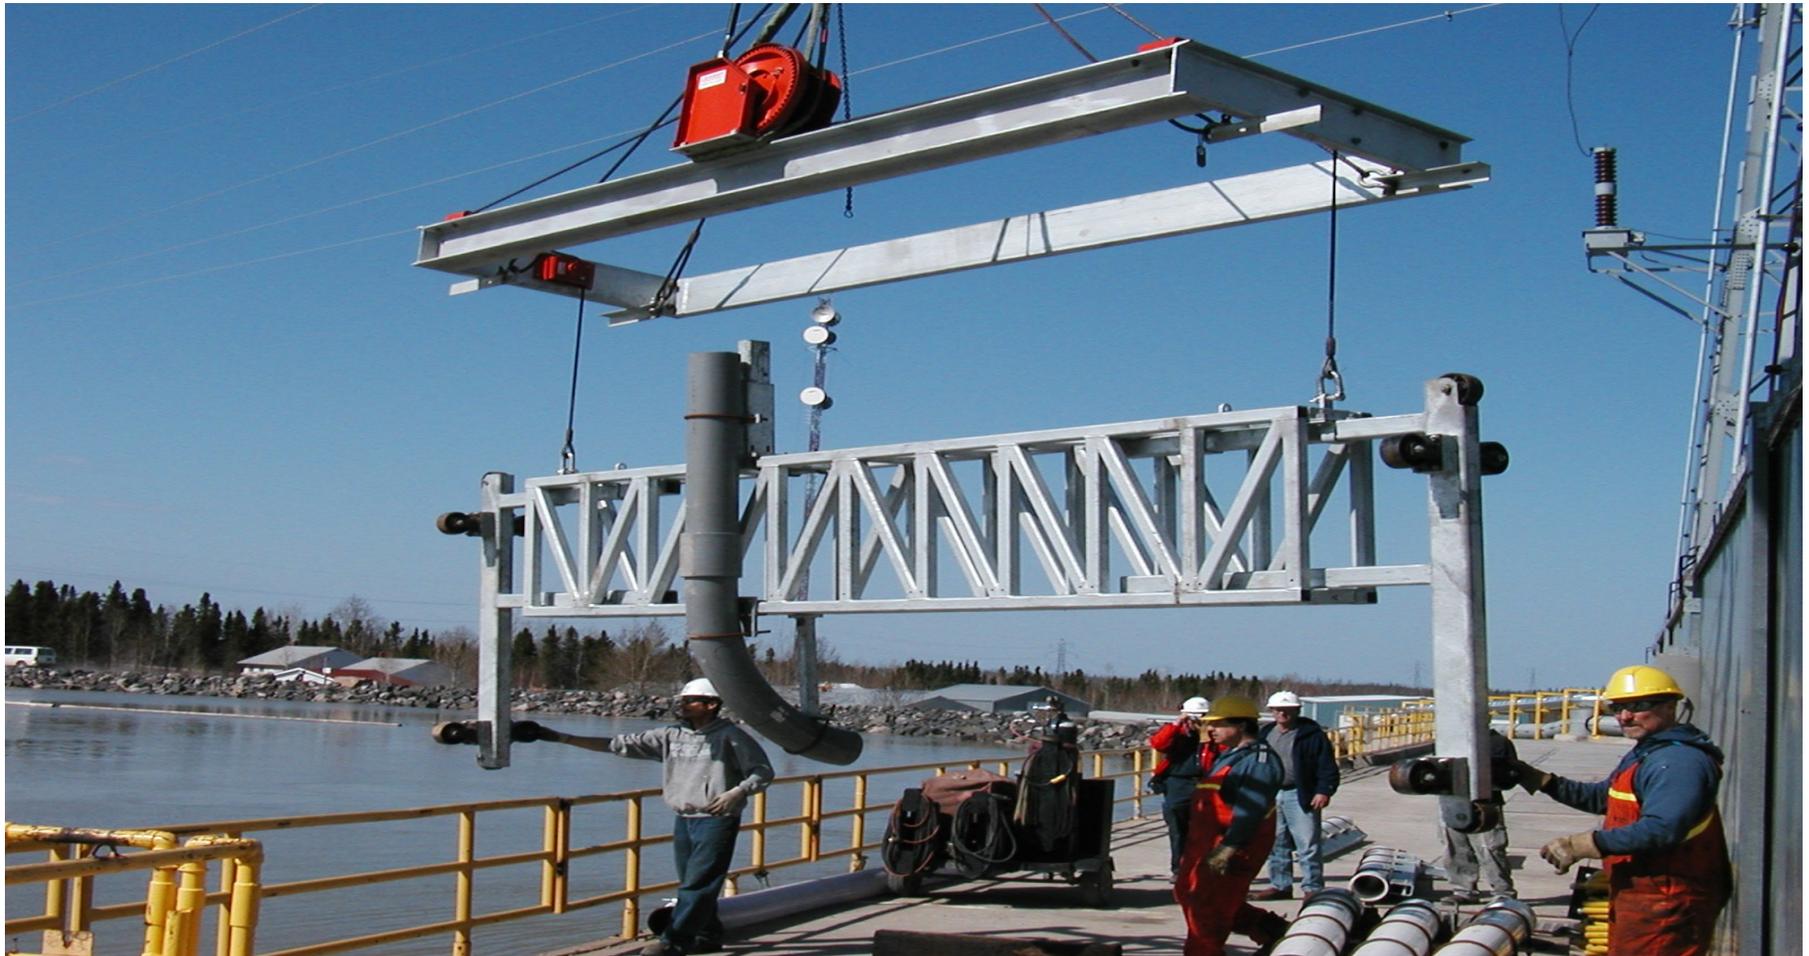
Figure 2-8

Steel support frame and lower section of the 20 cm diameter PVC release pipe used to release fish into Unit 2 intake at the Kelsey GS.

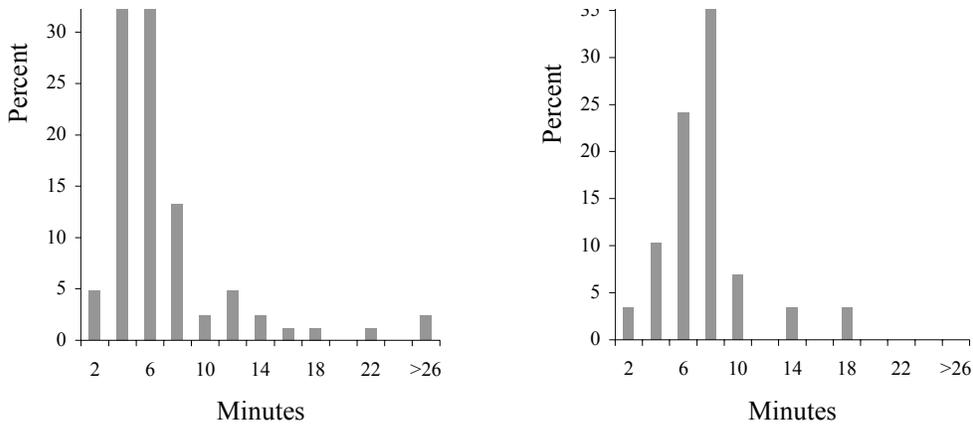
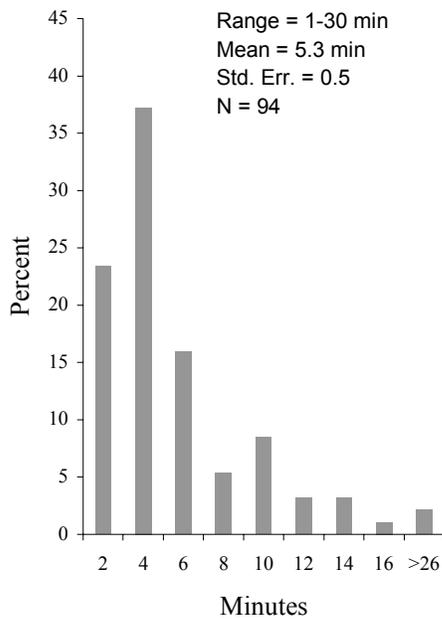
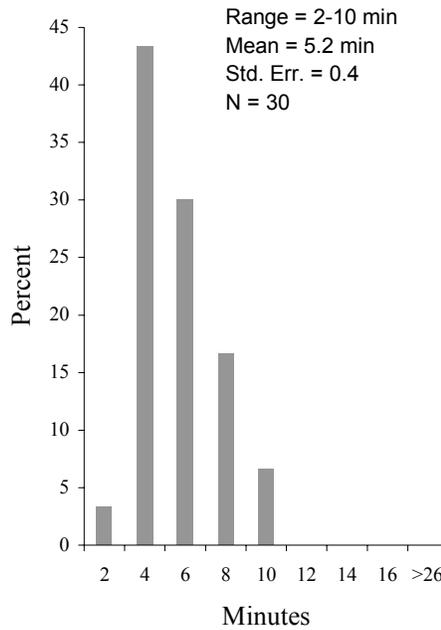
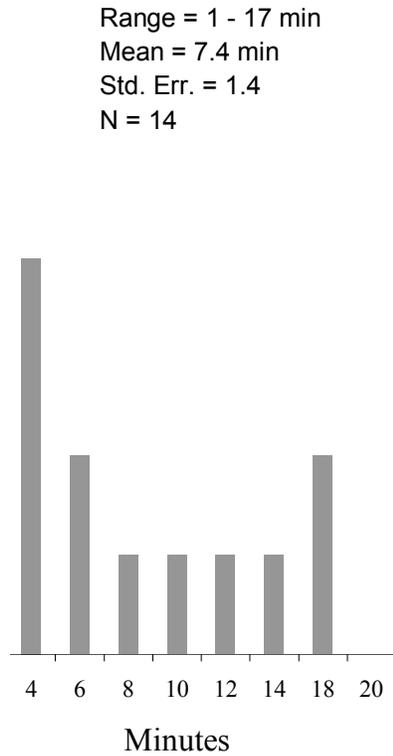
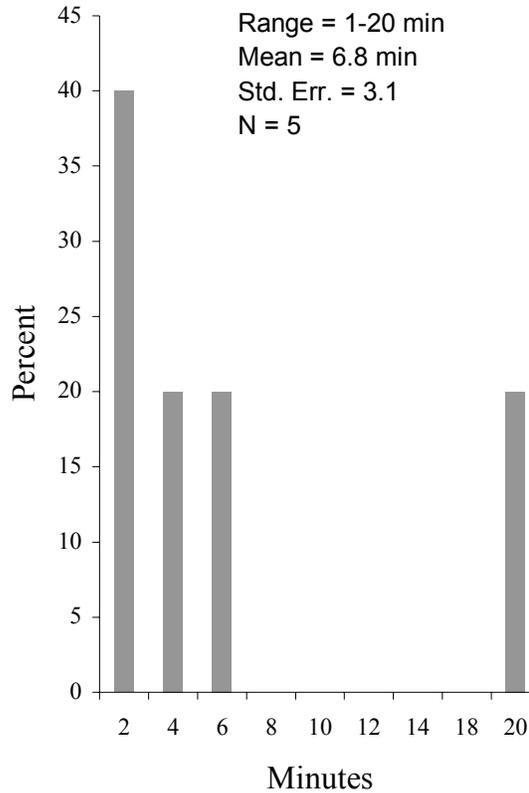
Figure 3-1

Frequency distribution of recapture times (minutes) of treatment and control northern pike and walleye released through the Kelsey GS, June 2006.

Frequency distribution of recapture times (minutes) of treatment and control lake whitefish released through the Kelsey GS, June 2006.

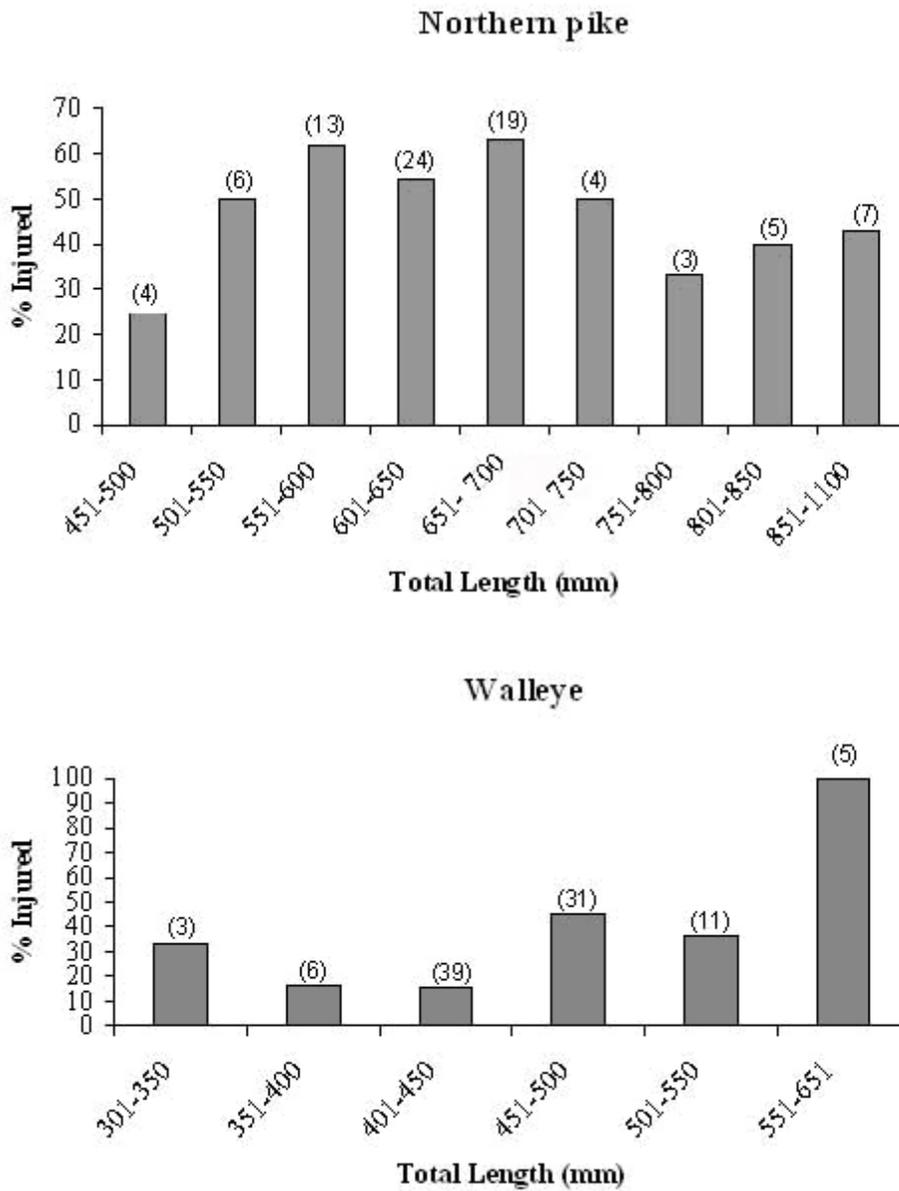
Figure 3-2

Relationship of turbine passage related injury versus total length of northern pike and walleye in passage through the Kelsey GS, June 2006. Number of fish examined post-passage in each length group is given in parentheses.

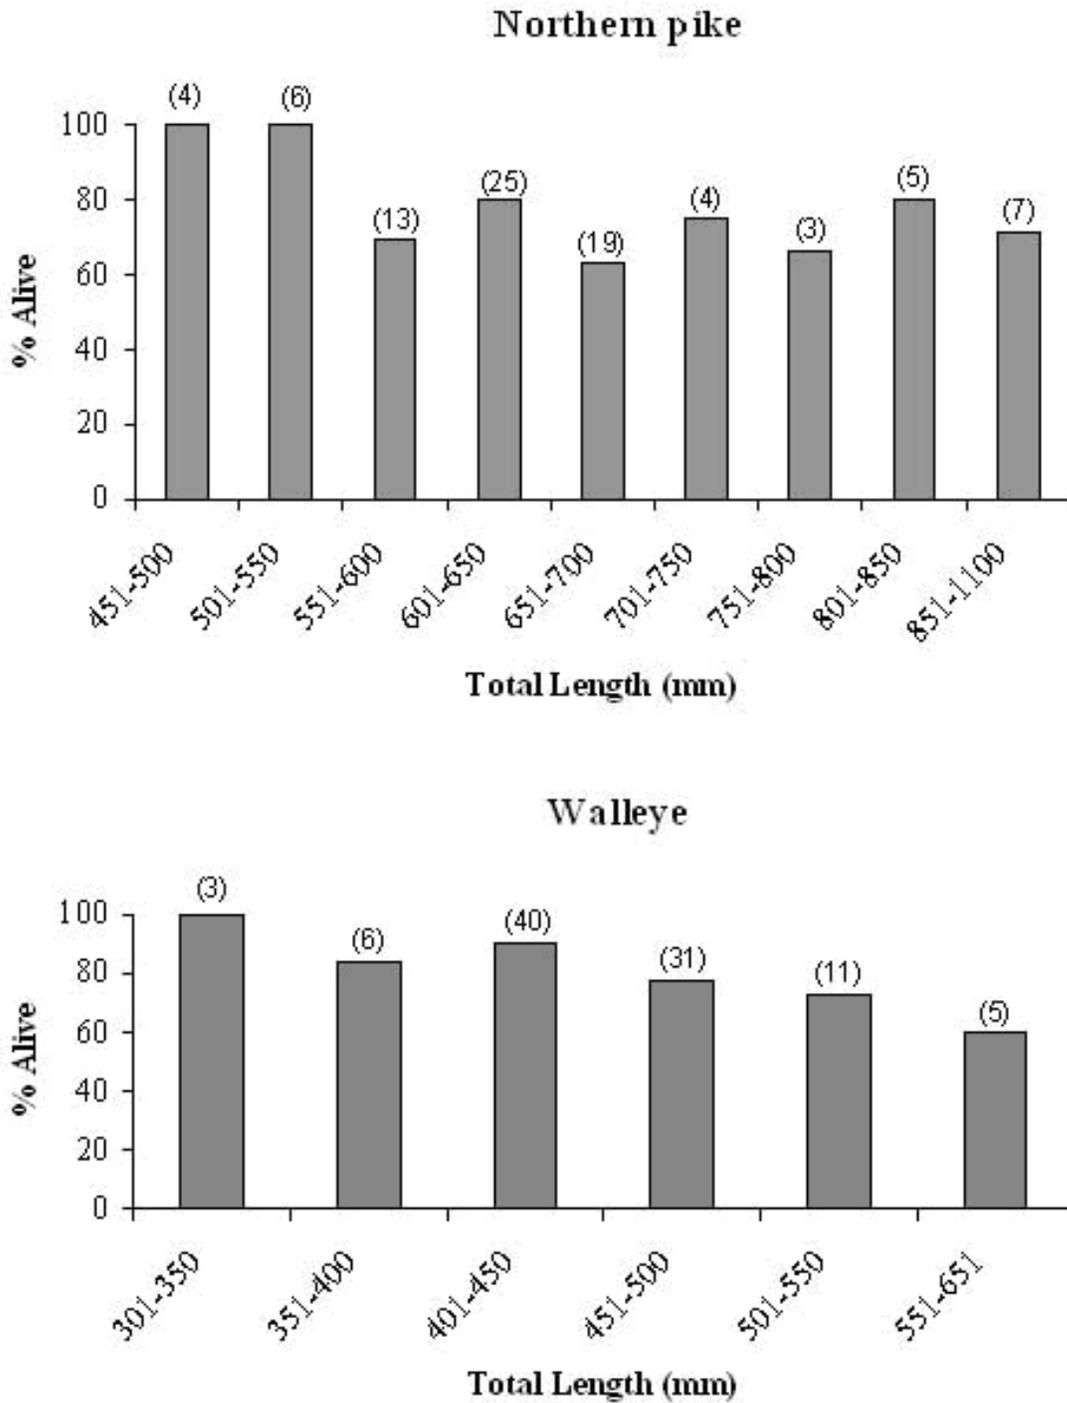
Figure 3-3b Relationship of turbine passed alive fish versus total length of northern pike and walleye in passage through Unit 2 of the Kelsey GS, June 2006. Number of fish examined post-passage in each length group is given in parentheses.

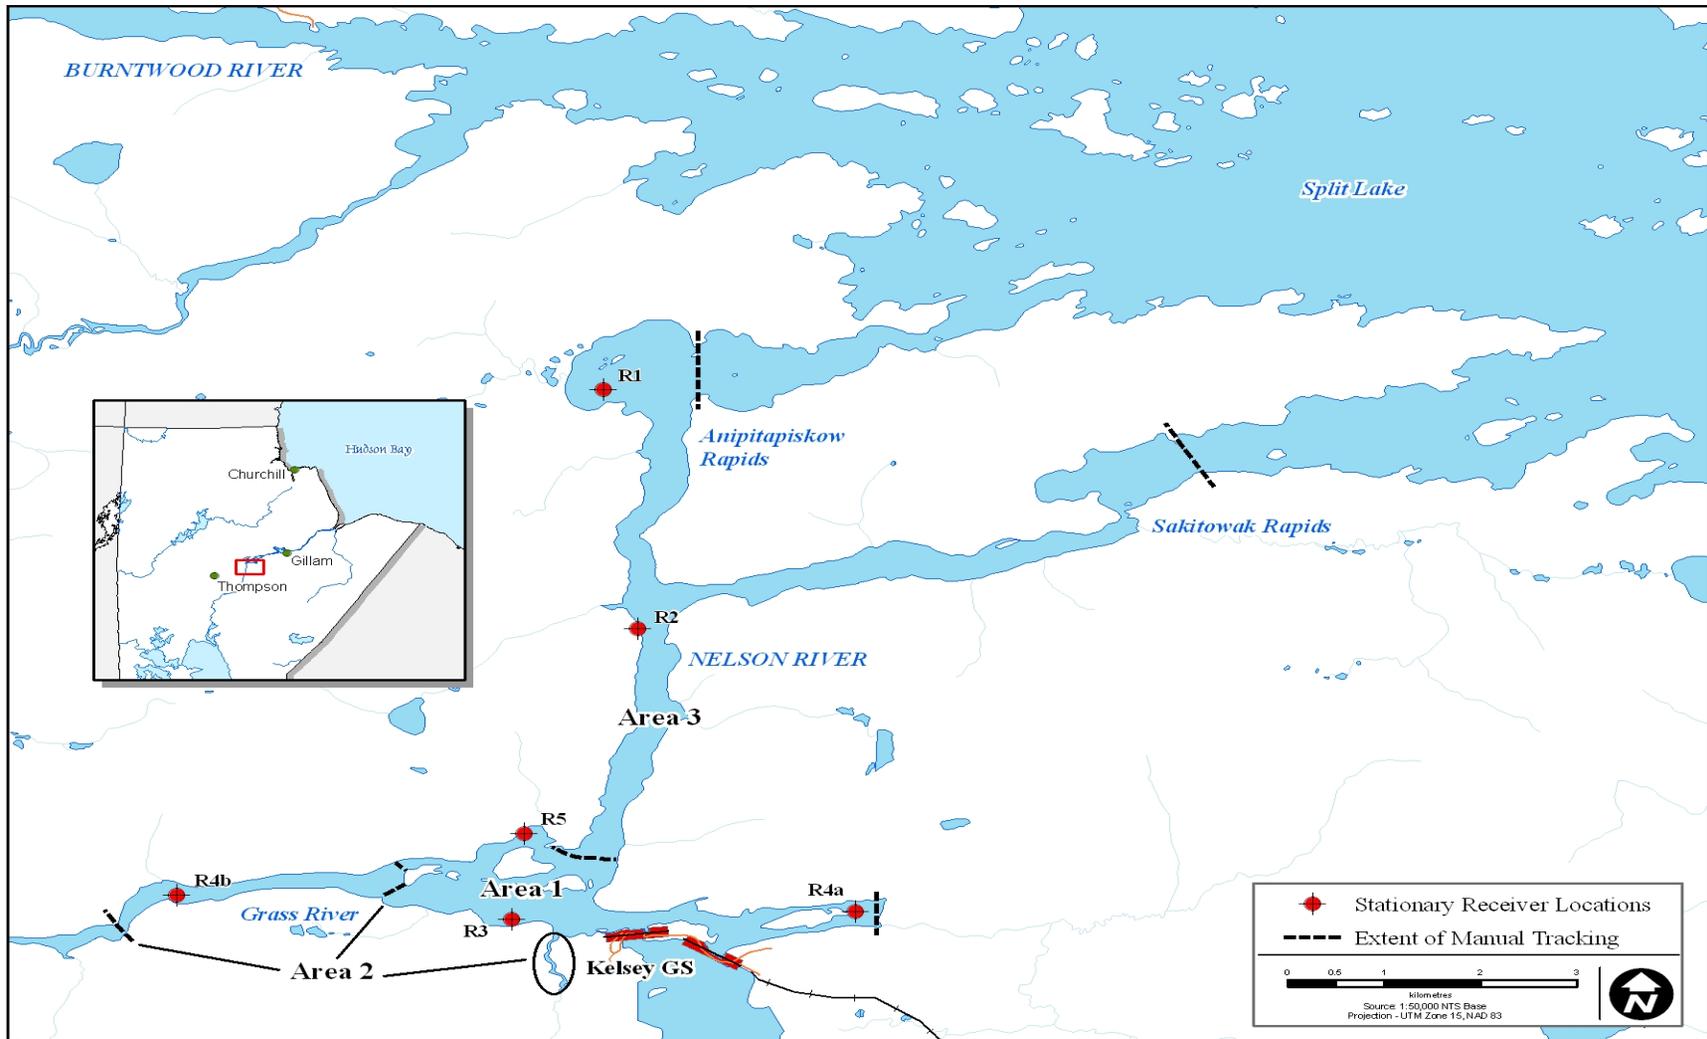
Figure 1. Overview of the Kelsey GS Study Area with locations of stationary acoustic receivers (stars), and the approximate extent of manual tracking (stipled lines) in June-August, 2006.

Just downstream of the Kelsey GS the Nelson River is joined by the Grass River from the west (Figure 1). Past the confluence, the Nelson River flows north for approximately 5 km until it splits into two branches, one branch continues north around a large island and the other flows east around the island. Both branches have a set of rapids that must be passed before they enter into Split Lake where they are joined by water from the Burntwood River. The aquatic habitat within the area downstream of Kelsey ranges from a low velocity, relatively high water clarity riverine environment in the Grass River to a medium to high velocity, low water clarity riverine environment in the upstream portion of the Nelson River. More lacustrine conditions start to exist past the two sets of rapids on the Nelson River at the eastern edge of the Study Area (Figure 1) and continue to do so as the river enters Split Lake. Aquatic macrophytes are common in the Grass River but are not prominent along the shoreline of the Nelson River in the vicinity of Kelsey GS.

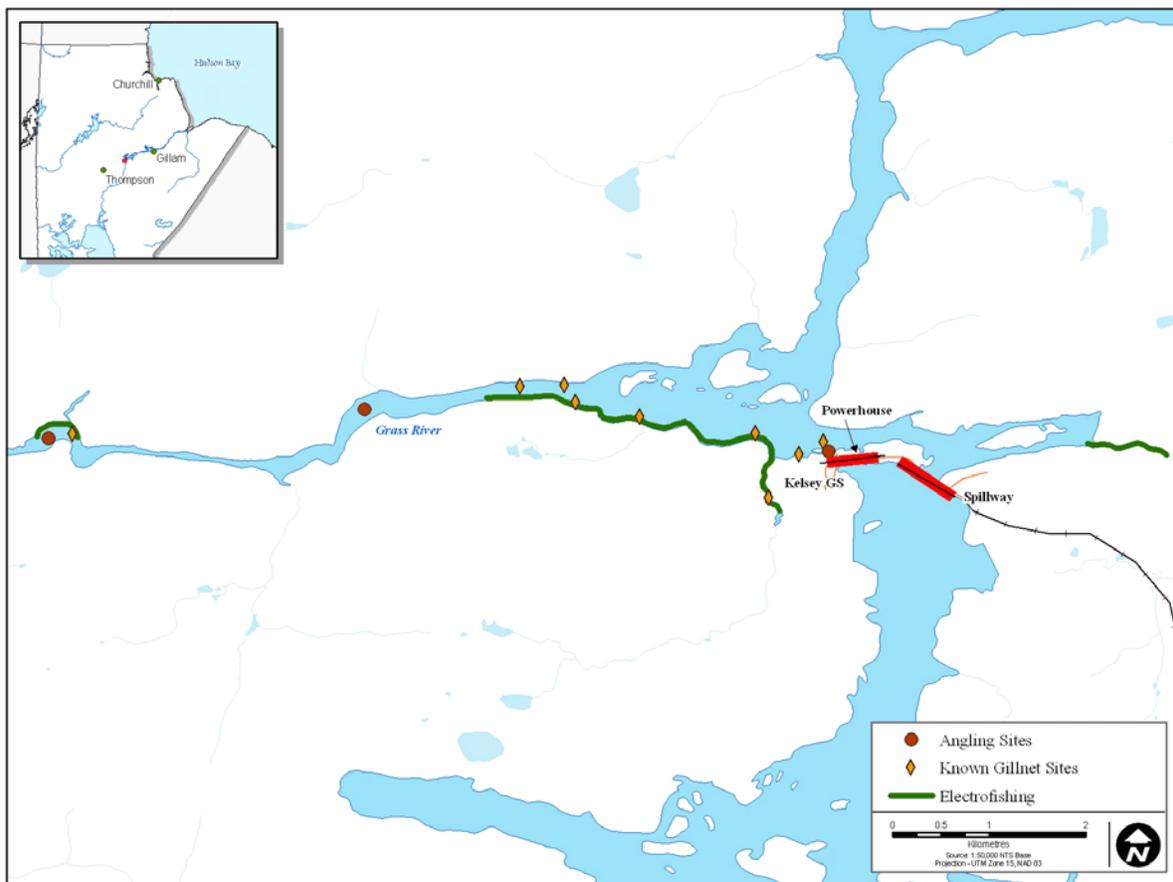
Figure 2. Areas where fish for the Turbine Passage Study were captured by either gillnetting (blue circles), electrofishing (green bands), or angling (red dots) from 1-7 June, 2006.

Northern pike (*Esox lucius*) and walleye (*Sander vitreus*) used in this study were captured from several locations (Figure 2) downstream of Kelsey GS by gillnetting (Figure 3), boat electrofishing (Figure 4), and angling. Captured fish were immediately placed in a tub of fresh water and transported to the Kelsey GS where fish were transferred to soft-walled pools of approximately 5000 L volume (see Part 2A of the study). Fish remained in these pools for a 24 hour monitoring period before acoustic transmitters were surgically implanted. Fish were monitored for 16-24 hours post-surgery before being released either as treatment or control fish. Prior to release each fish was externally fitted with a radio transmitter and “HI-Z Turb’N” tags to enable its relocation after turbine passage.

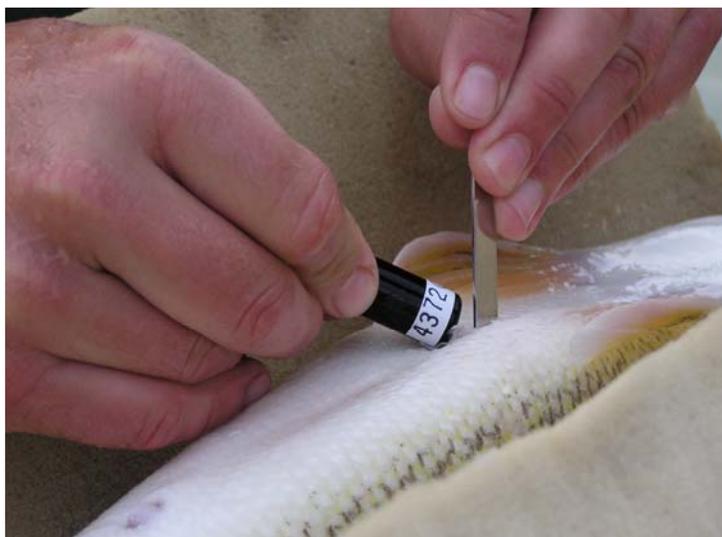
Figure 5. Implantation of a V13-1L acoustic transmitter into a walleye at Kelsey GS, June, 2006.

shaped surgical table, ventral side up (figures 5 and 6). As anaesthetized fish are unable to ventilate on their own, fresh water was continually pumped over the gills during the surgical procedure (Figure 6).

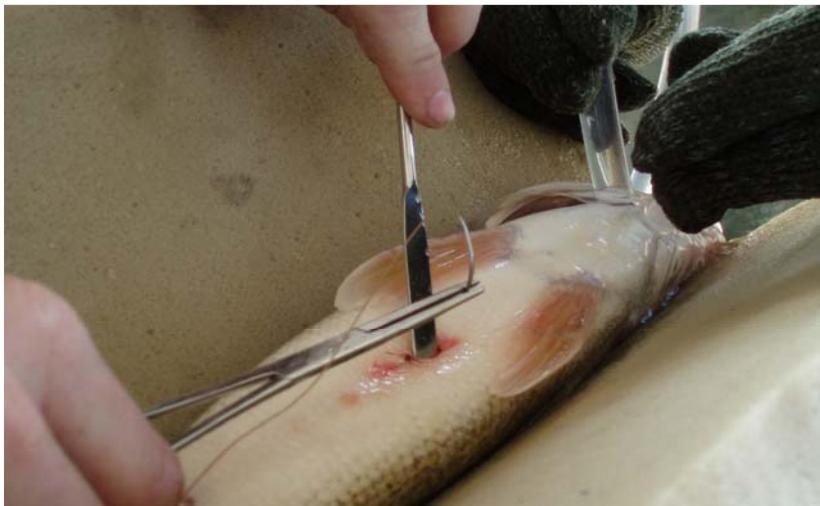
Figure 6. Suturing and gill irrigation of a walleye after implantation of an acoustic transmitter at Kelsey GS, June, 2006.

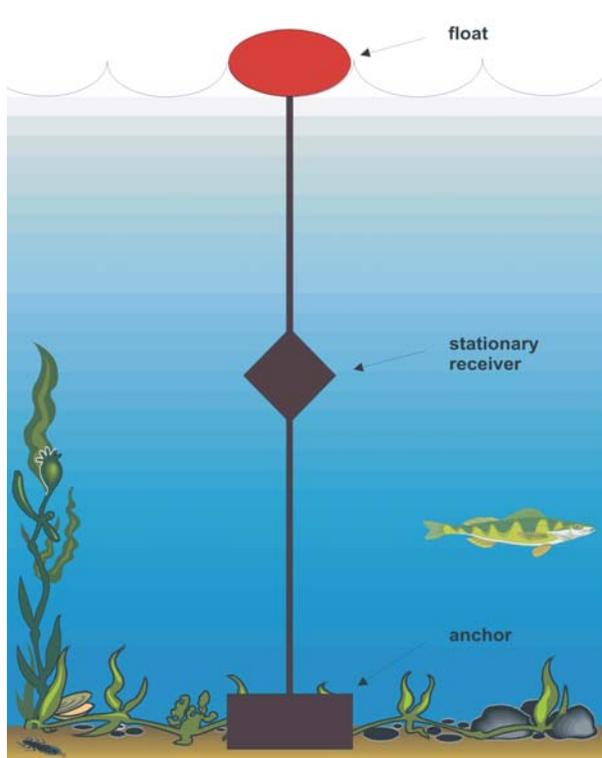
Figure 8. Schematic presentation of a deployed stationary acoustic receiver with anchor and float.

At each stationary receiver location, a coated steel cable attached to a king anchor was held vertically in the water column by a large float (Figure 8). Stationary receivers were attached via steel brackets to the cable and lowered into the water using a second float line (Figure 9). A U-bolt attached to the cable approximately 2 m off the river bottom served as a stopper. Tests performed for similar studies (e.g., Pisiak and Barth 2006) have shown that receivers positioned near the river bottom had a higher range of detection than those placed near the surface. This set-up allowed each receiver to be held vertically in the water column and allowed for the receivers to be pulled up the anchor cable with relative ease while eliminating the need to pull the anchor. This also ensured that following each download, receivers would be repositioned in the same location and at the same depth. Stationary receivers recorded the transmitter code number, date, and time of detection in an internal data logger until downloaded by an IBM/PC/AT computer (Figure 10). A VR2PC computer interface (VEMCO Ltd.) was used to transfer data between receiver and computer.

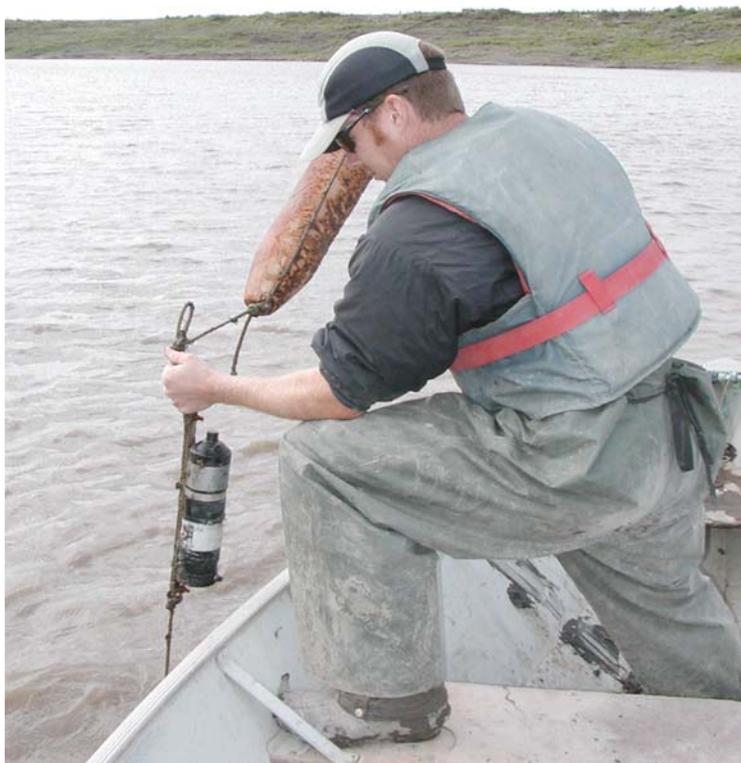
Figure 9. Deployment of a stationary receiver, showing steel cable, receiver, and float.

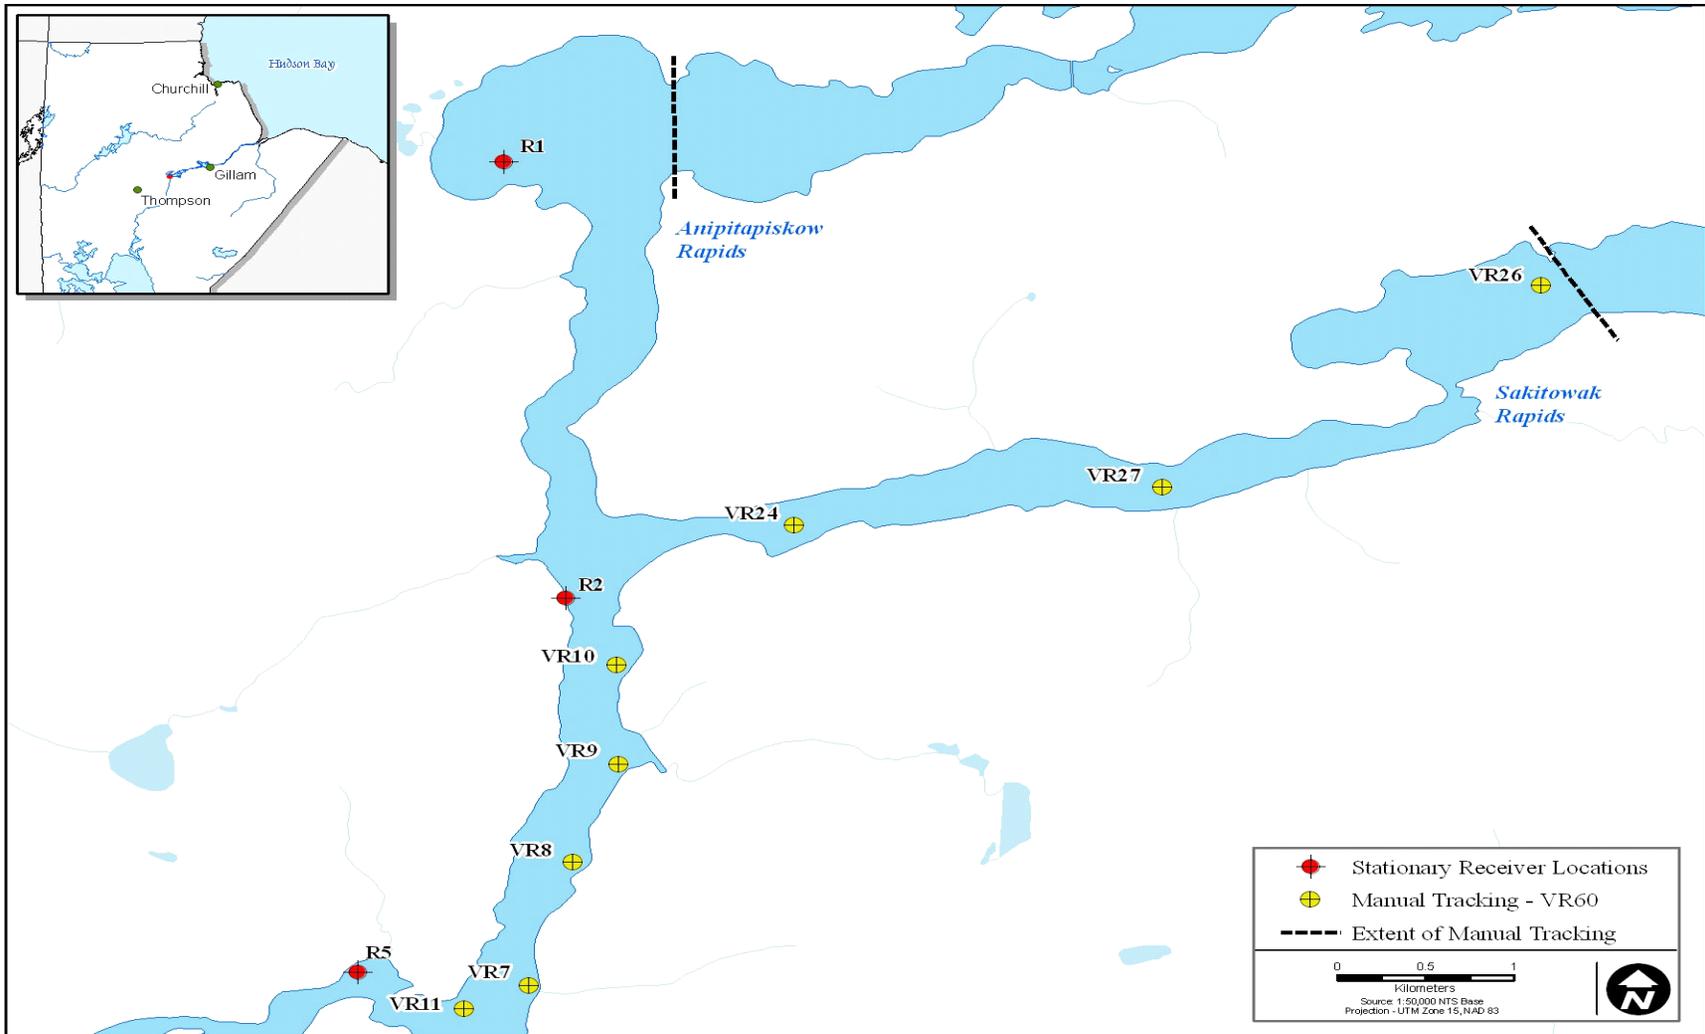
Figure 11. Sites with fish relocation(s) from manual tracking in the area north of the Kelsey Generating Station, June-September, 2006.

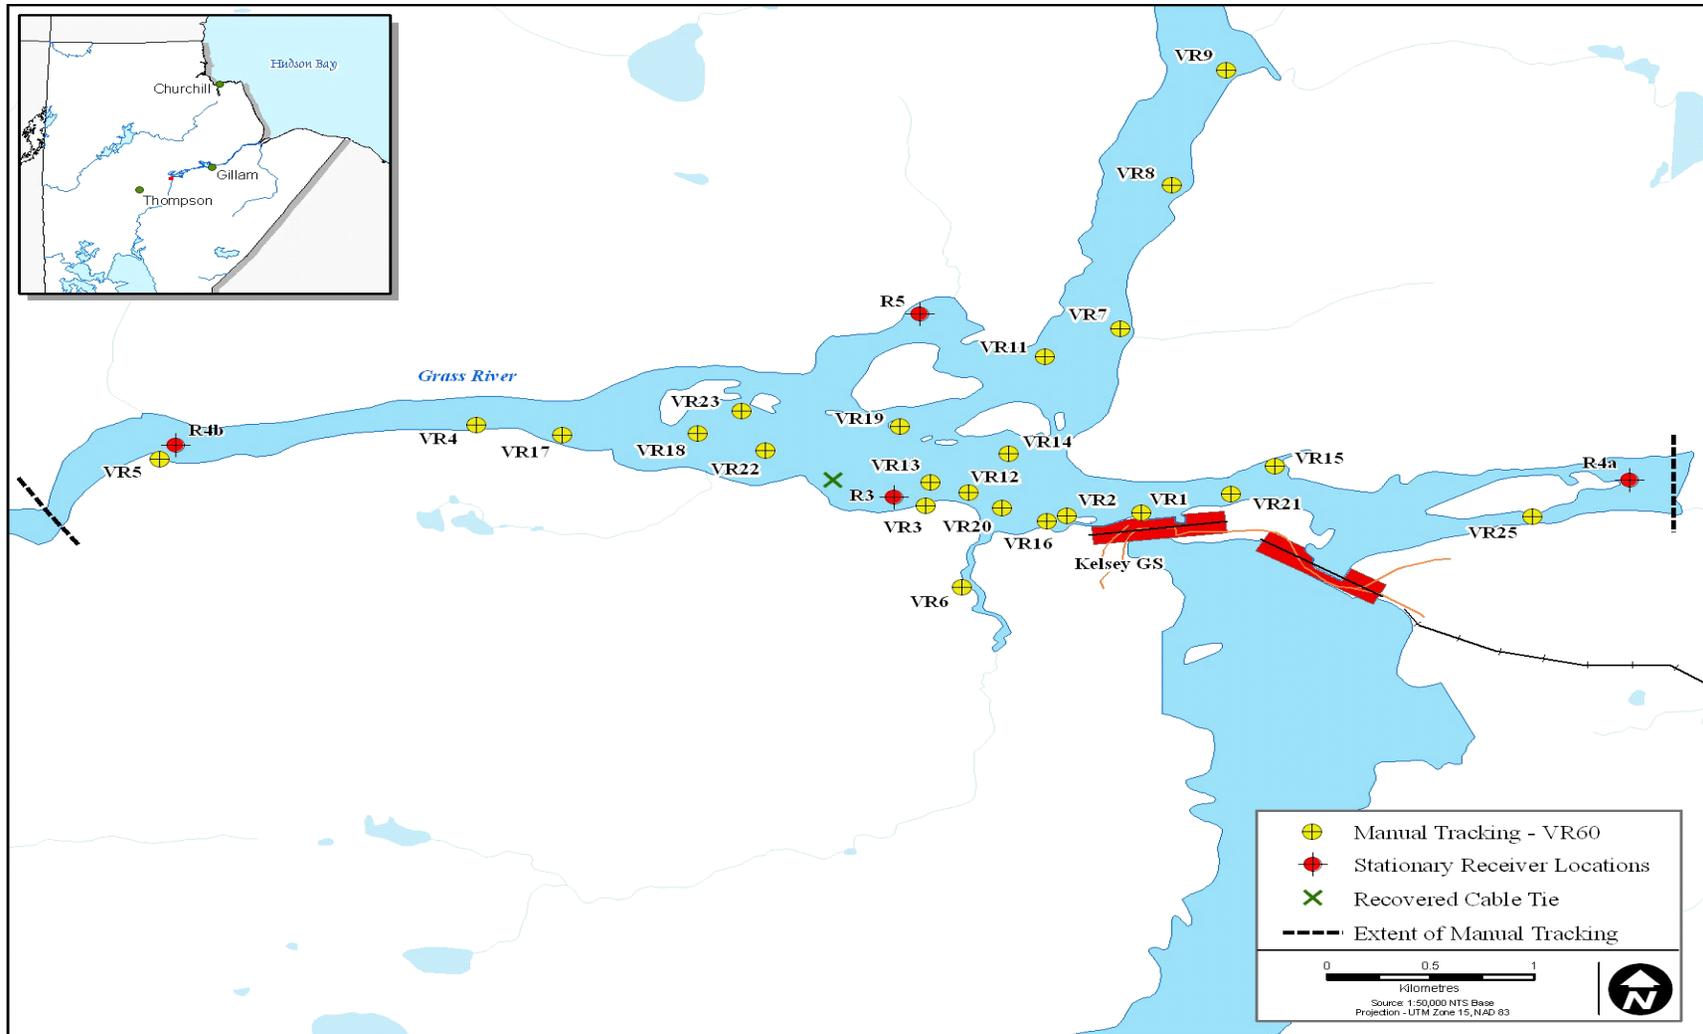
Figure 12. Sites with fish relocation(s) from manual tracking in the area near the Kelsey Generating Station, June-September, 2006.

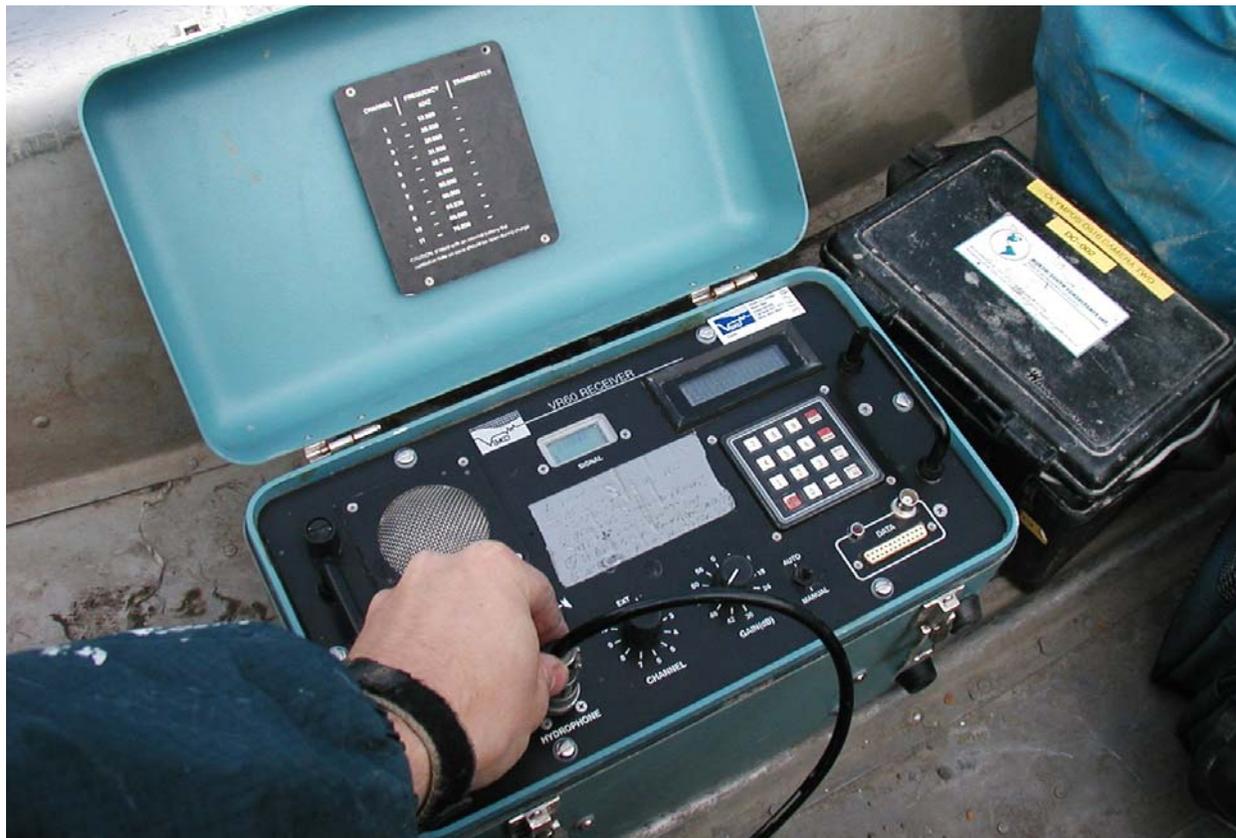
Figure 13. VR-60 acoustic receiver used for manual tracking of fish at the Kelsey GS, June-September, 2006.

Manual tracking was intended to be done on a monthly basis. Due to VR-60 receiver malfunction or logistical problems, complete tracking runs were only available for the periods 7-9 June and 31 August-3 September. For each of these two runs, the boat followed a regular path within the boundaries of the tracking area (Figure 1), stopping every 300-500 m to check for acoustic signals. The hydrophone was lowered 1-2 m into the water and held there for approximately 3-5 minutes. If a number of signals were detected in the area, the hydrophone was held in the water for a longer period of time to ensure all signals in the area were detected.

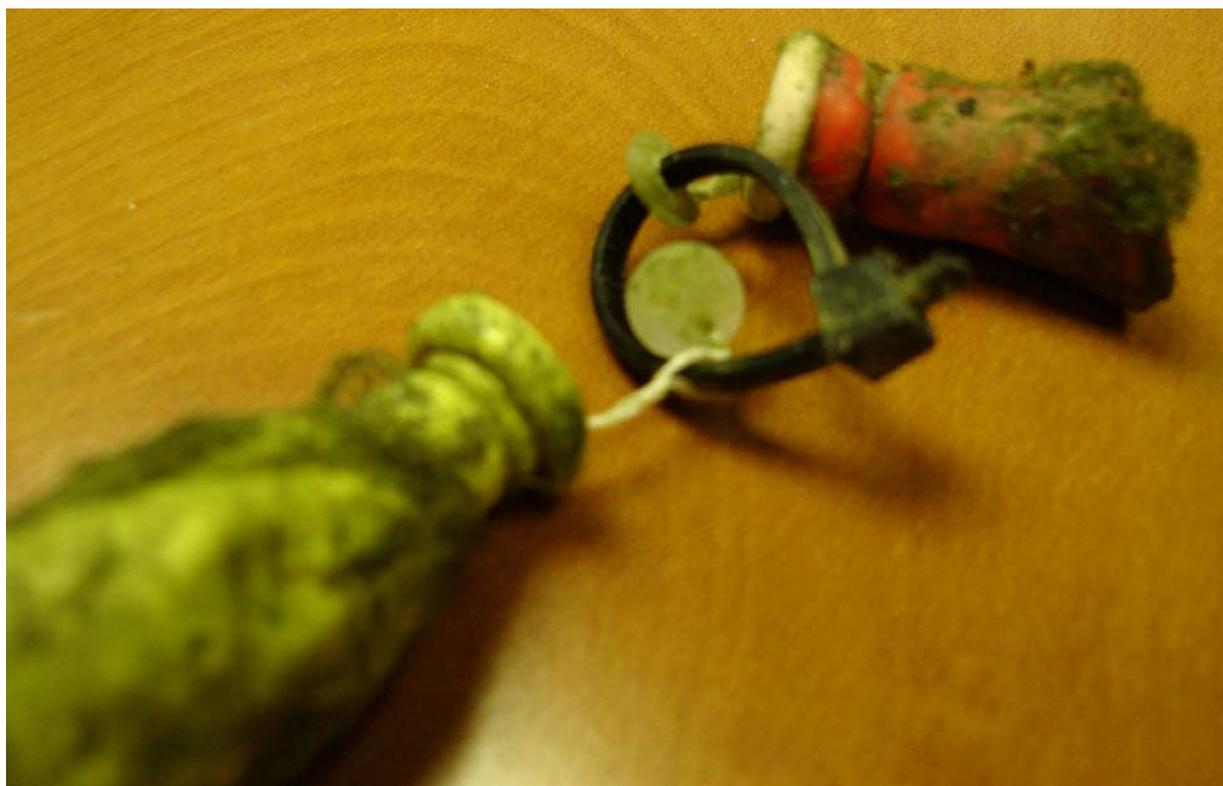
Figure 14. Intact cable tie and deflated "Hi-Z" balloons found on 2 September, 2006, west of stationary receiver location R3 (see Figure 12).

is available on walleye #84651, the physical evidence from the other two fish suggests that all of the fish for which no acoustic signal was received had suffered some type of injury during or shortly after turbine passage. Some indirect evidence suggests that at least one of the three non-recovered fish may have died near the Kelsey GS fairly soon after its turbine passage. On 3 September, 2006, during an unrelated study, an intact cable tie with two attached deflated balloons (Figure 14) was recovered when pulling a bottom-set gillnet approximately 300 m northwest of stationary receiver R3 (Figure 14). Due to the interior placement of the cable ties within a fish's bony structures (see Part 2A of this report), it is very unlikely that the recovered cable tie could have been removed from the fish without causing a fatal injury. The recovery location suggests that the tagged fish actively moved to this spot before the cable tie with the balloons fell off, because this spot is several hundred meters away from the main current of the Nelson River as it moves north downstream of the Kelsey GS (Figure 12). Any passive transport of the fish with the cable tie attached or of the (detached) cable tie to this location is very unlikely. Furthermore, the heavy filamentous algae cover on the balloons that, at the time of recovery, measured more than 2 cm in length, suggests that the balloons (with the cable tie) must have detached from the fish for some considerable time prior to 3 September.

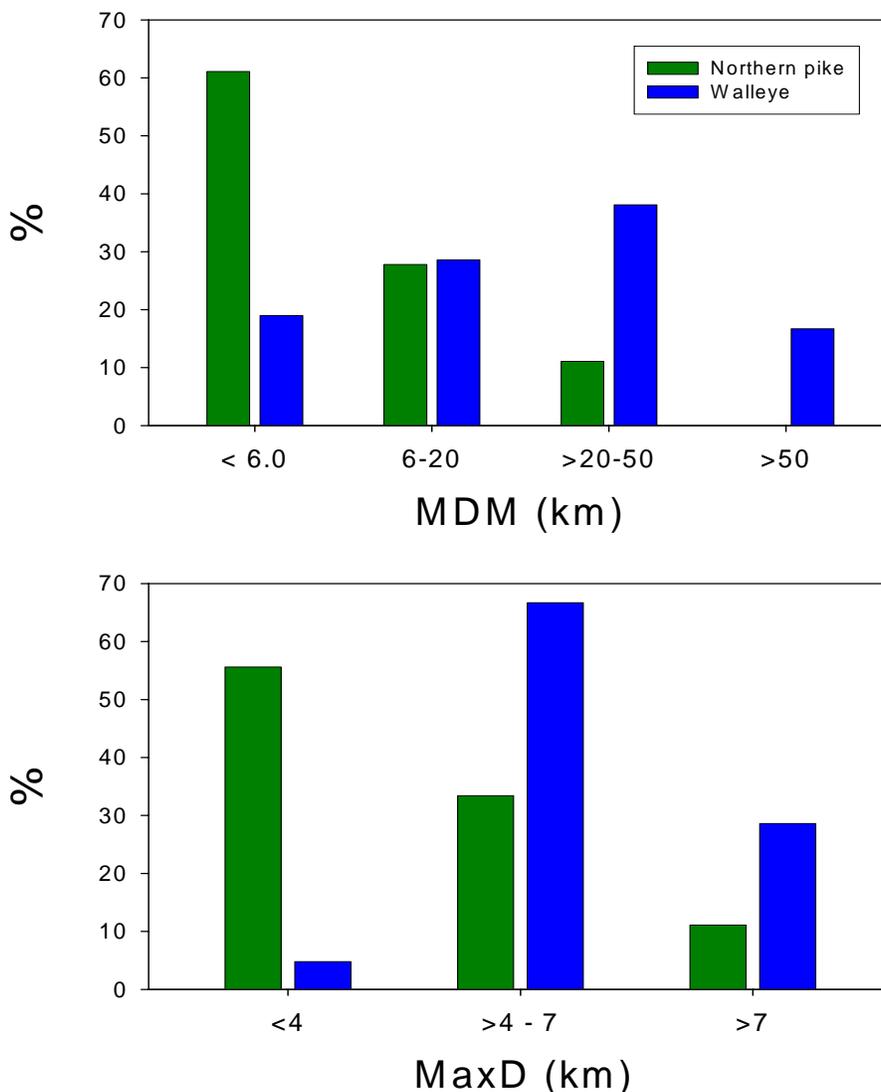
Figure 15. Proportion (%) of northern pike and walleye within each class of Minimum Distance of Movement (MDM) and Maximum Distance from Kelsey GS (MaxD) for 18 and 21 acoustic-tracked northern pike and walleye, respectively, after their release near the turbine outflow and subsequent tracking between 5 June and 3 September.

interspecific differences in the distribution of the different MDM and MaxD categories. For example, none of the pike had a MDM of >50 km and more than 60% had a MDM of <6 km, whereas three walleye (17%) had a MDM of >50 km and only 19% had a MDM of <6 km (Figure 15). Similarly, more than half of the pike had a MaxD of <4 km, whereas over 95% of all walleye had moved more than 4 km away from the station (Figure 15).
