FISH MOVEMENTS AND TURBINE PASSAGE AT SELECTED MANITOBA HYDRO GENERATING STATIONS

2005 – 2006 INTERIM REPORT

Prepared
for
Manitoba Hydro

North/South Consultants Inc. and Normandeau Associates Inc.

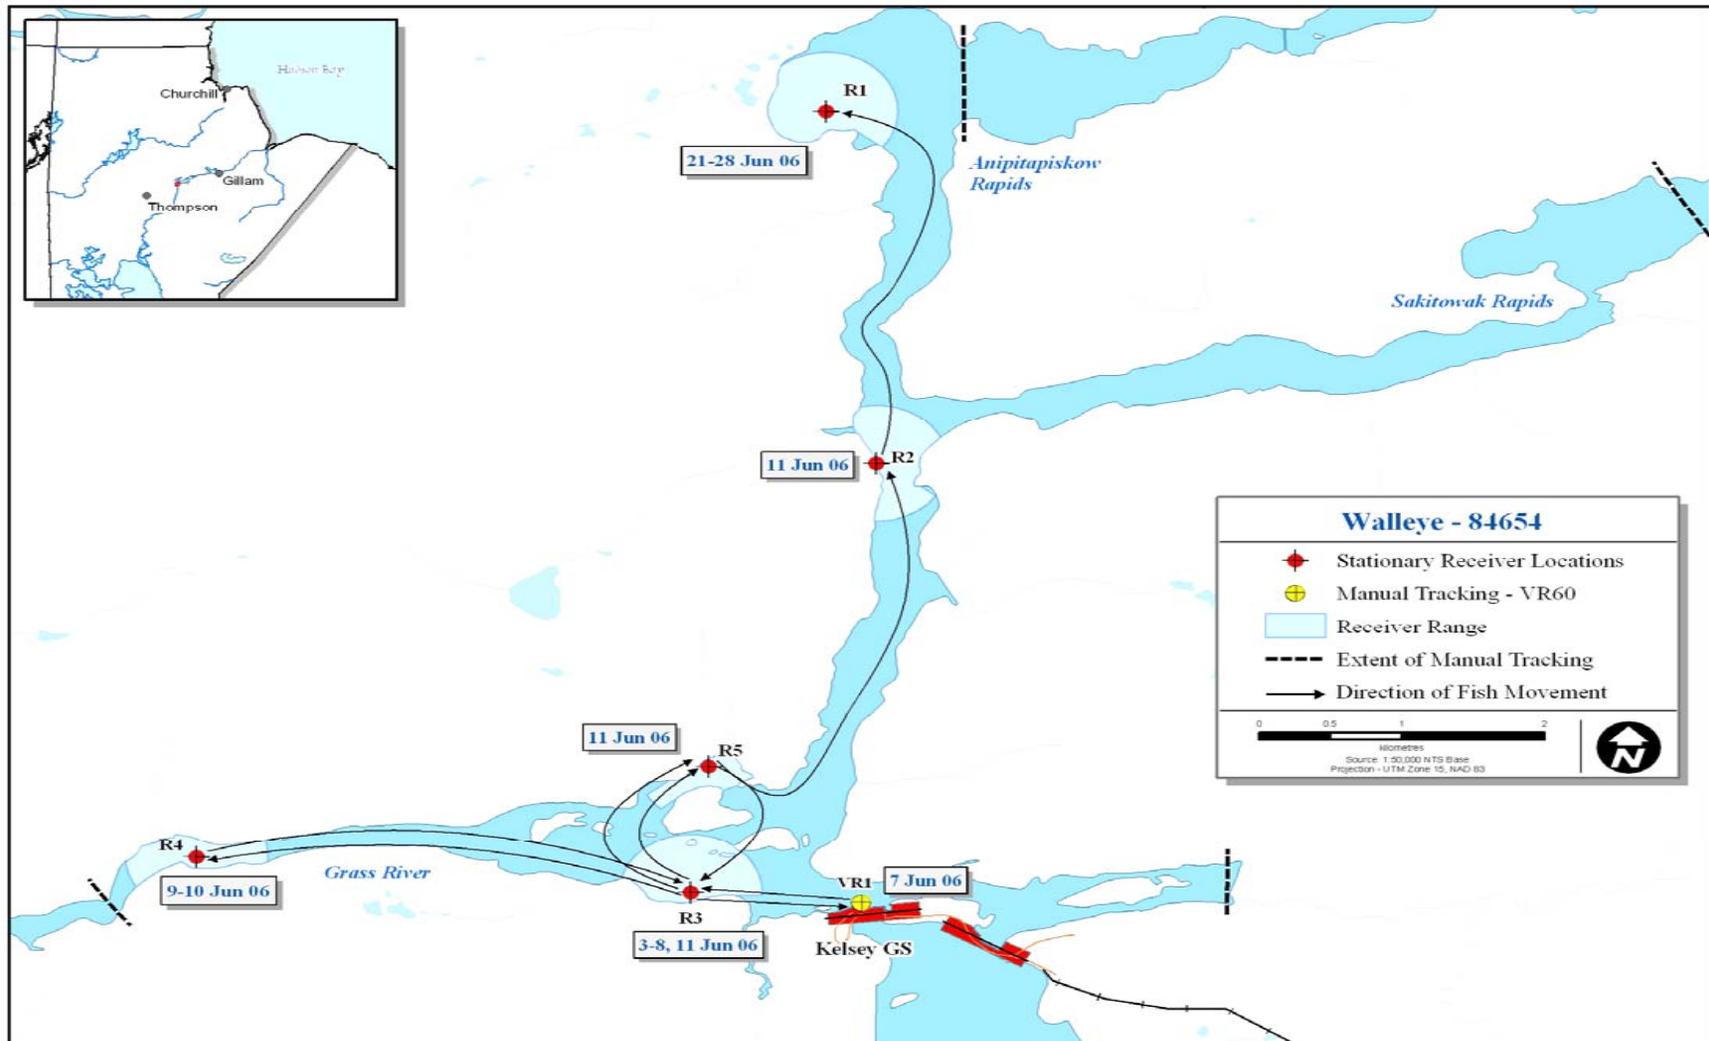
Figure 17. Movement of walleye #84654 between 3 and 21 June, 2006 after turbine passage on 3 June, 2006.

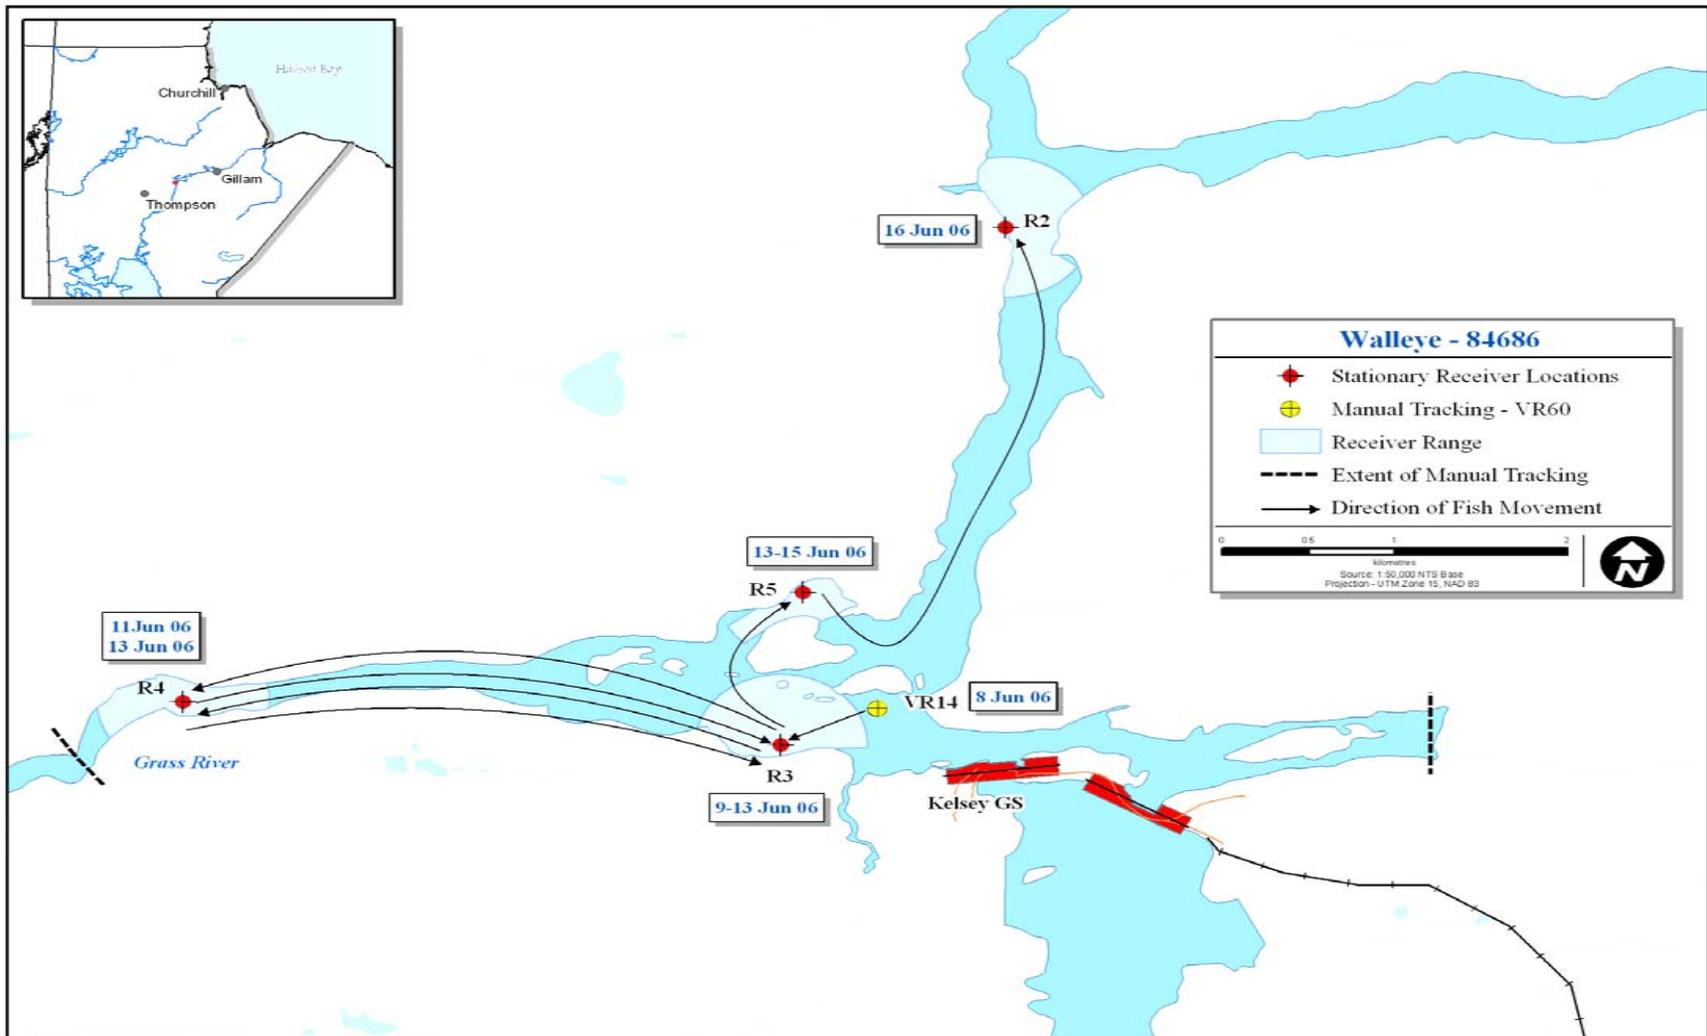
Figure 18. Movement of walleye #84686 between 8 and 16 June, 2006, after turbine passage on 7 June, 2006.

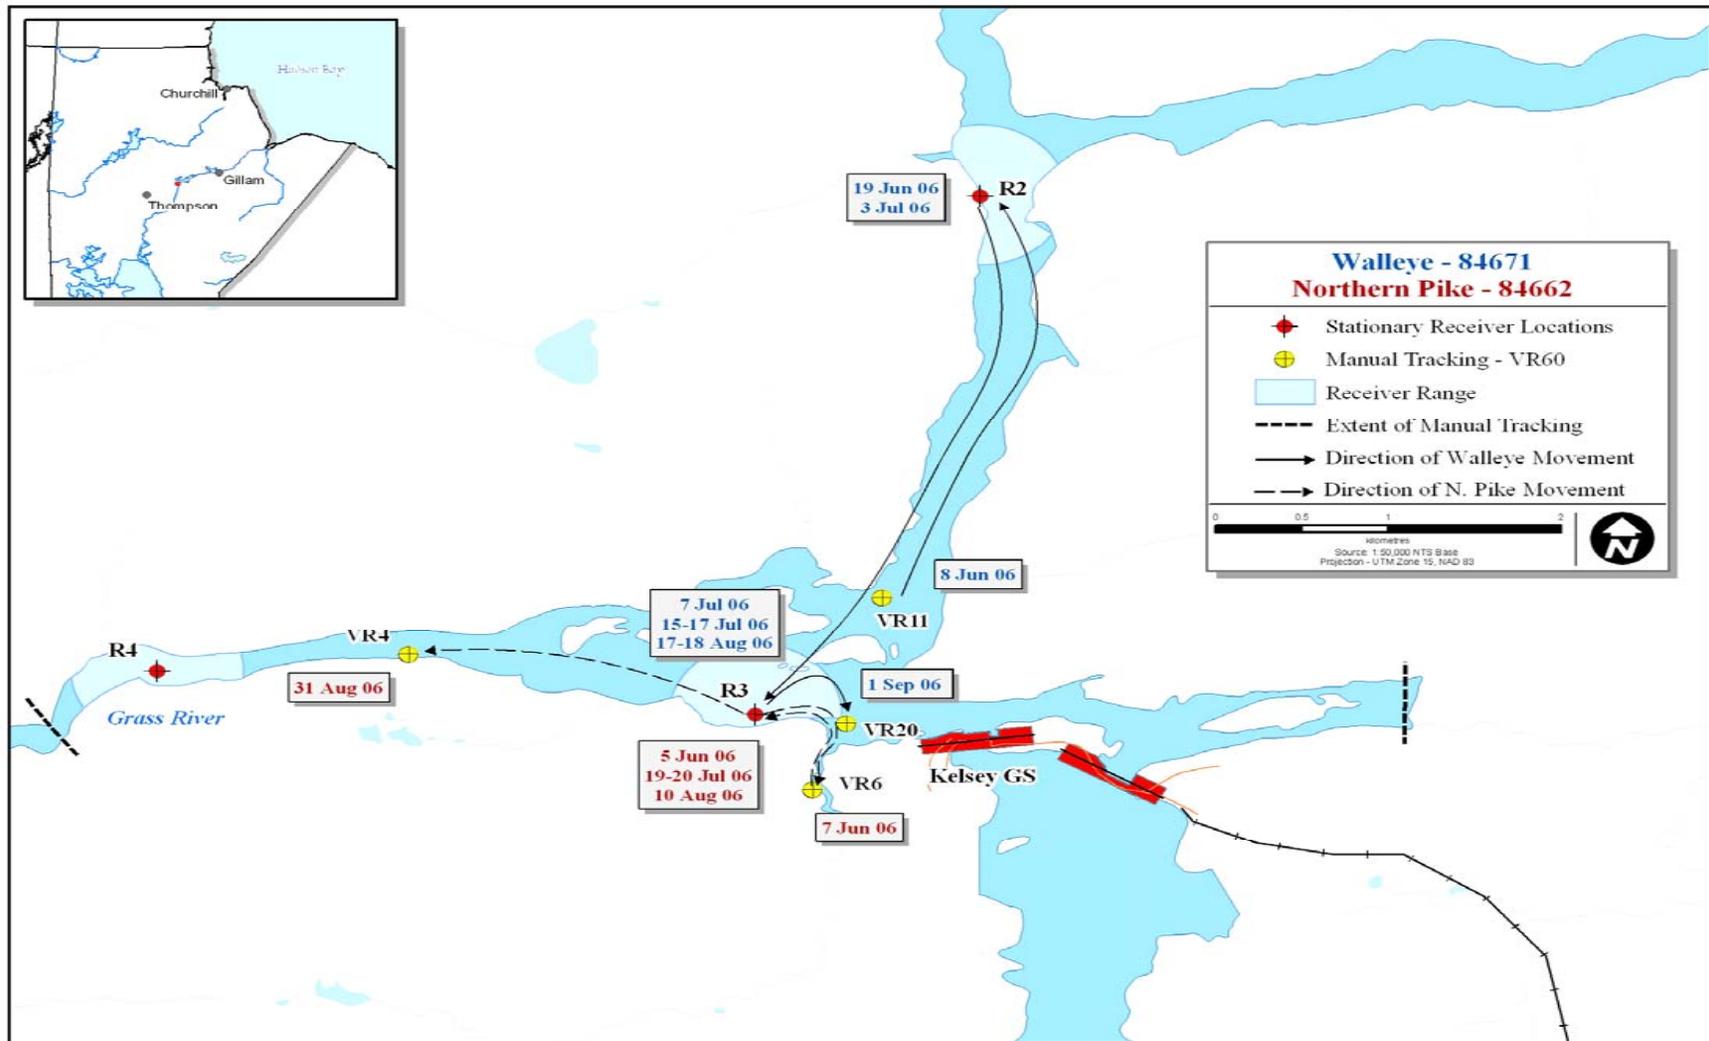
Figure 19. Movement of walleye # 84671 between 8 June and 1 September, 2006, after turbine passage on 7 June, 2006, and northern pike # 84662 between 5 June and 31 August, 2006, after being released as a control fish on 5 June, 2006.

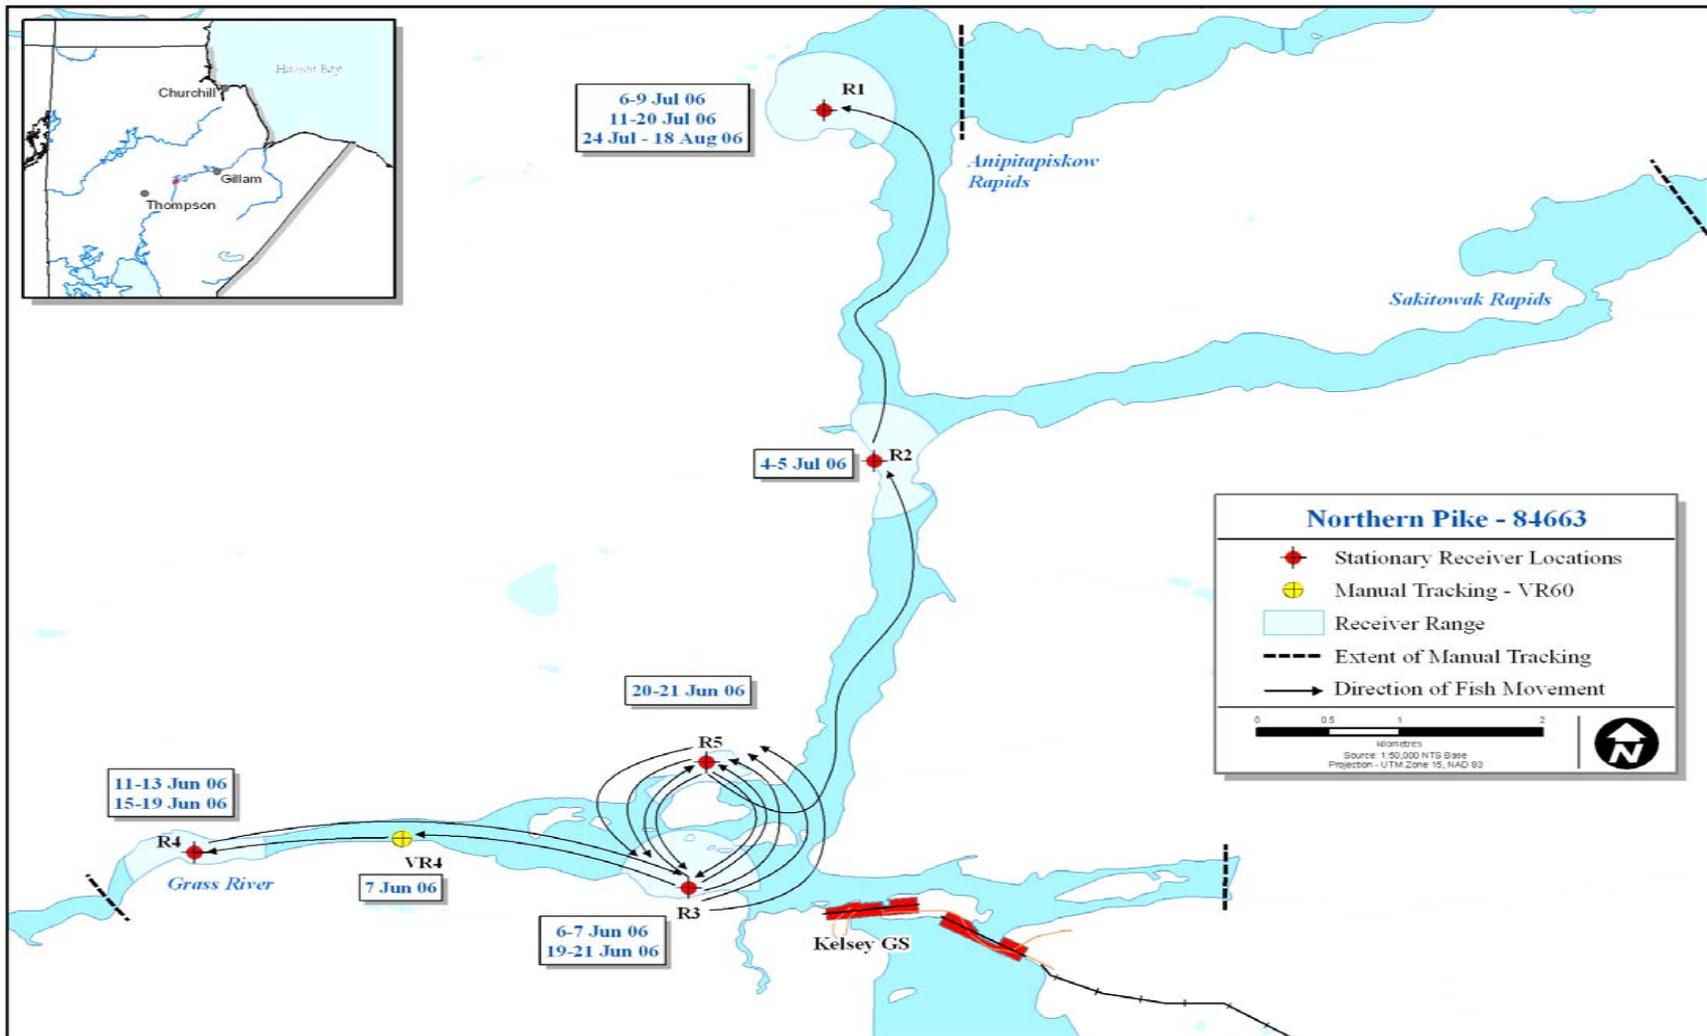
Figure 20. Movement of northern pike #84663 between 6 June and 18 August, 2006, after being released as a control fish on 5 June, 2006. Not all movements between R3 and R5 are shown.

Approximately one third of the walleye moved at least temporarily into the Grass River, downstream on the Nelson River, or were relocated in both areas 2 and 3 (Table 8; also see figures 17-18, 21-22, 24). Substantial numbers of northern pike were relocated in the Grass River or downstream on the Nelson River, but only two individuals moved between both of these areas (also see Figure 20).

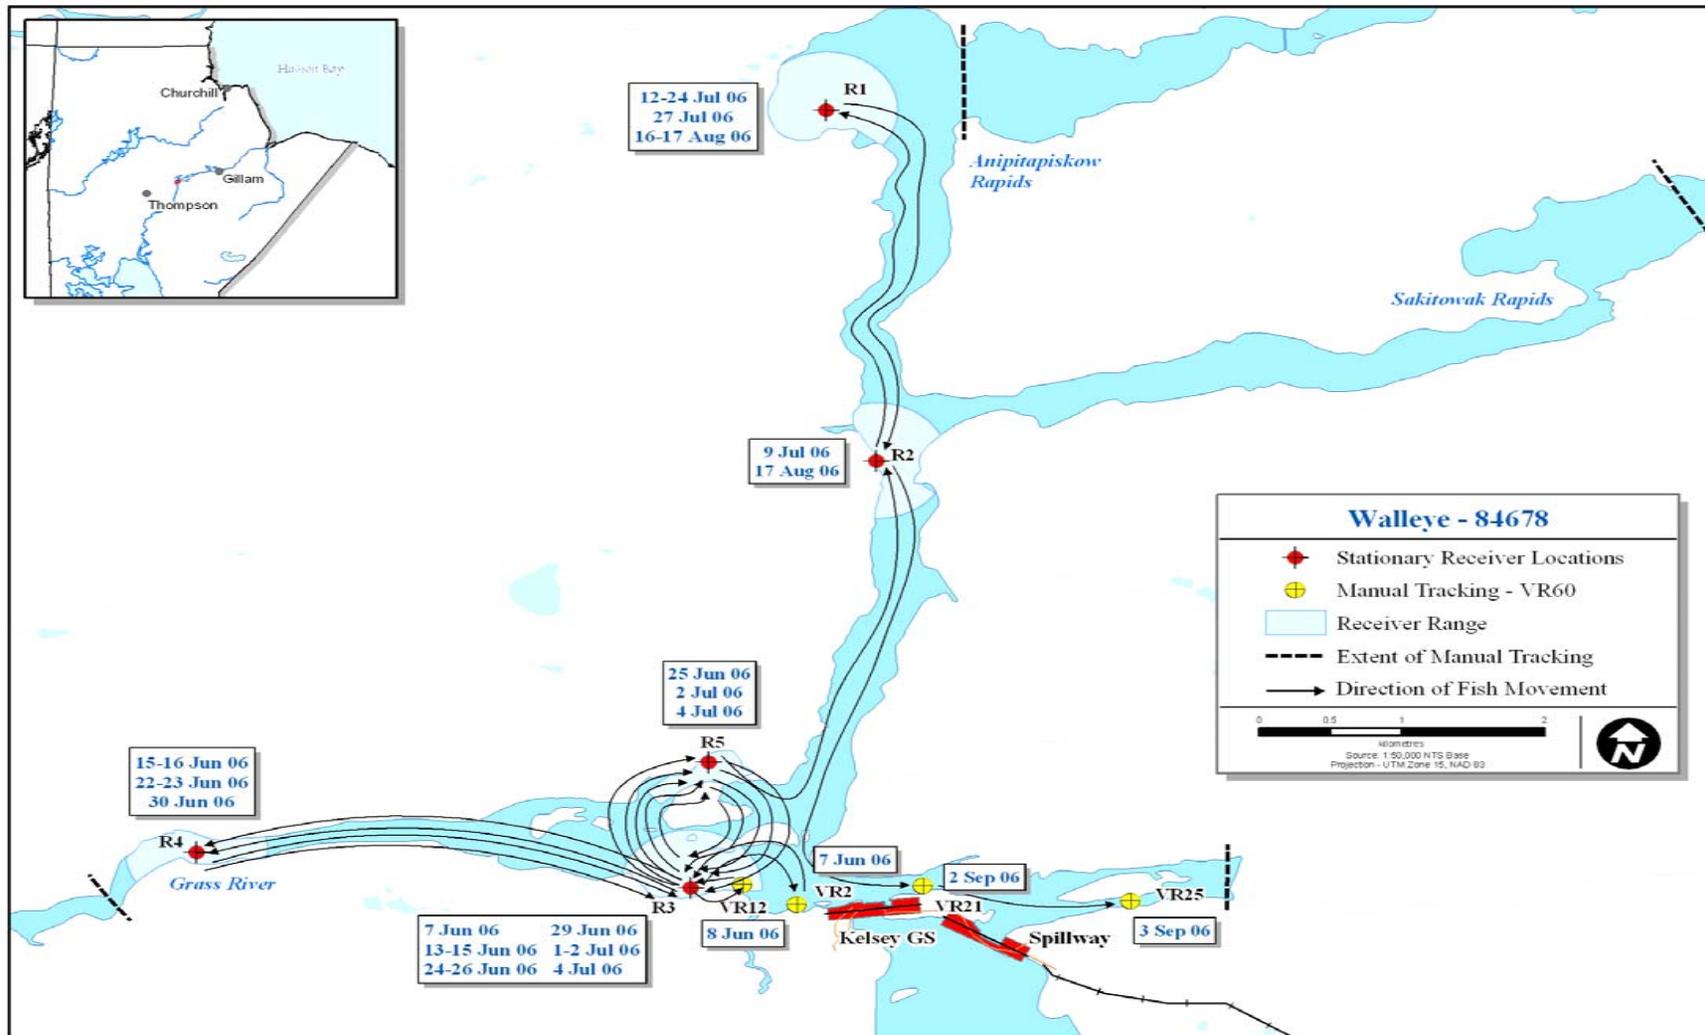
Figure 21. Movement of walleye #84678 between 7 June and 3 September, 2006, after turbine passage on 7 June, 2006. Not all movements between R3 and R5 are shown.

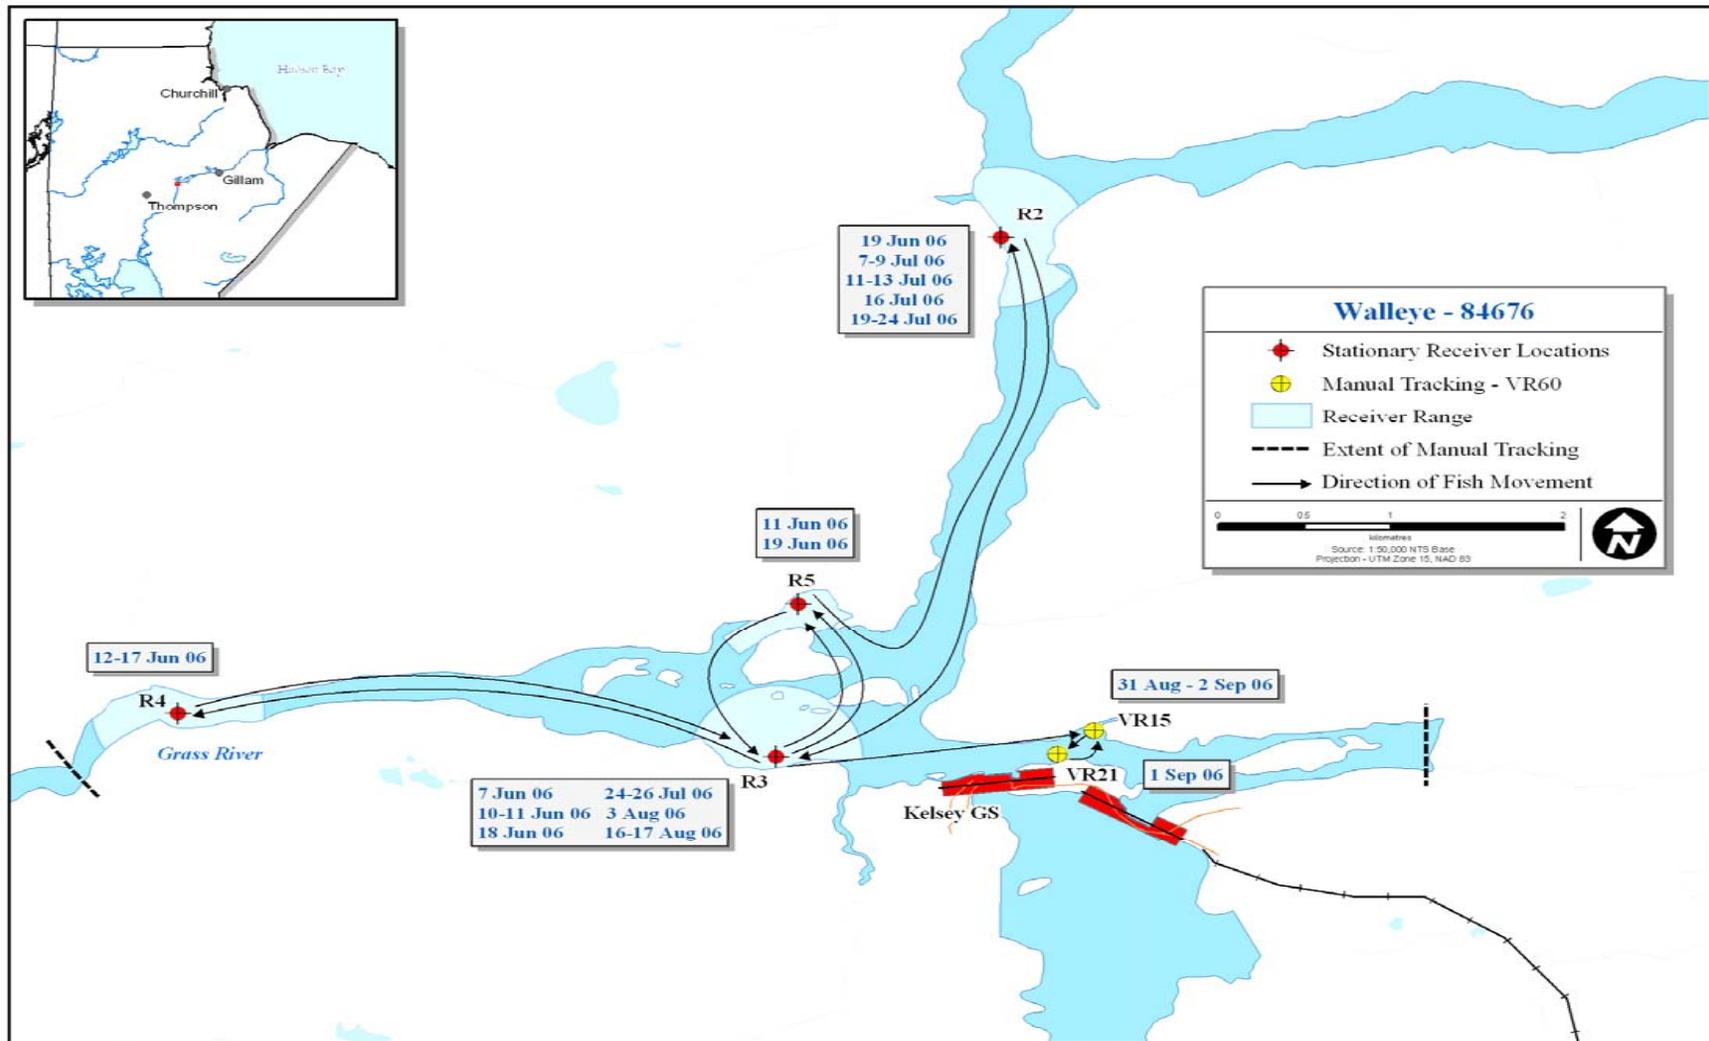
Figure 22. Movement of walleye #84676 between 7 June and 2 September, 2006 after turbine passage on 7 June, 2006.

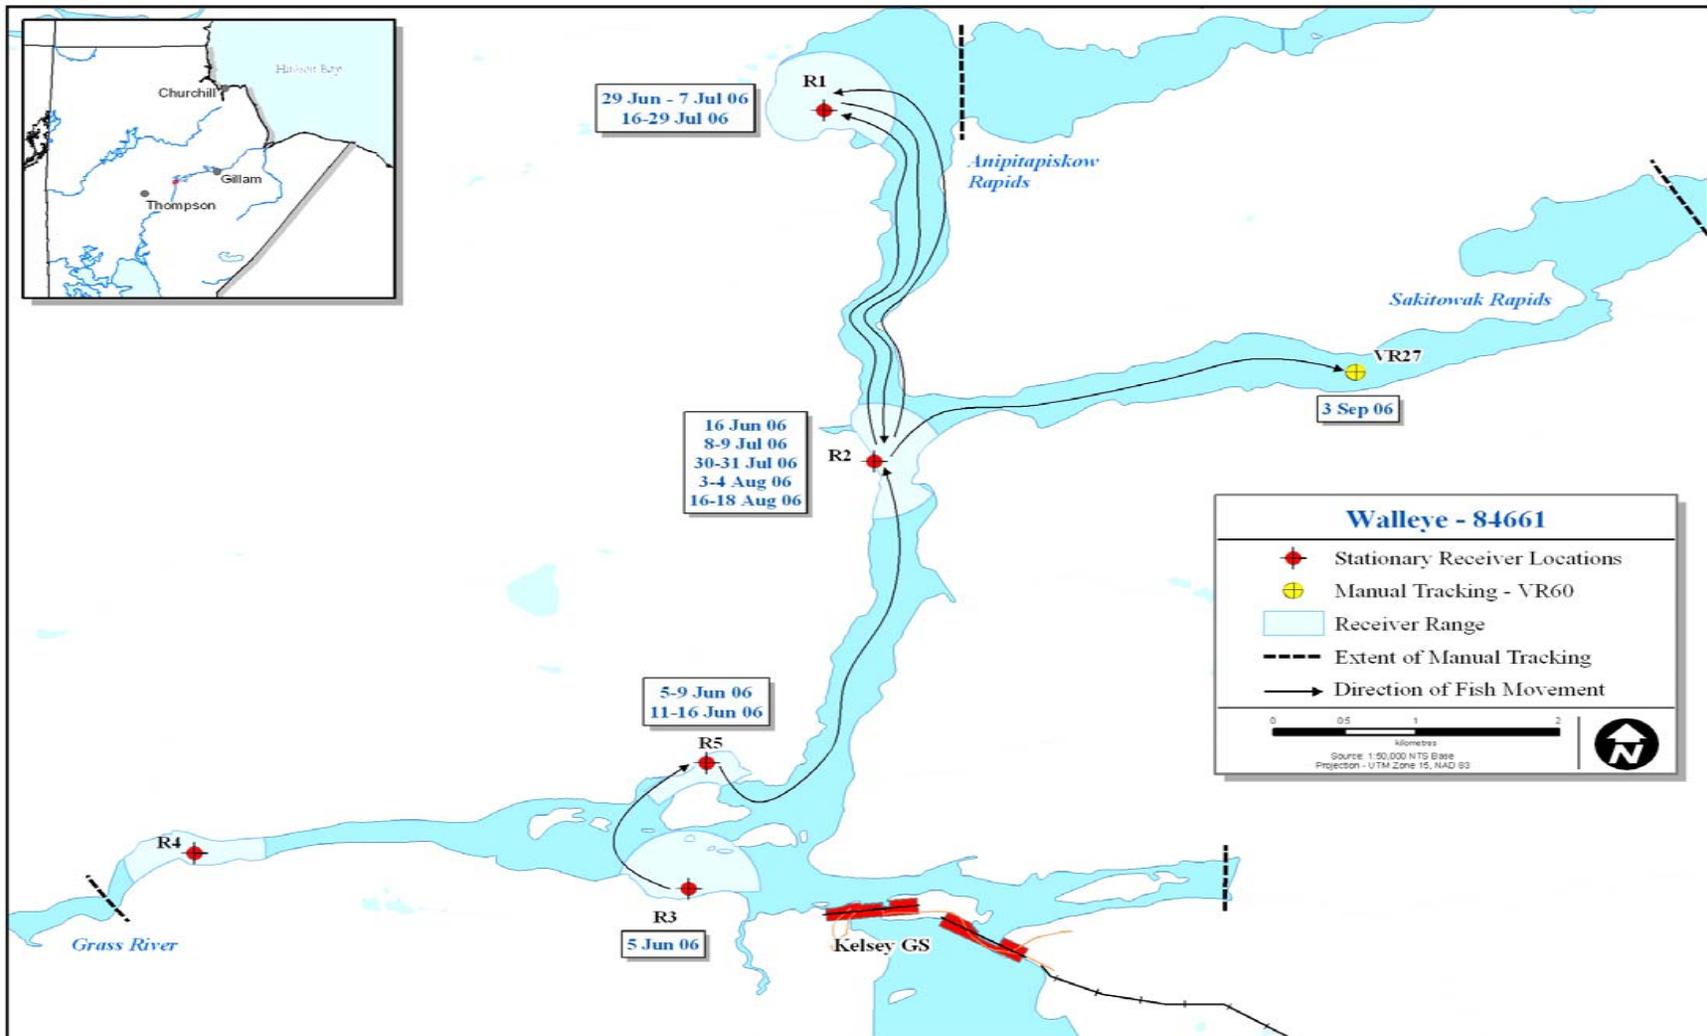
Figure 23. Movement of walleye #84661 between 5 June and 3 September, 2006 after turbine passage on 5 June, 2006.

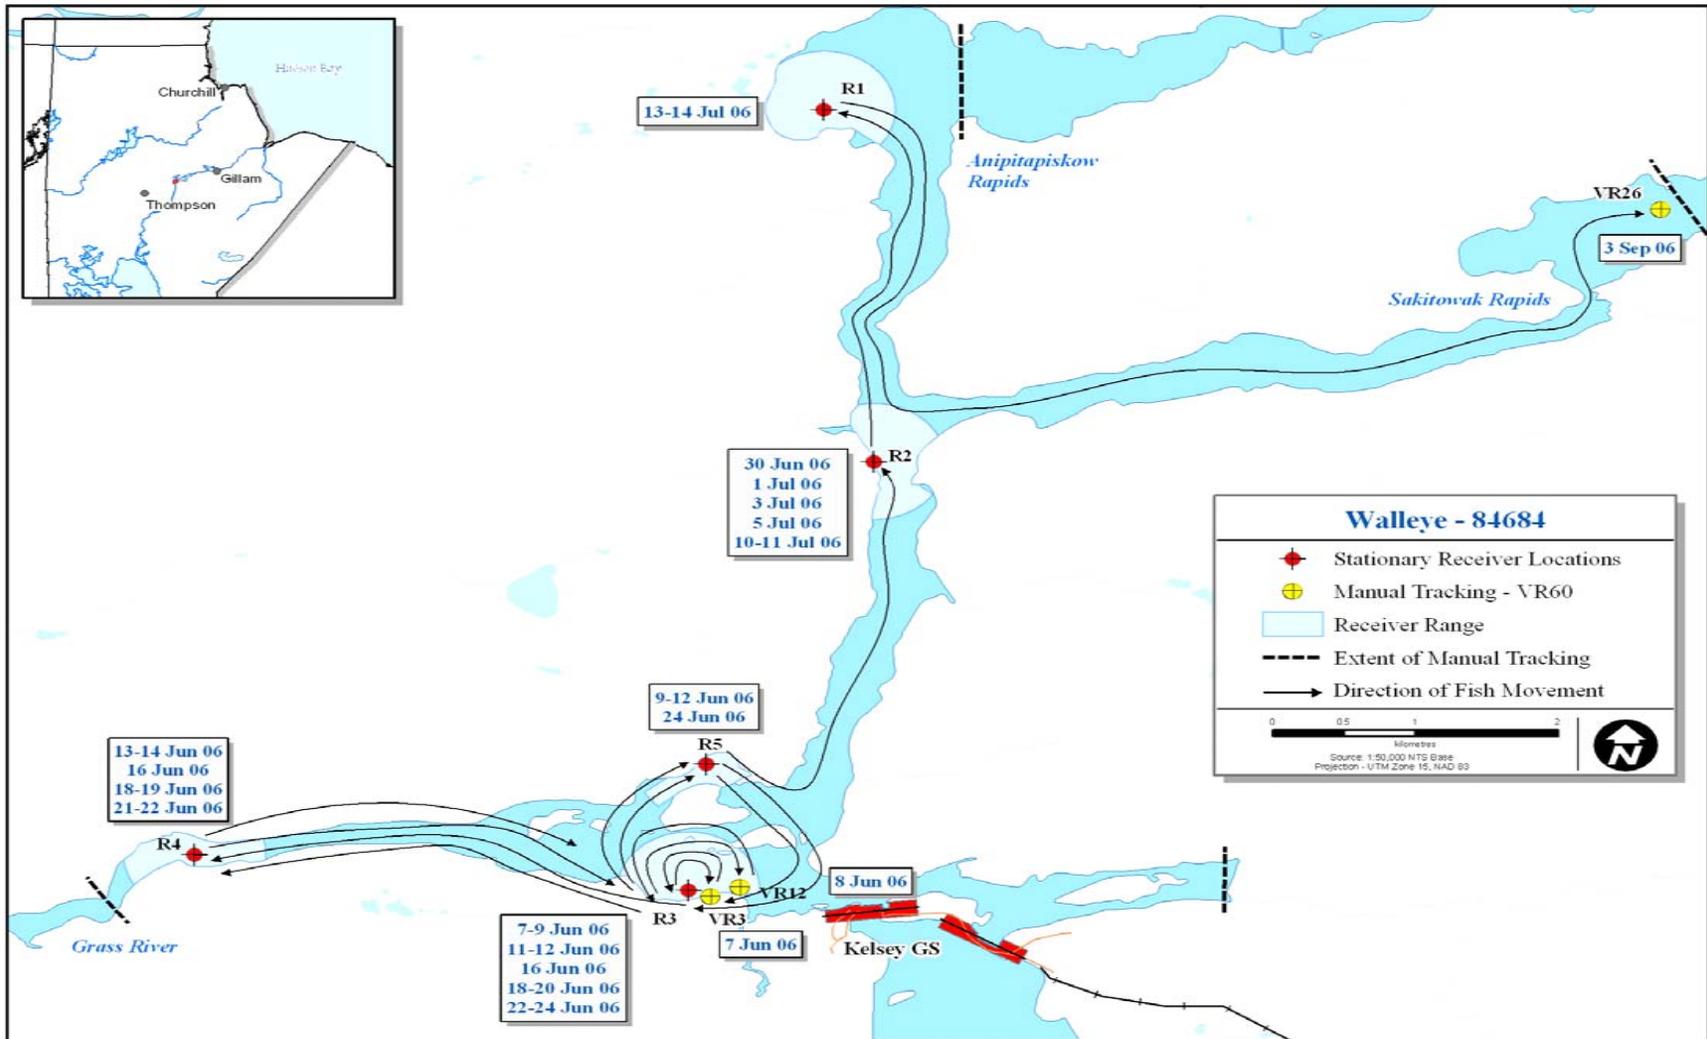
Figure 24. Movement of walleye #84684 between 7 June and 3 September, 2006 after turbine passage on 7 June, 2006.

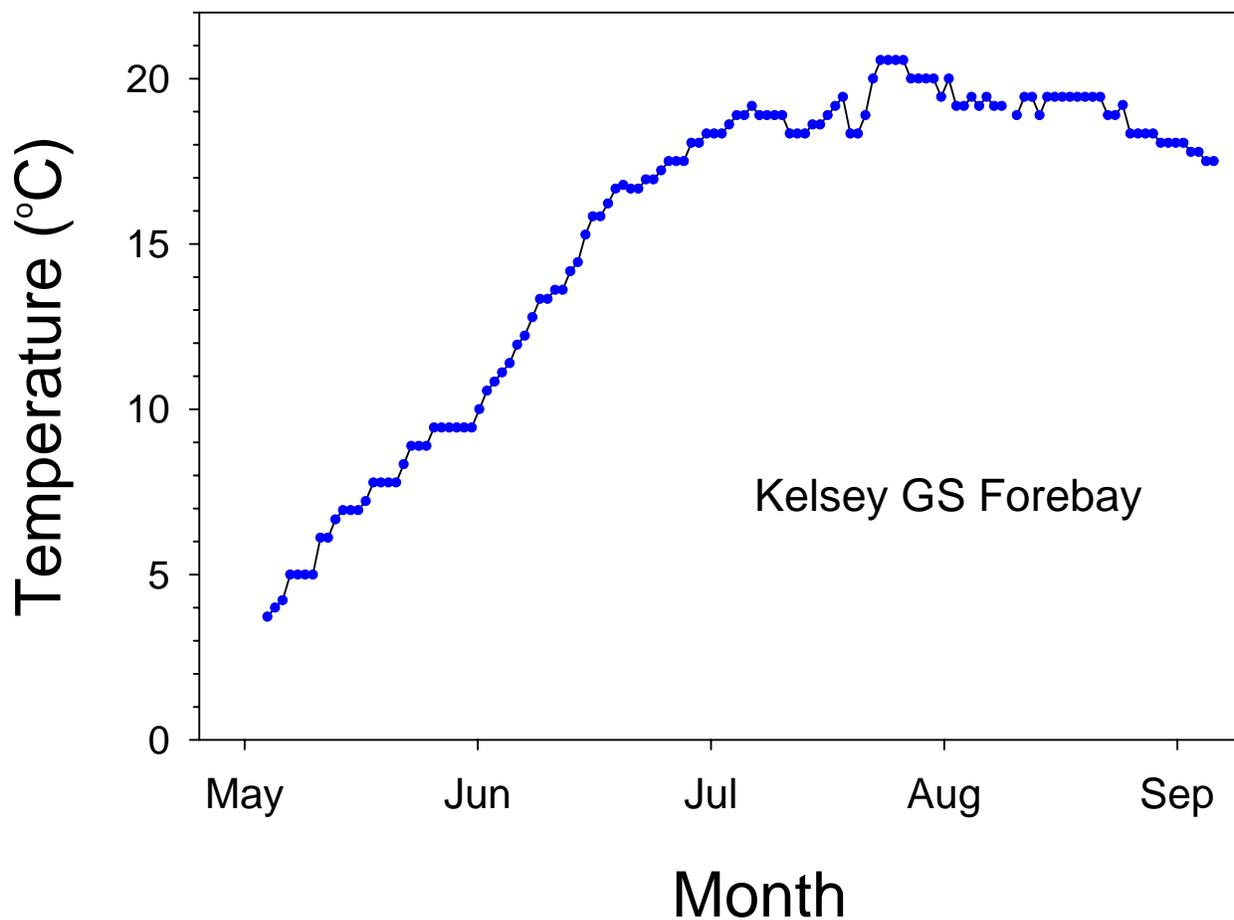
Figure 25. Daily Nelson River water temperatures from 4 May - 6 September, 2006, measured on the forebay side of the Kelsey GS powerhouse.
