**LA SALLE REDBOINE CONSERVATION DISTRICT:  
LA SALLE RIVER WATERSHED ASSESSMENT SURVEY – WITH  
EMPHASIS ON LA SALLE RIVER, ELM RIVER, ELM CREEK  
CHANNEL, AND THE KING DRAIN - 2005**

P. G. Graveline and J. Larter

2006

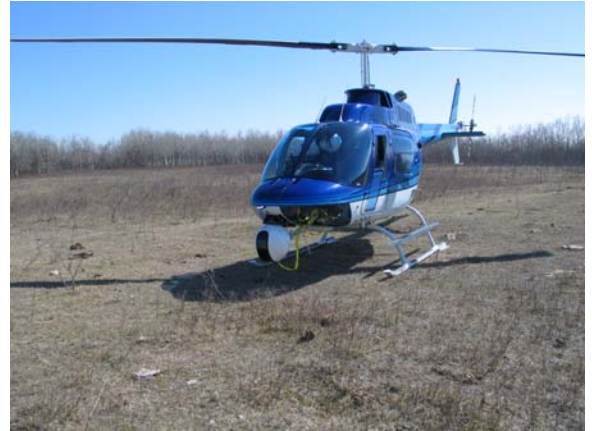
Taiga Air Services (Winnipeg) was chartered to collect aerial video from a helicopter using a digital nose mounted camera and Red Hen System Media-Mapper software. This application produced real-time geo-referenced video and digital still images which were then integrated into a Geographic Information System (GIS). In-flight real-time Geographic Positioning System (GPS) coordinates, altitude, speed and track information were encoded into the digital video and images captured from the onboard nose mounted camera. Specific points of interest (e.g., dams, fords, etc.) along the video flight route were marked as integrated video waypoints.

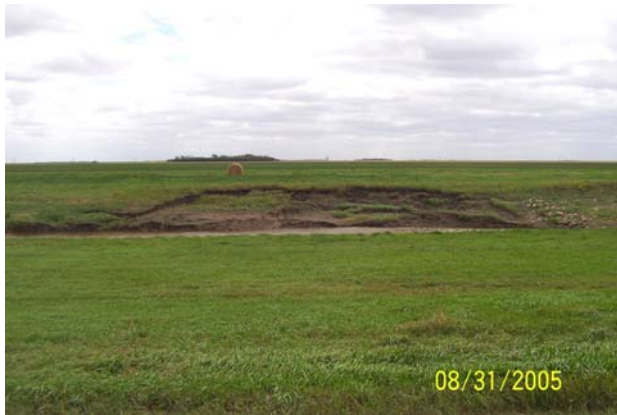
Assessments of bank stability were based on the potential for detachment of soil from the upper and lower stream banks and the subsequent deposition to the stream channel. Both the left bank (LB) and right bank (RB), when looking upstream, were classified and rated. Due to the scale and resolution of the aerial video, bank stability was at times difficult to visually assess. Ratings were

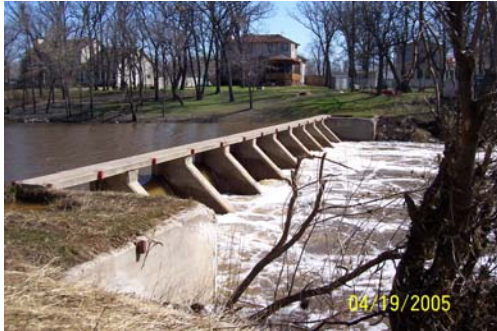
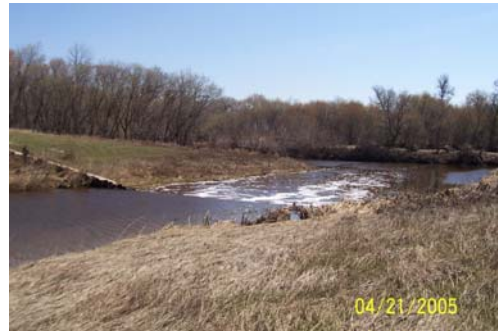
Under the classification of anthropogenic barriers, dams may also be referred to as ‘low-head dams’. A low head dam is defined as a constructed barrier in a river, spanning the entire width, with a hydraulic height not exceeding eight meters (ICF 2005). Dam composition may include concrete, rubble, boulder, or a similar aggregate.

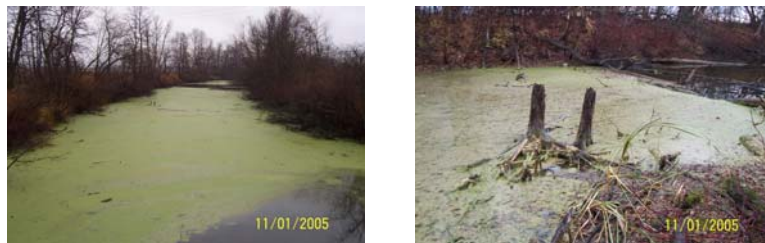
As discussed in Section 3.1.2, eutrophication can lead to the excessive growth of aquatic plants and algae. A number of duckweed/algal mats were identified via aerial footage taken in late October, 2005. Groundtruthing at two sites on November 1 revealed that these mats consisted primarily of duckweed, though algae may also have been present.

Duckweed/algal growth at '1919B (headwaters) and at 'FORT' (near Fortier Gospel Chapel)

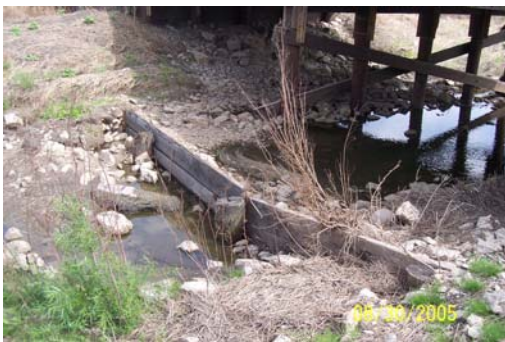
The carp, which were young-of-the-year and had a mean length of 69 mm (n = 18), were all captured in the King Drain. These fish were captured upstream of a small wooden weir which effectively blocked their downstream migration. Although not represented in the catch, it is possible that additional fish species (e.g. northern pike, white sucker, and
