#### **Source Water Protection**

## **Public Drinking Water Sources**

Throughout the development of the Pembina River integrated watershed management plan, members of the source water protection committee conducted preliminary source water assessments in the immediate area around the public water systems to identify potential sources of contaminants. Recommendations were developed to address the issues that pose a threat of contaminating the public drinking water sources.

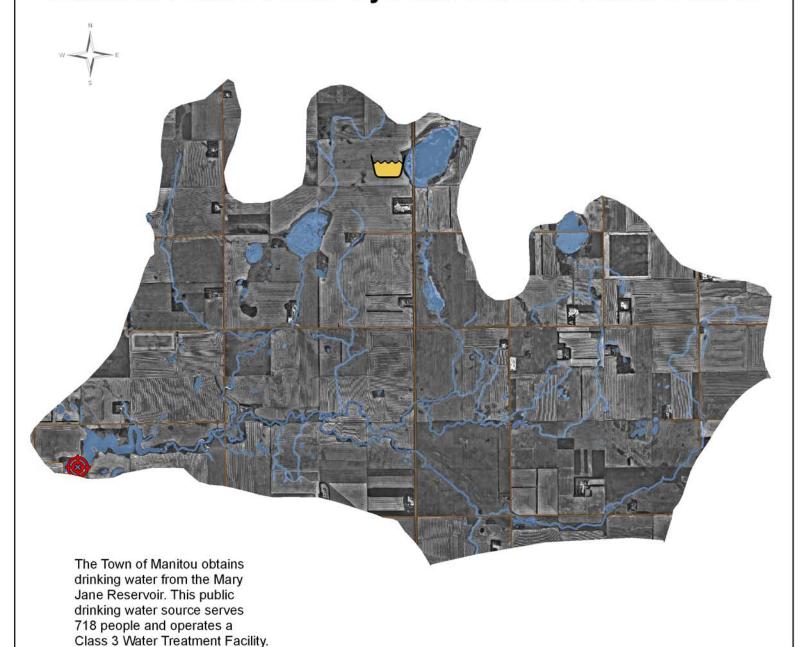
## Public drinking water supply for the town of Manitou.

The orthophoto illustrates land use within the Mary Jane Reservoir watershed

# Recommended actions for all potential pollutant sources: 1. Reduce nutrient inputs from this sub watershed.
