# 2024 Annual River Crossing Report

**Environment Act Licences No. 2684 RRR, 2669 E RR & 2716 RR**

**Environment and Climate Change**

April 2025

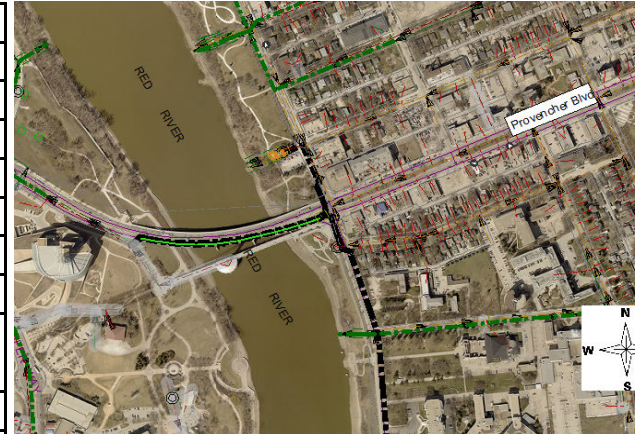
| Condition Grade | 3 |

Inspection and condition assessment of the Provencher Bridge Force Mains suggest that the pipe are in good condition. The lowest reported wall thickness was 95% RW.

| | 3 to 5 years | 5 to 10 years | Type |
|---|---|---|---|
| Rehabilitation | \$ 90,000.00 | | Replace pipe hangers, rollers, and cladding |

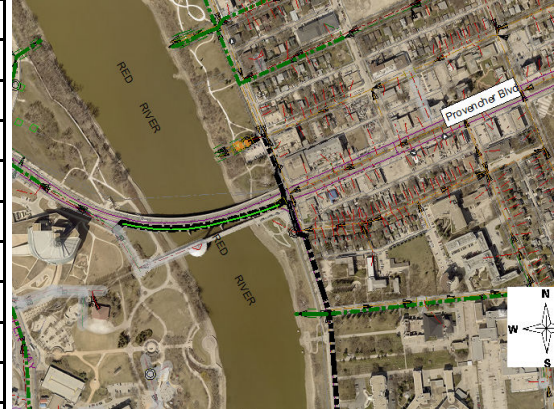
| Condition Grade | 1 |

Inspection and condition assessment of the Provencher Bridge Force Mains suggest that the pipe are in good condition. The lowest reported wall thickness was 95% Remaining Width.

| | 3 to 5 years | 5 to 10 years | Type |
|---|---|---|---|
| Rehabilitation | \$90,000 | | Replace pipe hangers, rollers, and cladding |

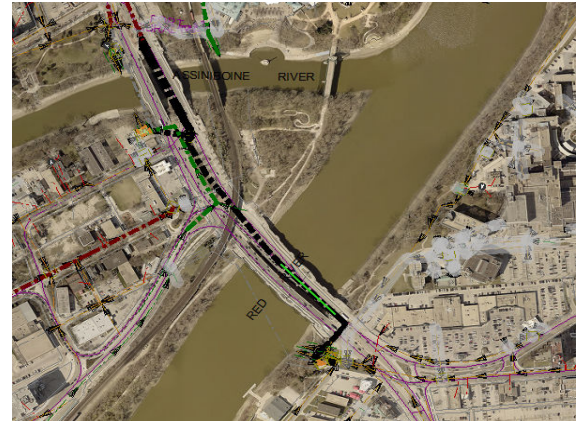
| Condition Grade | 4 |

Inspection and condition assessment of the Norwood Bridge Force Main, suggest that the pipe is in good condition. The lowest reported wall thickness was 86% RW.

| | 3 to 5 years | 5 to 10 years | Type |
|---|---|---|---|
| Rehabilitation | \$ 788,000.00 | | Replace expansion joints |
