Manitoba Hydro

Pointe du Bois Spillway Replacement

Alteration

August 2012

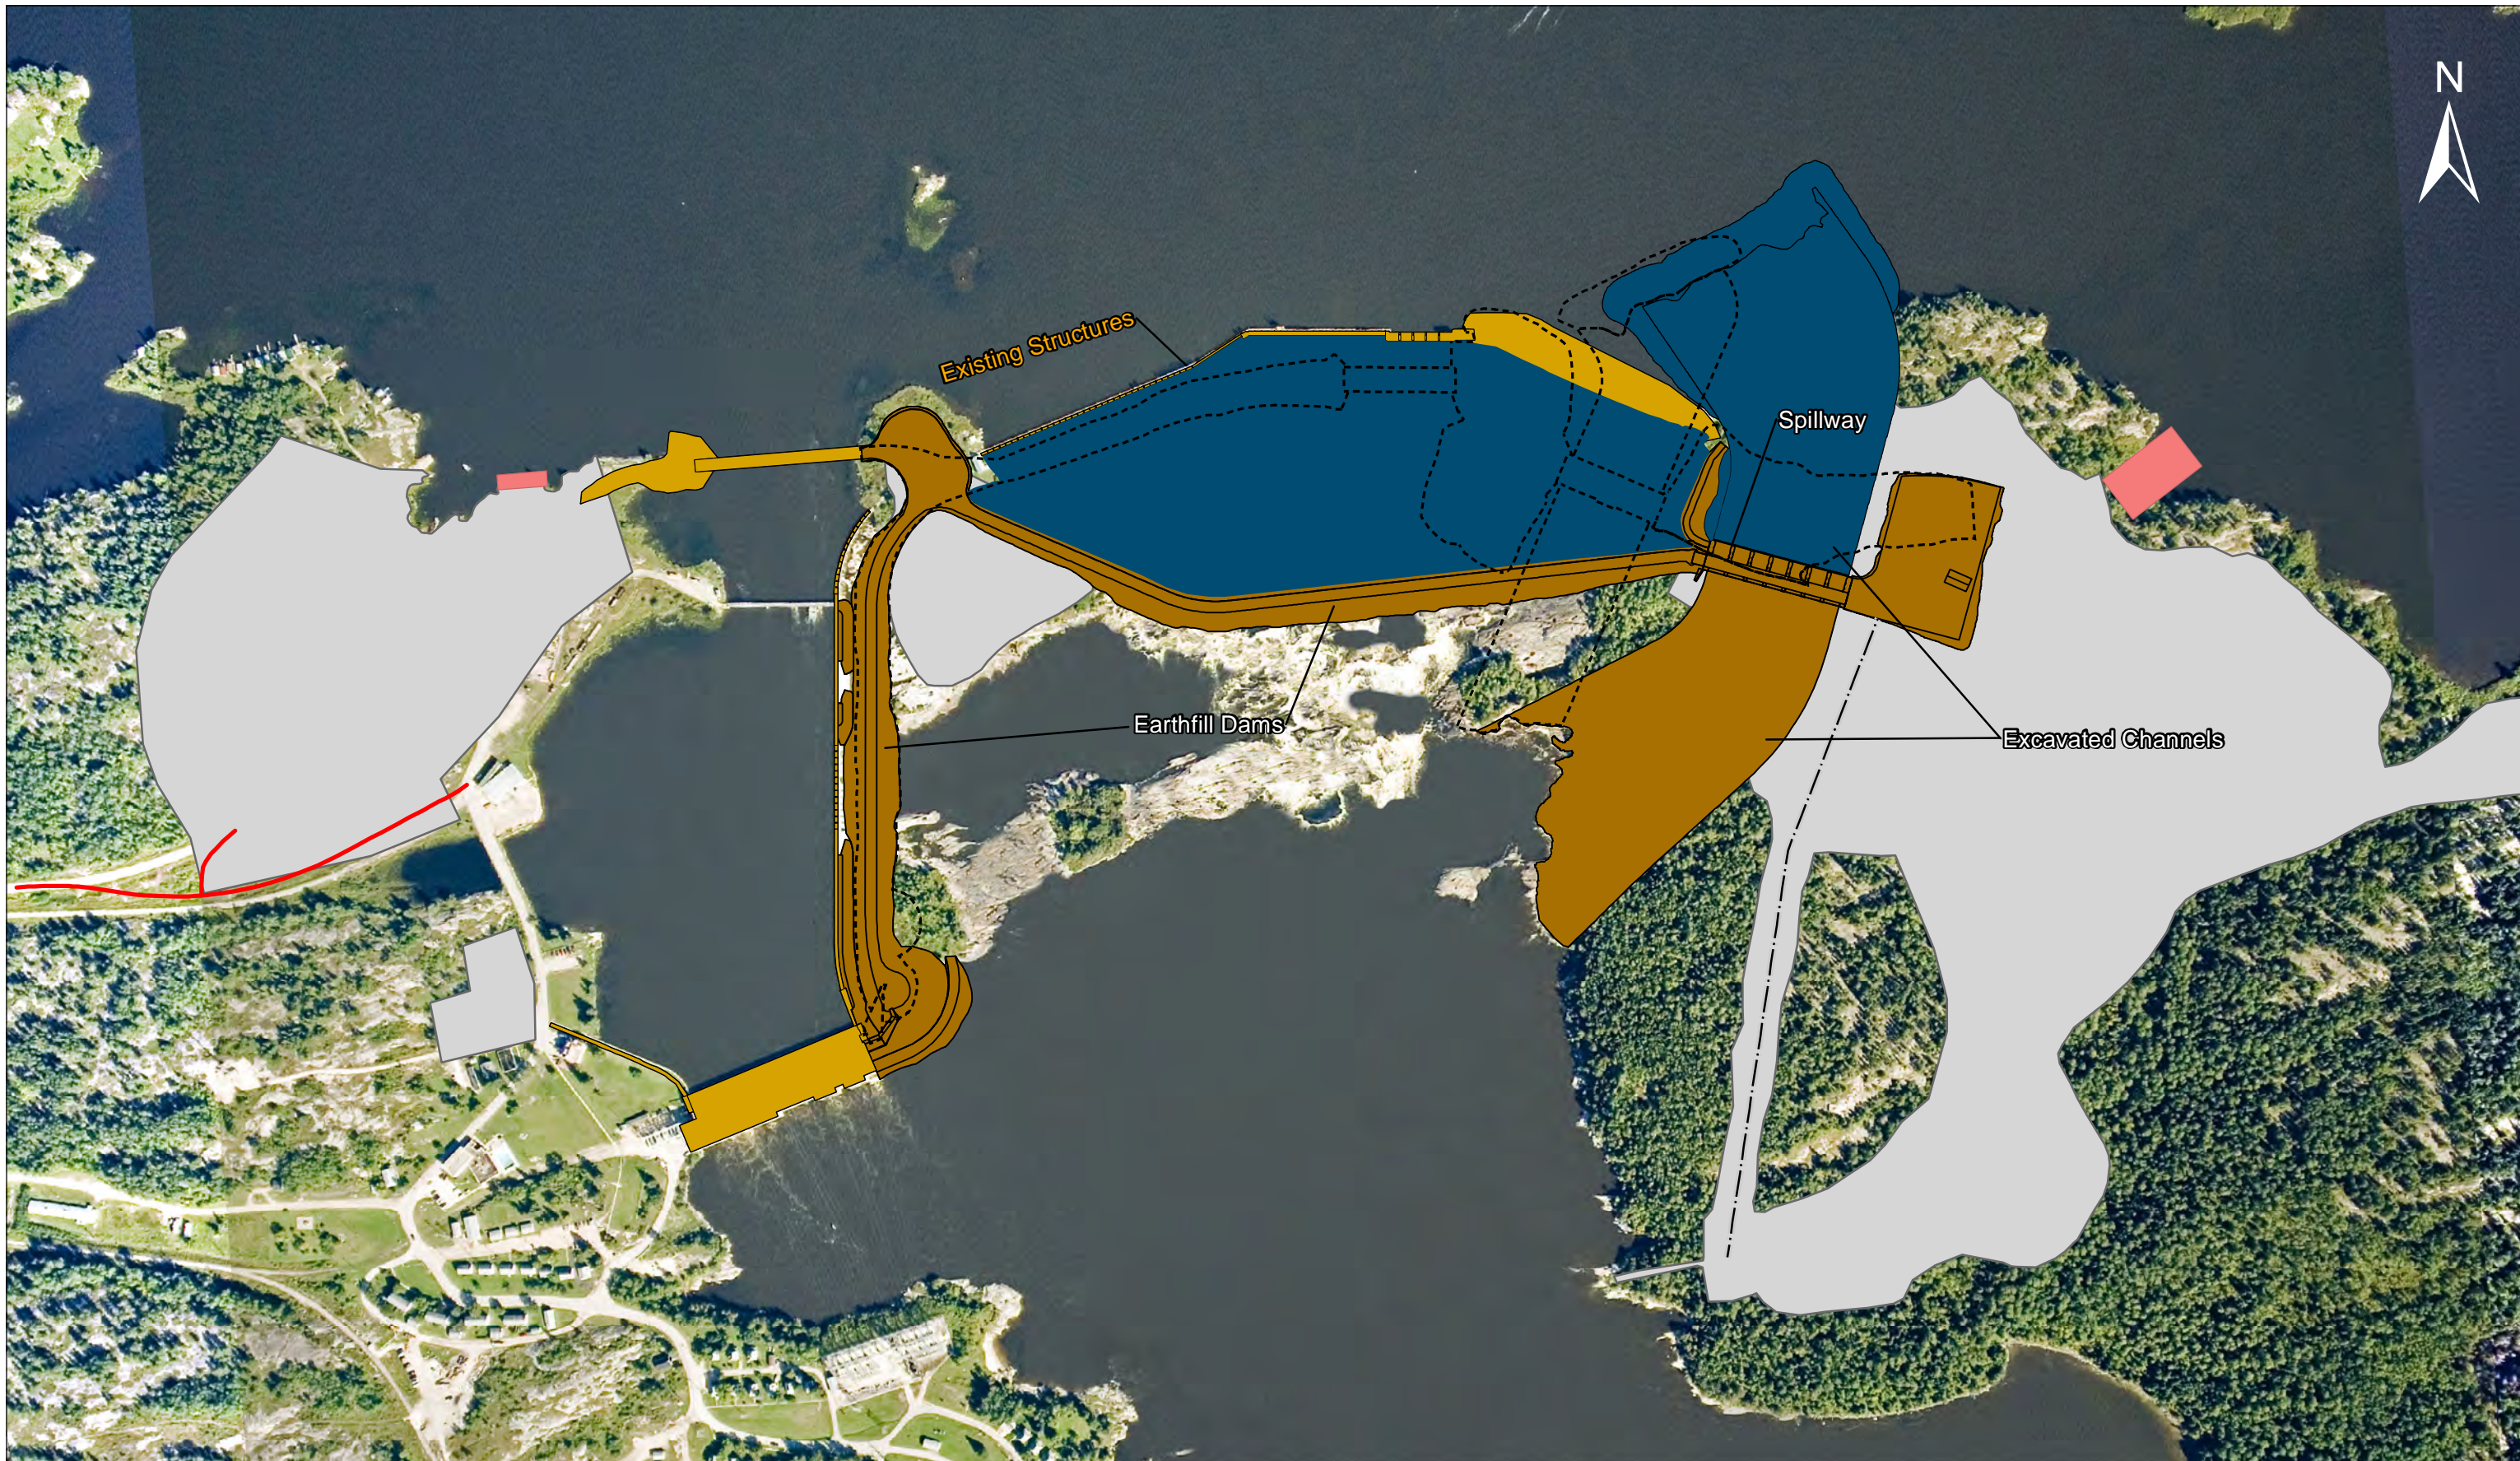
Figure:
3.1
Rev 1

Original and Revised
Arrangements

Figure 3.1 Rev1 outlines the existing, Original and Revised Arrangements.

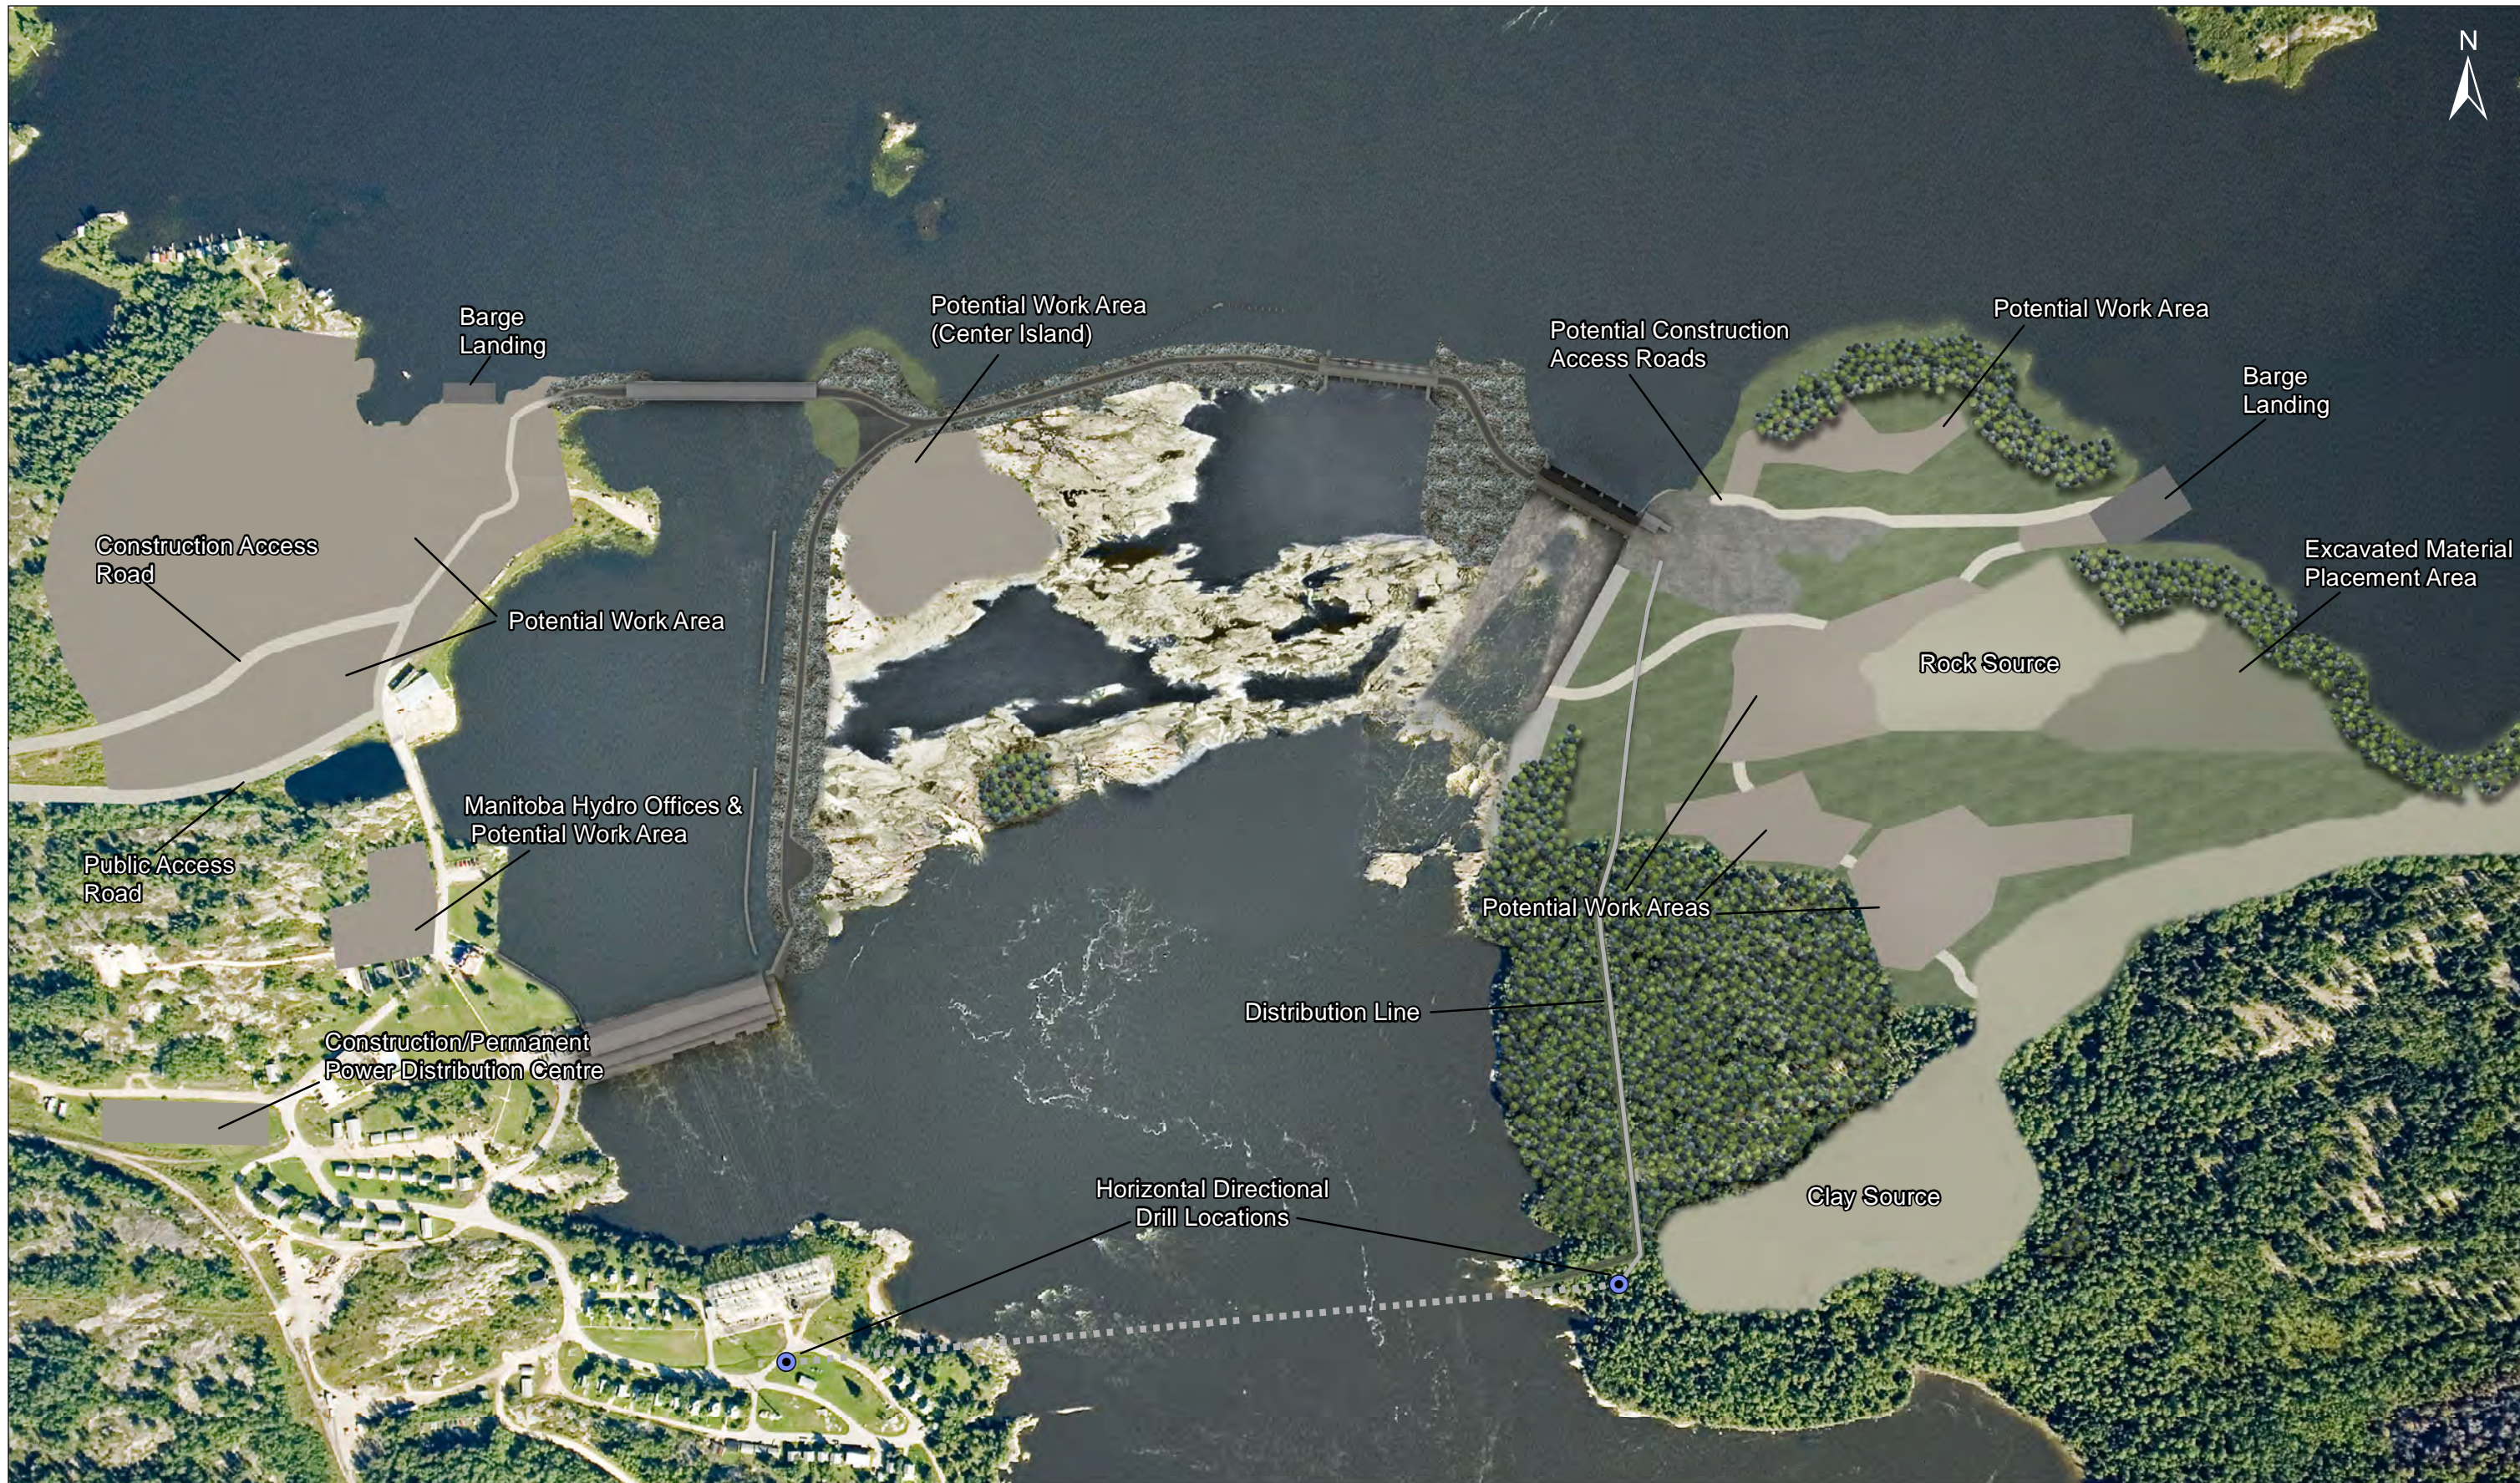
DATA SOURCE: Manitoba Hydro, KGS Acres		<h2 style="text-align: center;">Pointe du Bois Spillway Replacement Project</h2>	Figure: 3.4
		DATE CREATED: 12 MAY 2011	CREATED BY: HPP - GIS & Special Studies		
		REVISION NO: VERSION: 1.0	REVISION DATE: 26 MAY 2011	QA/QC: RHP, MWZ, BMP

Supporting construction infrastructure and principal structures for the Original and Revised Arrangements are shown in Figures 3.4 and 3.5 and Figures 3.4 Rev1 and 3.5 Rev1, respectively.

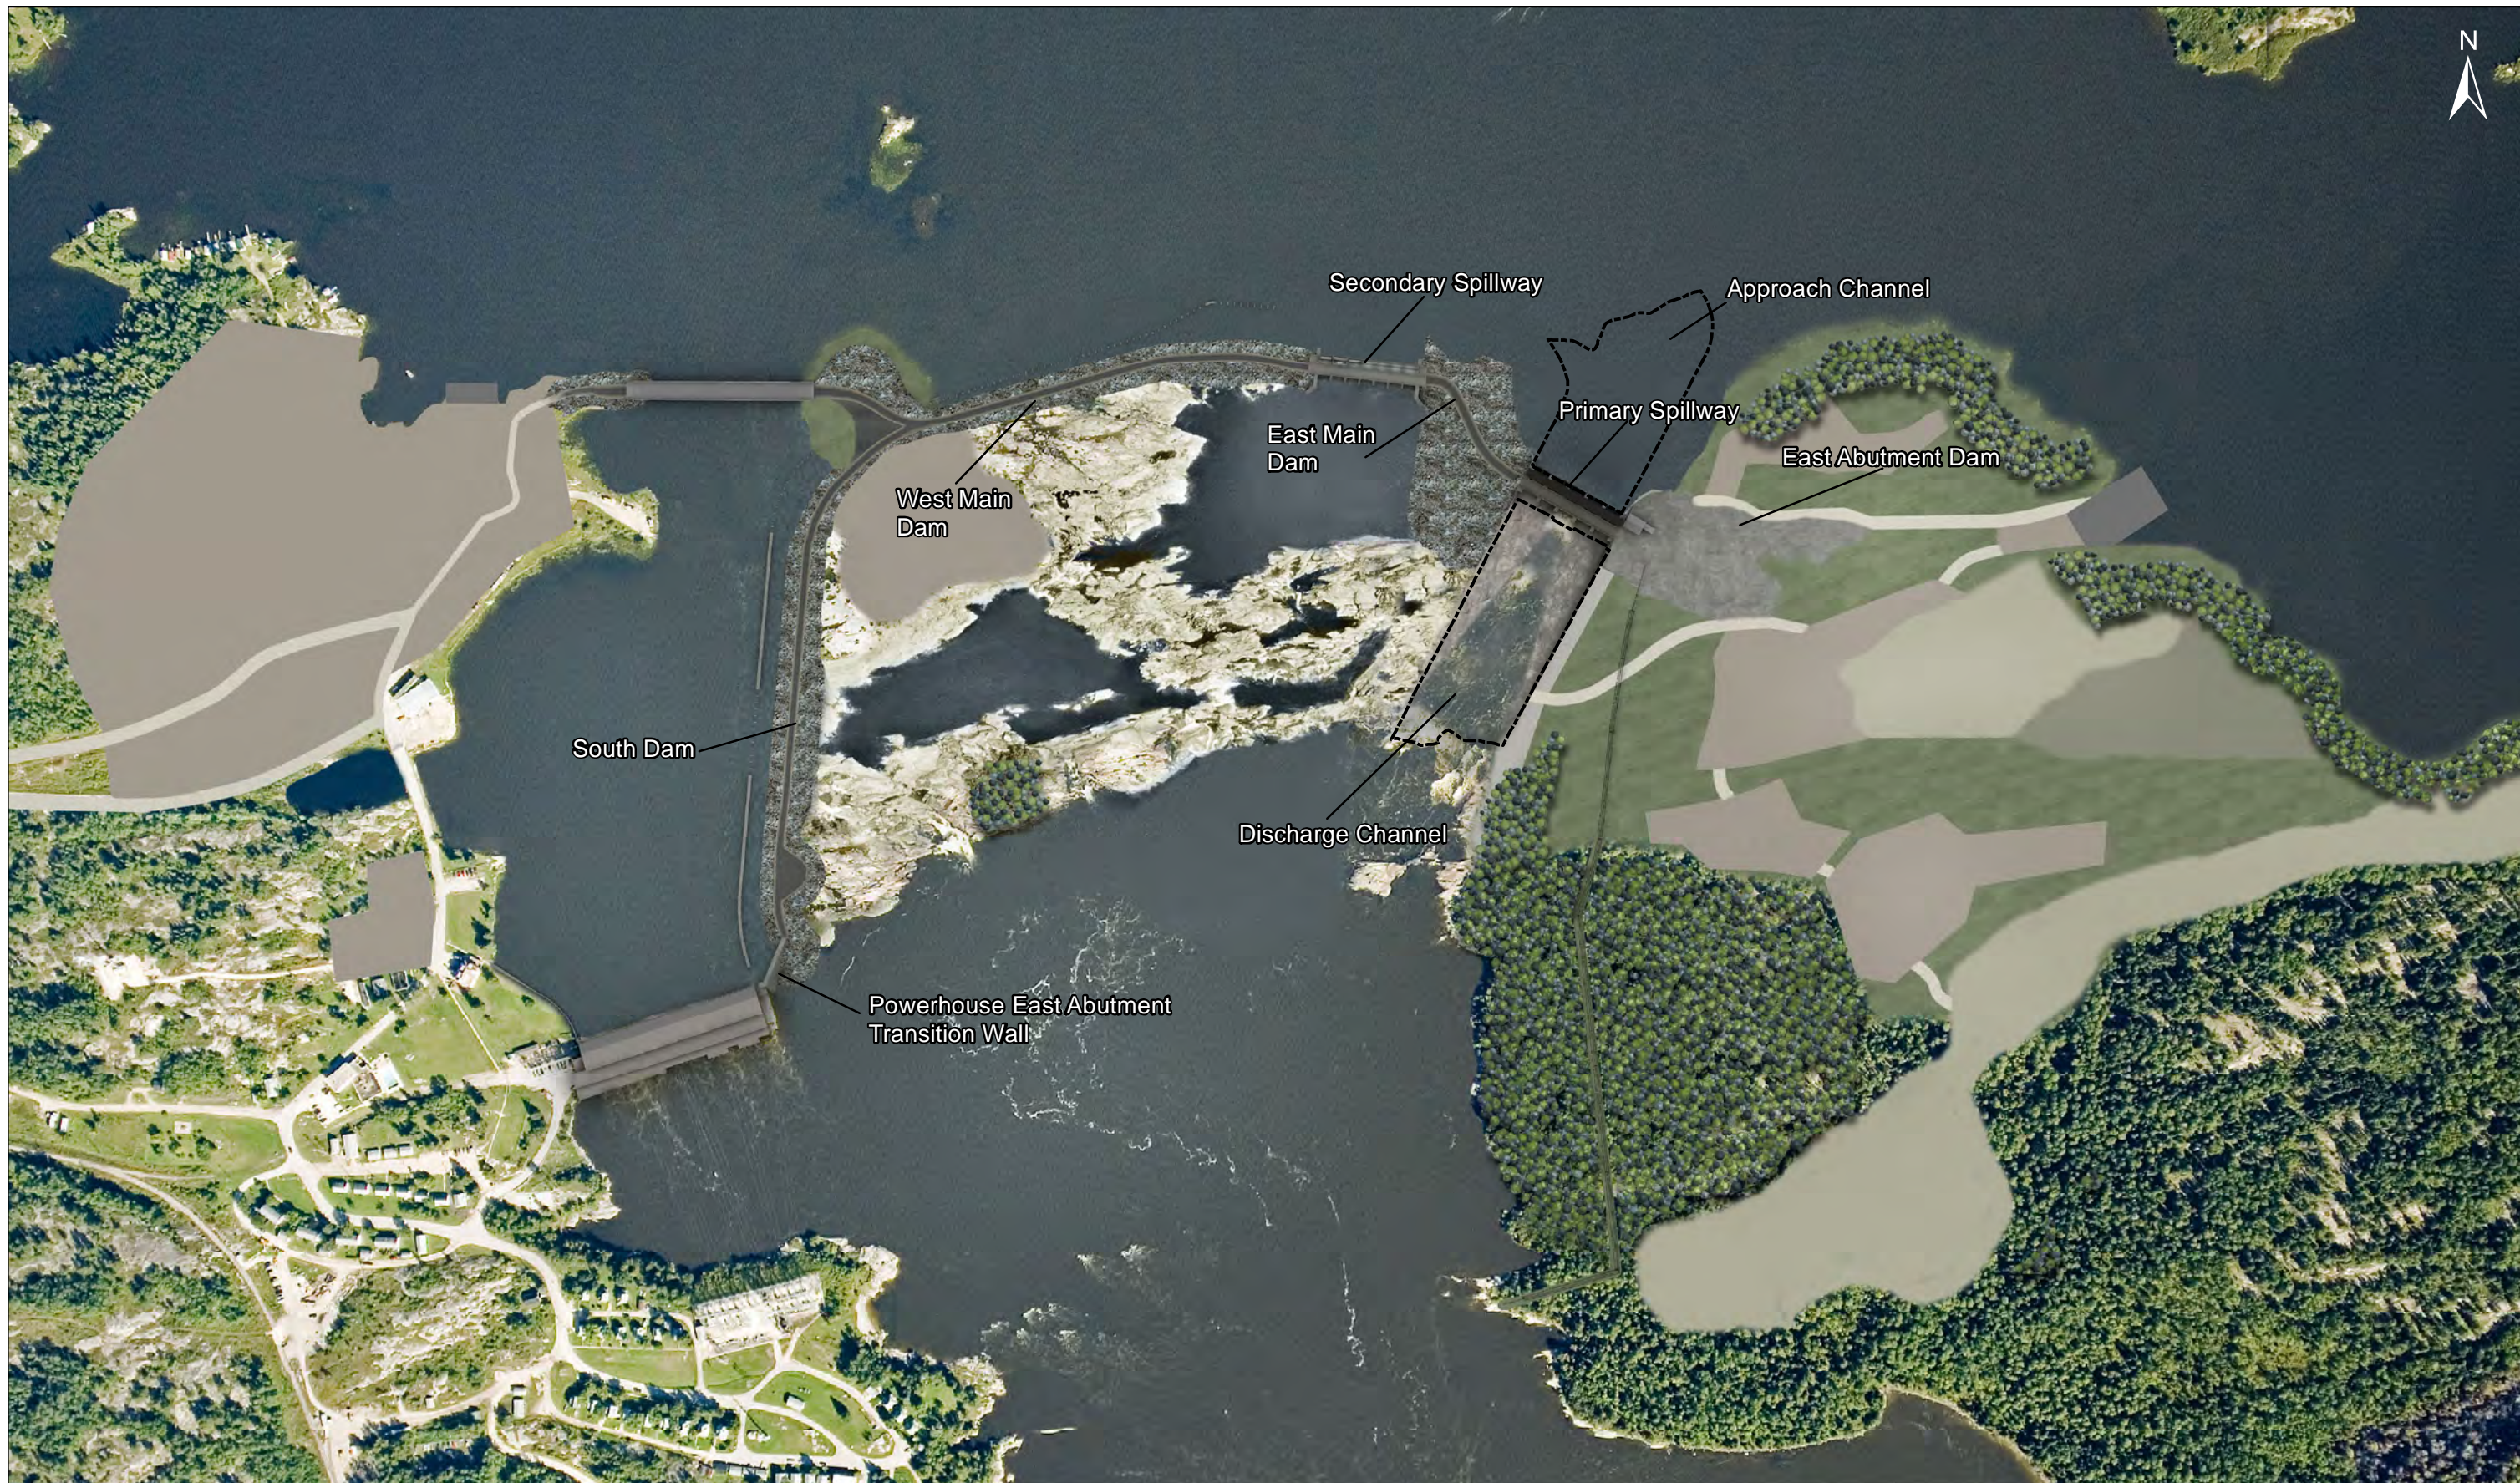
Figure:
3.5

Principal Structures

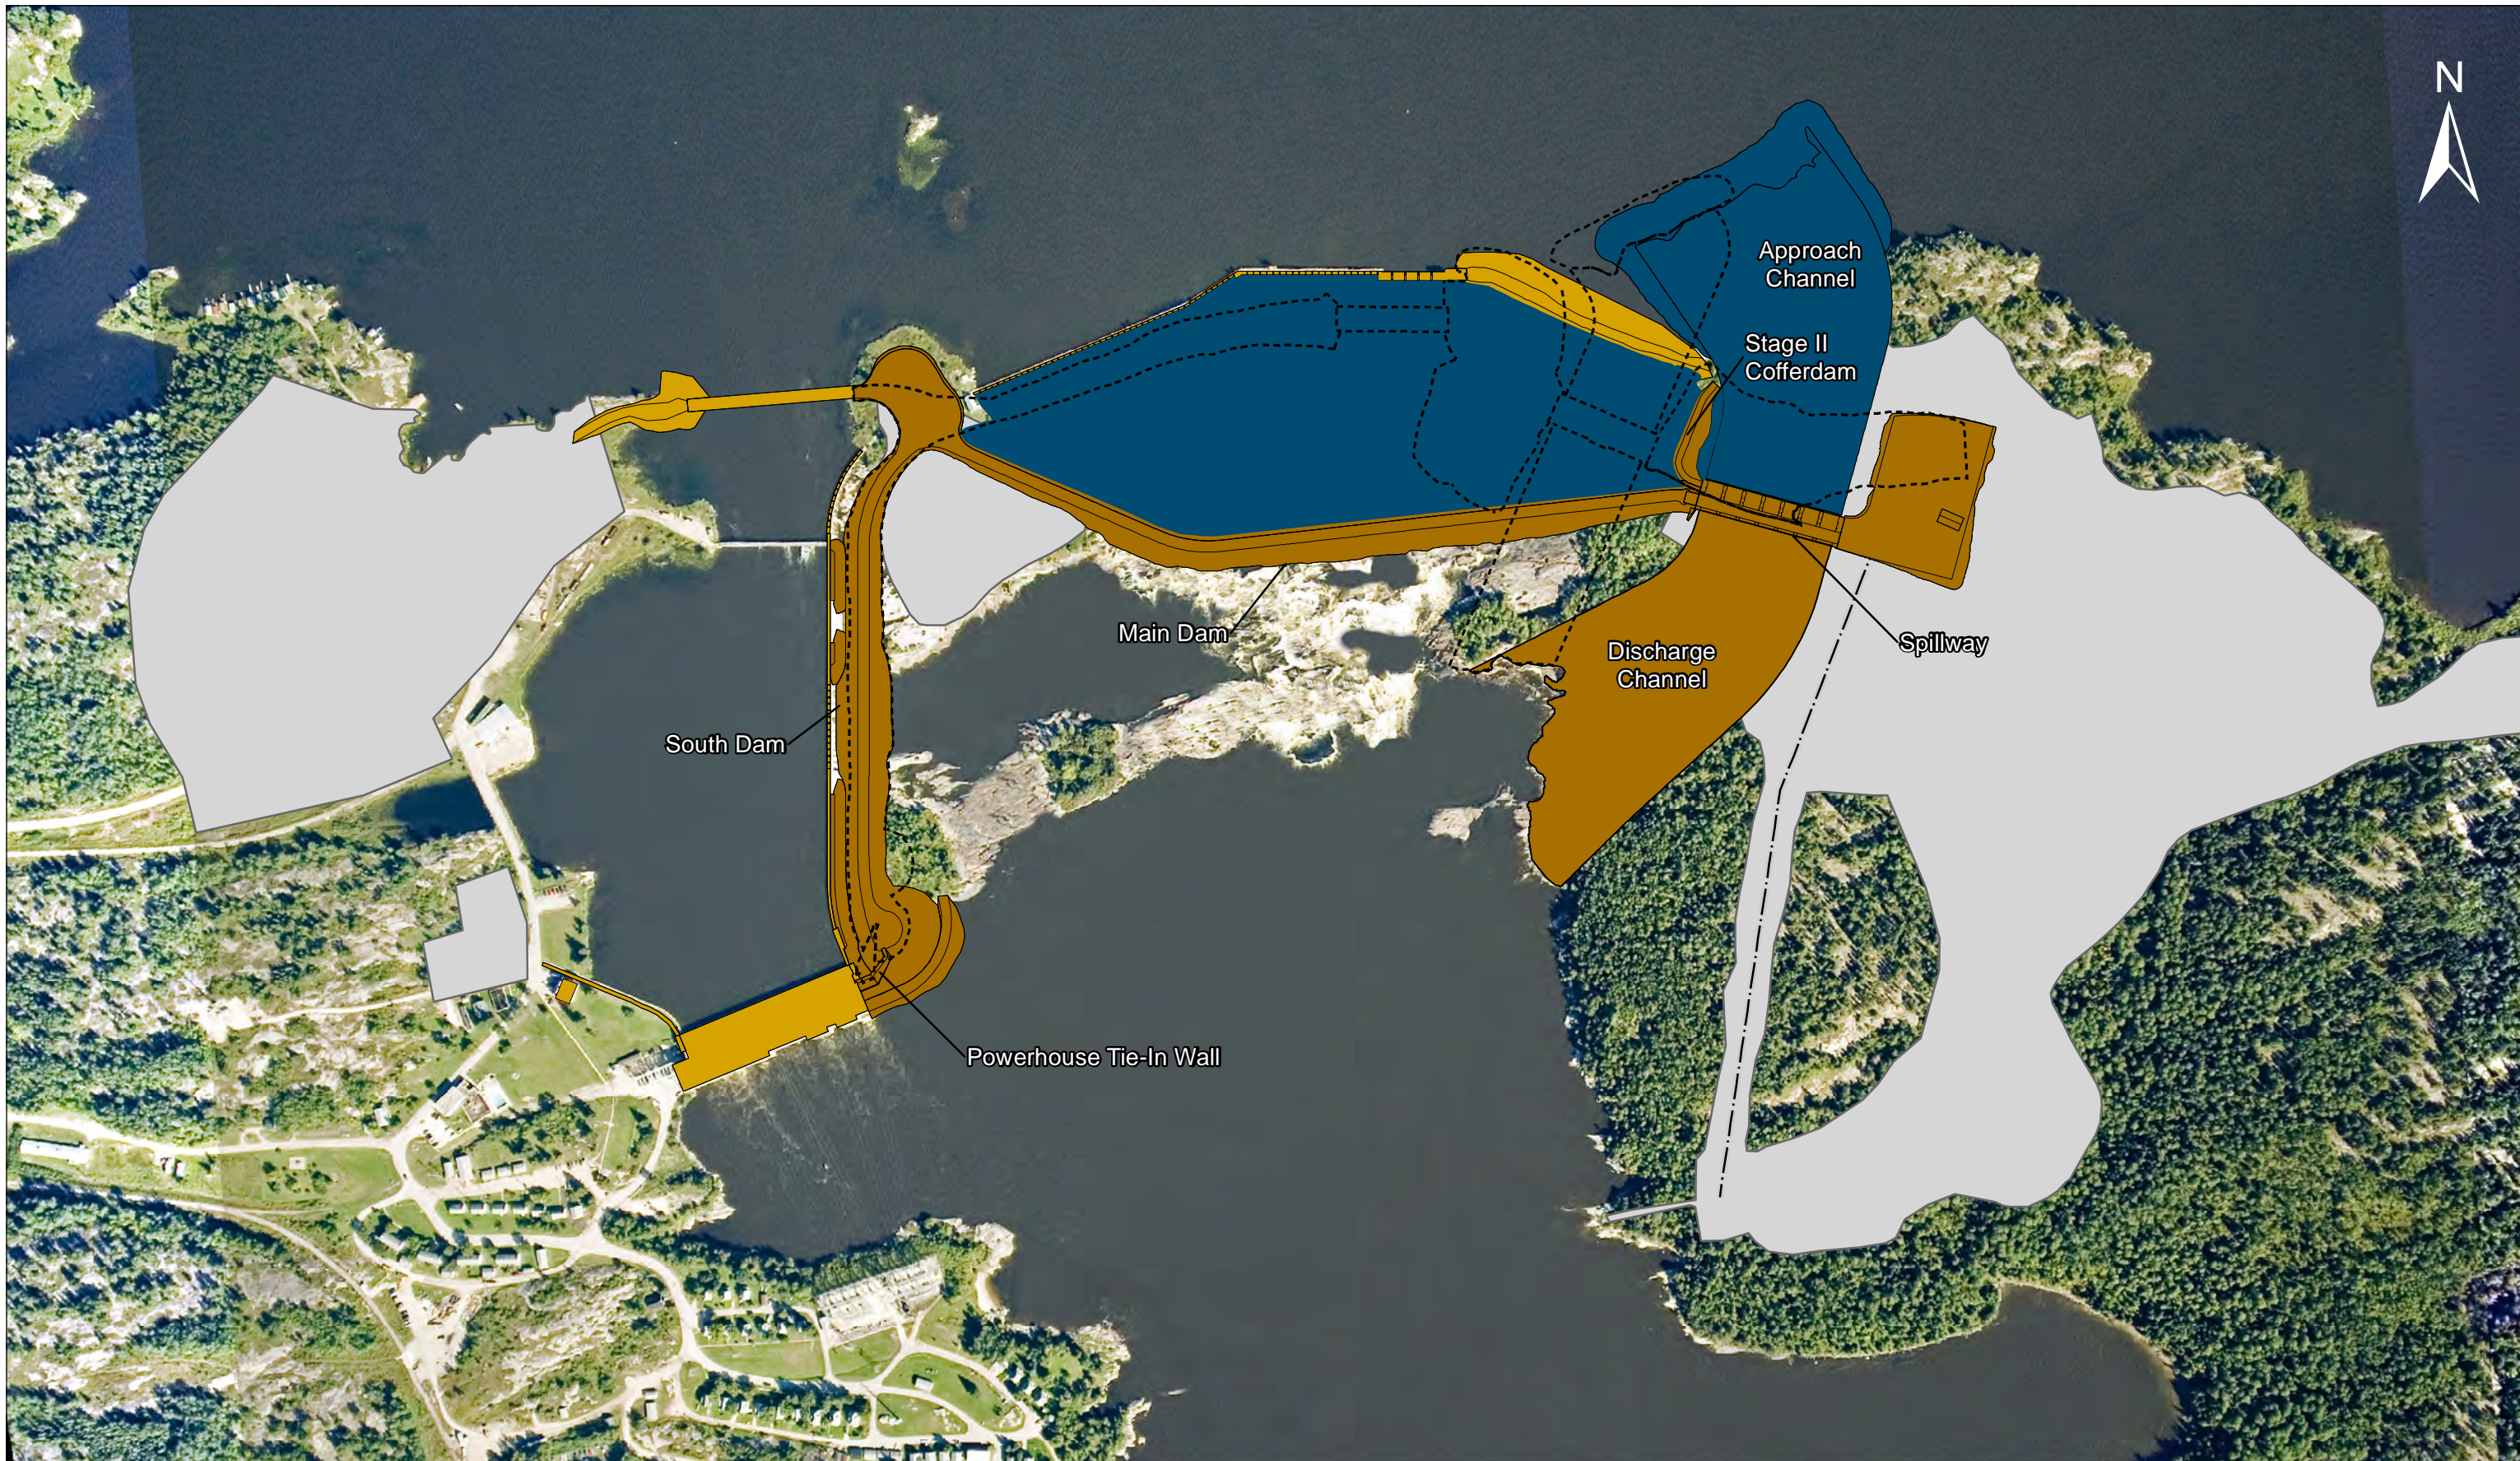
Figure:
3.5
Rev 1

Principal Structures

The principal structures for the project include the following and are shown on Figure 3.5 Rev1:

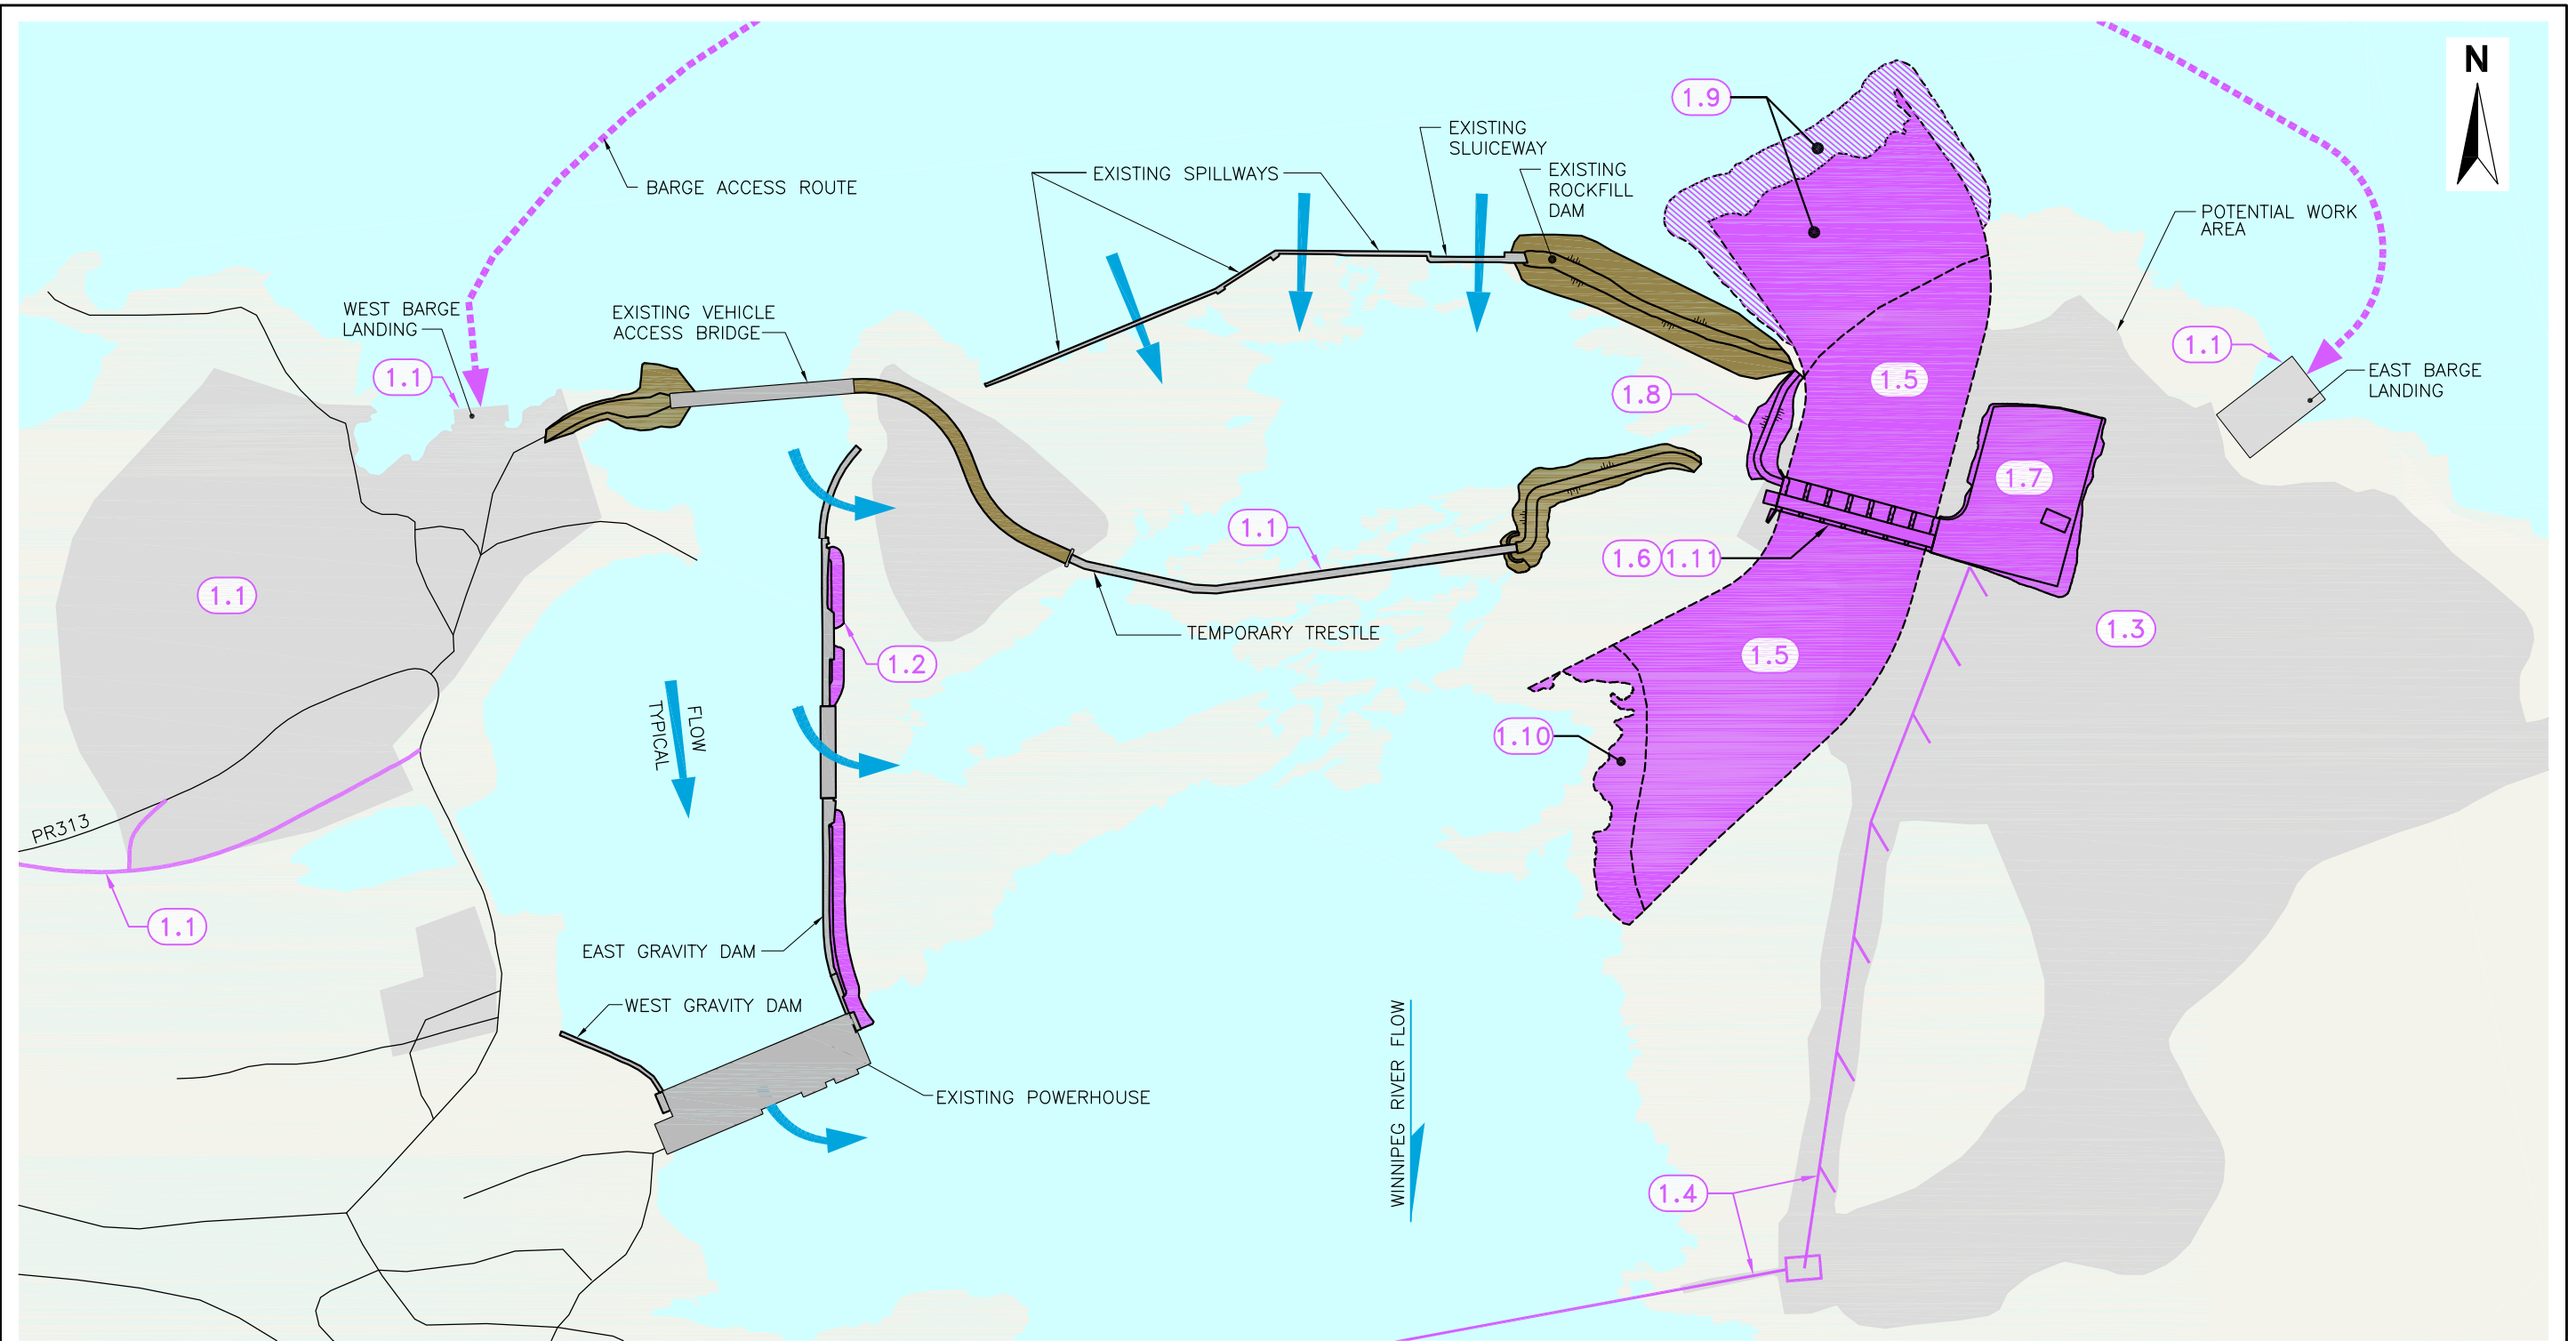
STAGE I

- 1.1 CONSTRUCT NEW LOCAL ACCESS ROAD, WEST SIDE SUPPORTING INFRASTRUCTURE, BARGE LANDINGS AND TEMPORARY TRESTLE
- 1.2 CONSTRUCT EAST GRAVITY DAM ROCKFILL SUPPORT
- 1.3 DEVELOP EAST SIDE WORK AREA

Pointe du Bois Spillway Replacement Project	
STAGE 1 Mobilization, Excavation & Spillway Construction	
	Figure: 3.7A Rev 1

Figure 3.7A Rev1 illustrates the components of Stage I construction and occurs while maintaining the operation of the existing spillway. As with the Original Arrangement, rockfill will be placed along the east gravity dam. Construction to provide access across the spillway (trestle) will continue. Excavation of the majority of the approach channel, discharge channel and footprint of the spillway structure will occur in the dry. These excavations will be separated from the river by maintaining a solid rock plug on the upstream side and by excavating to only 286.0 m (one metre above normal water levels) on the downstream end. The excavation will be a drill, blast and excavate operation using explosives to fracture the rock. Backhoes, dozers and rock trucks will be used to remove the material. Excess waste material will be hauled to east side material placement areas utilizing temporary haul roads in the work area. Following completion of the excavation, concrete placement for the primary spillway will be conducted. Typical equipment for concrete operations will be used, including cranes, concrete mixers and pumps, transit trucks, welders and hand tools. The spillway gates and hoists will be installed following concrete placement. Equipment used for gate installation includes cranes and scaffolding.

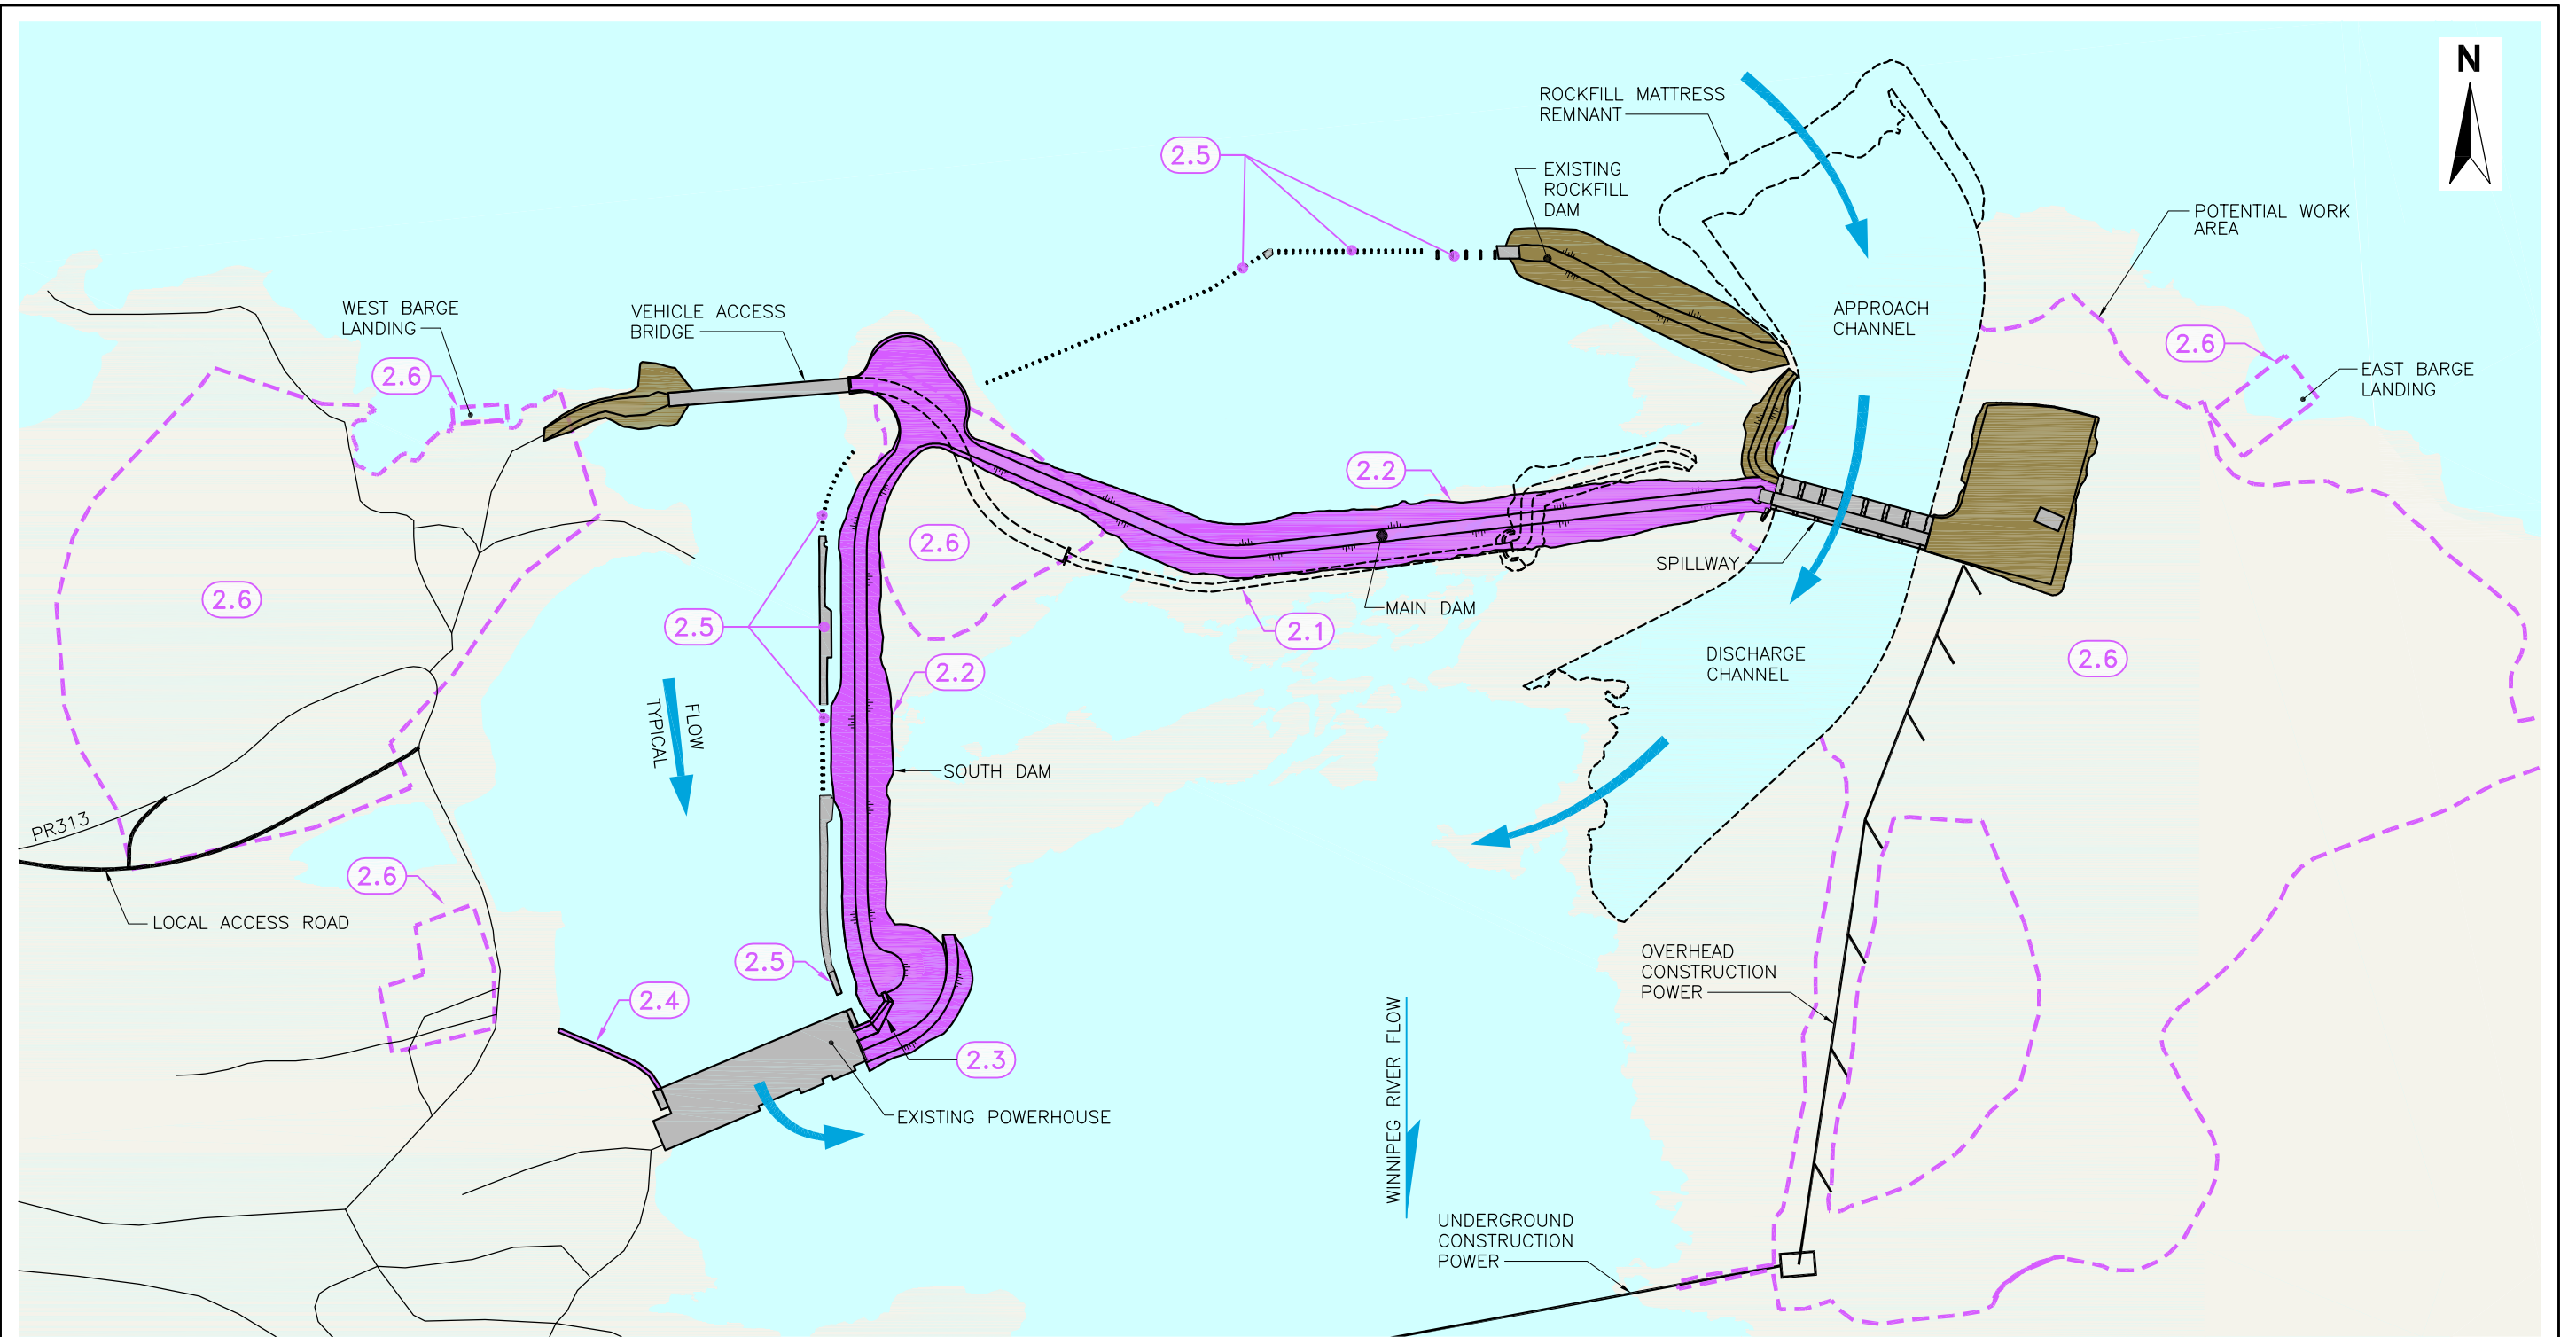
STAGE II

- 2.1 REMOVE TRESTLE
- 2.2 CONSTRUCT MAIN DAM & SOUTH DAM
- 2.3 CONSTRUCT POWERHOUSE TIE-IN WALL
- 2.4 REHABILITATE EXISTING WEST GRAVITY DAM & ABUTMENT

Pointe du Bois Spillway Replacement Project	
STAGE 2 Construction, Decommissioning & Rehabilitation	
Figure: 3.7B	Rev 1

Figure 3.7B Rev1 illustrates the components of Stage II construction that will occur following commissioning of the spillway.
