Manitoba Hydro

Pointe du Bois Spillway Replacement

Alteration

August 2012

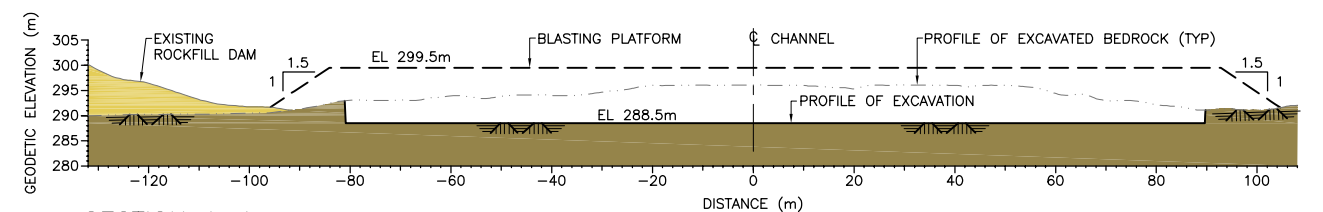
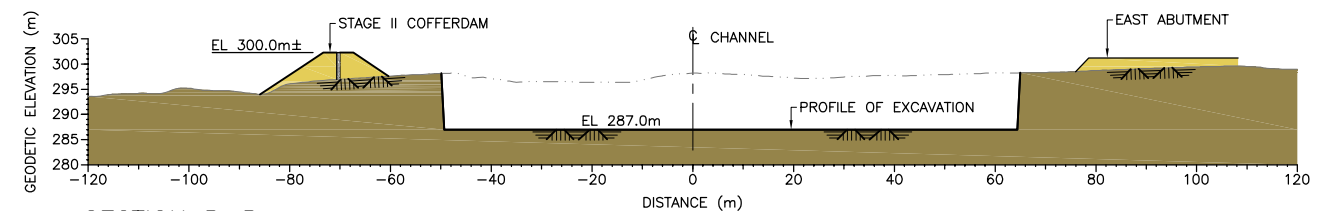
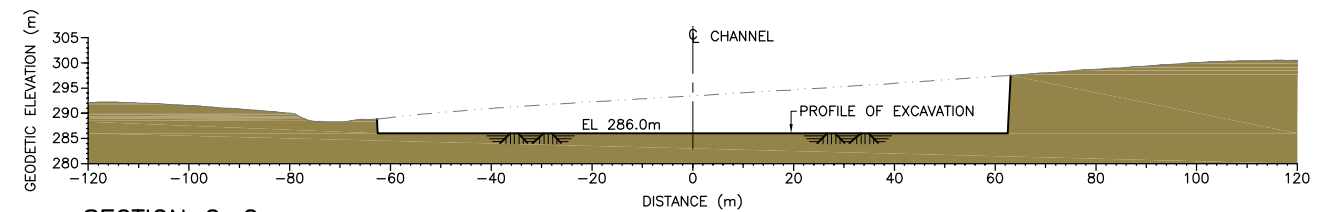
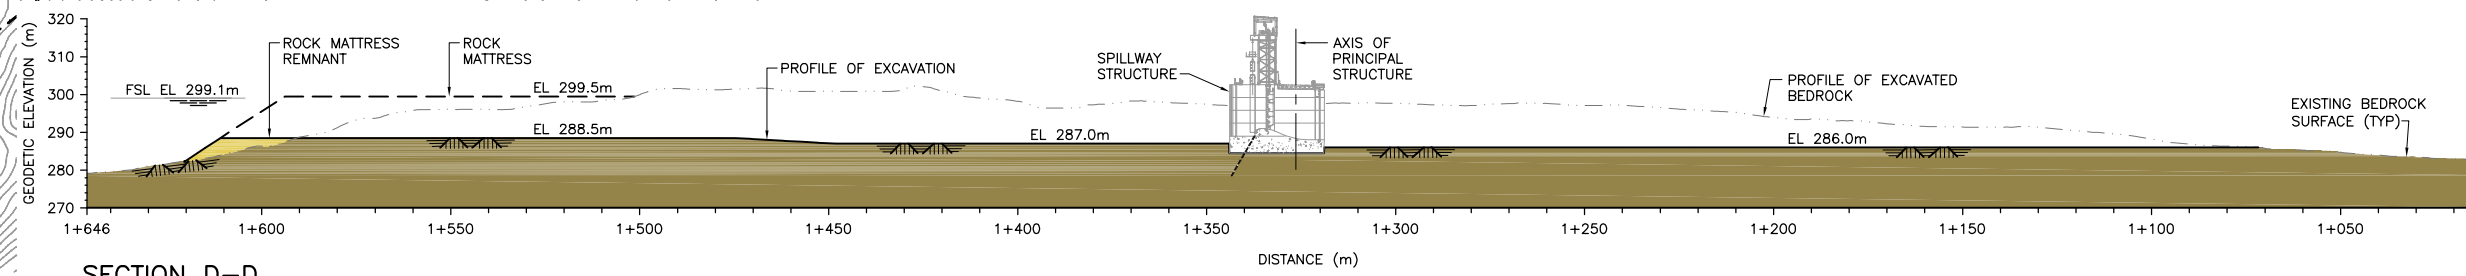
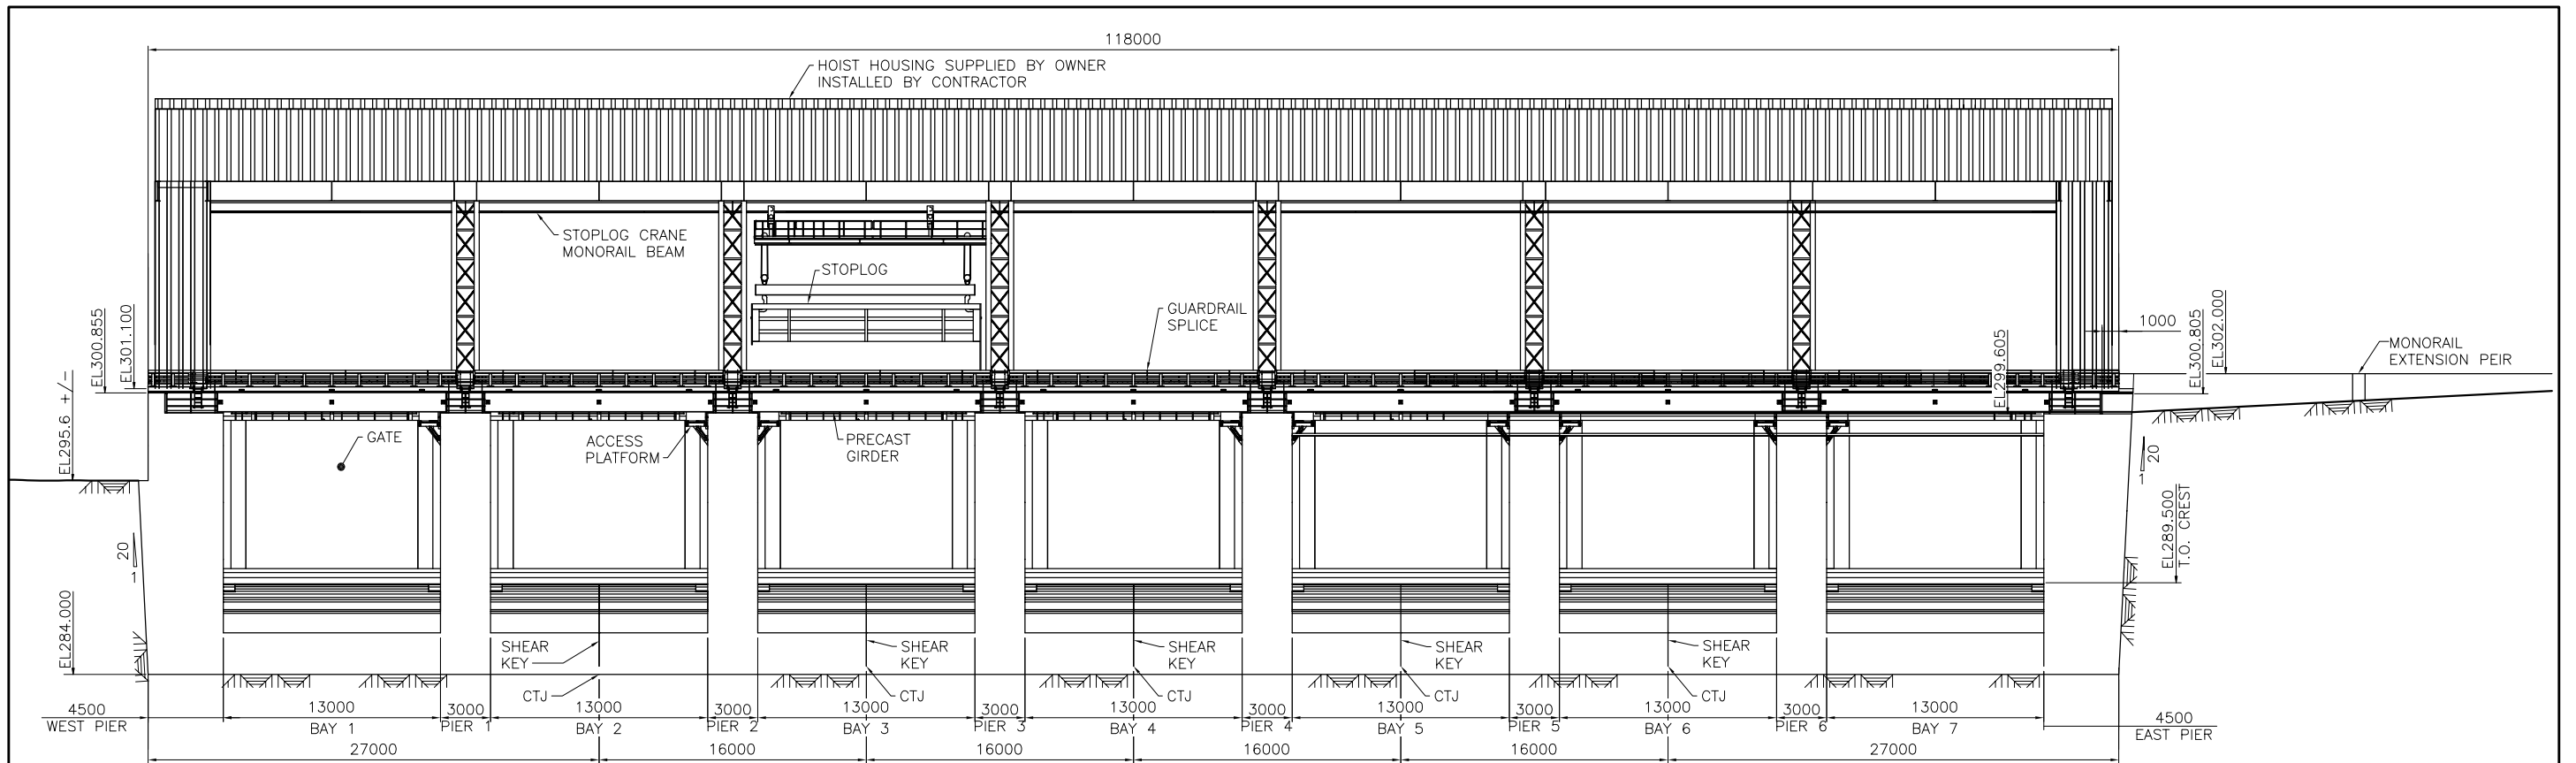
Figure:
3.19
Rev 1

SECTION A-A
SCALE: 1:1500

SECTION B-B
SCALE: 1:1500

SECTION C-C
SCALE: 1:1500

SECTION D-D
SCALE: 1:2000

**Spillway
Approach and Discharge Channels**

Approach and discharge channels will serve to direct water flow into and out of the new spillway structure. The approach channel will be approximately 230 m in length and 126 m in width. The discharge channel will be approximately 340 m in length and 126 m in width, flaring towards the exit. The approach channel will be excavated to an approximate elevation of 287.0 m immediately upstream of the spillway structure and transition to 290.0 m at the upstream end (Figure 3.19 Rev1).

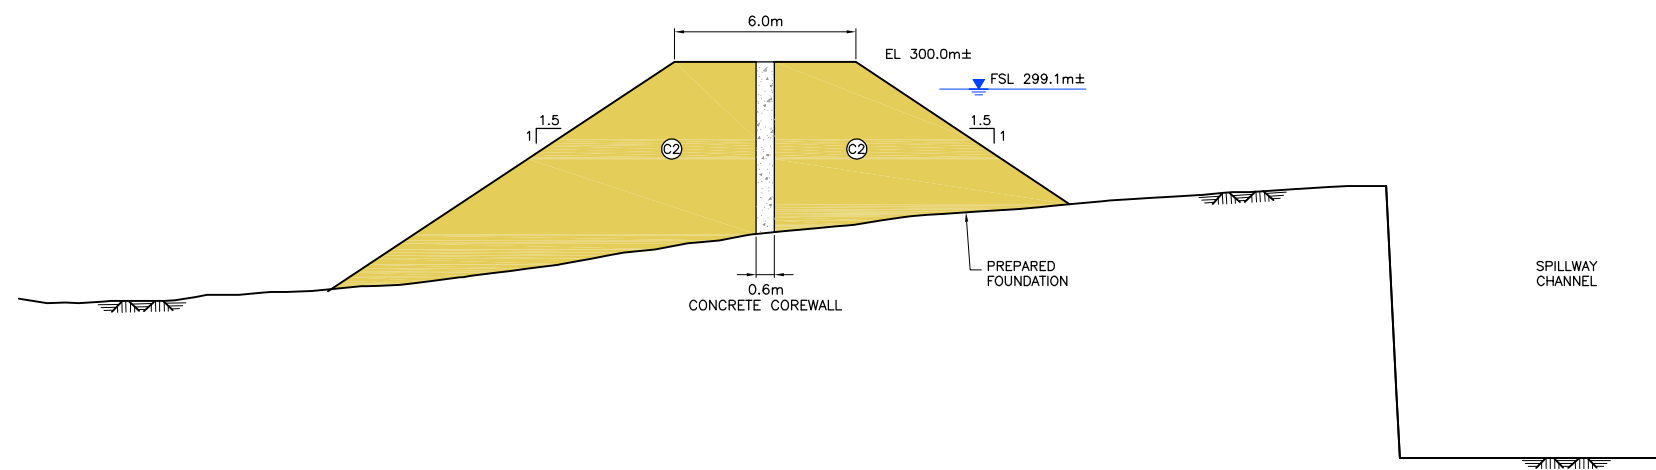
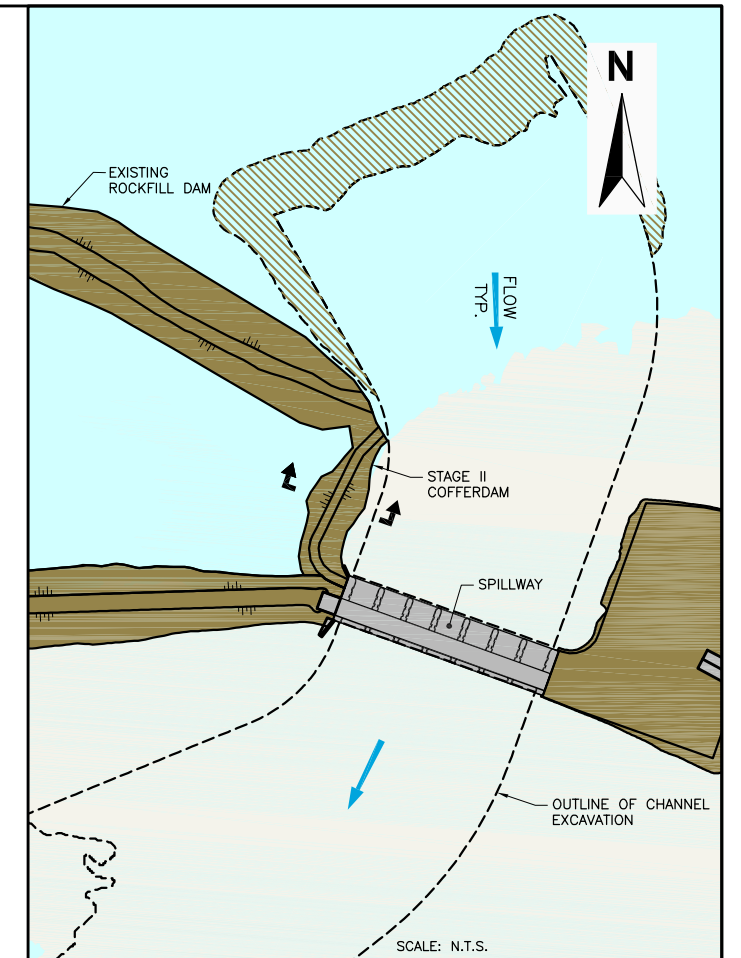
Figure:
3.20
Rev 1

Stage II Cofferdam

The Stage II cofferdam will provide a water tight seal to protect the earthfill dam construction while the new spillway is in service. It will be of concrete core construction and will be built in the dry prior to watering up the approach channel (Figure 3.20 Rev1). This cofferdam will not be removed.

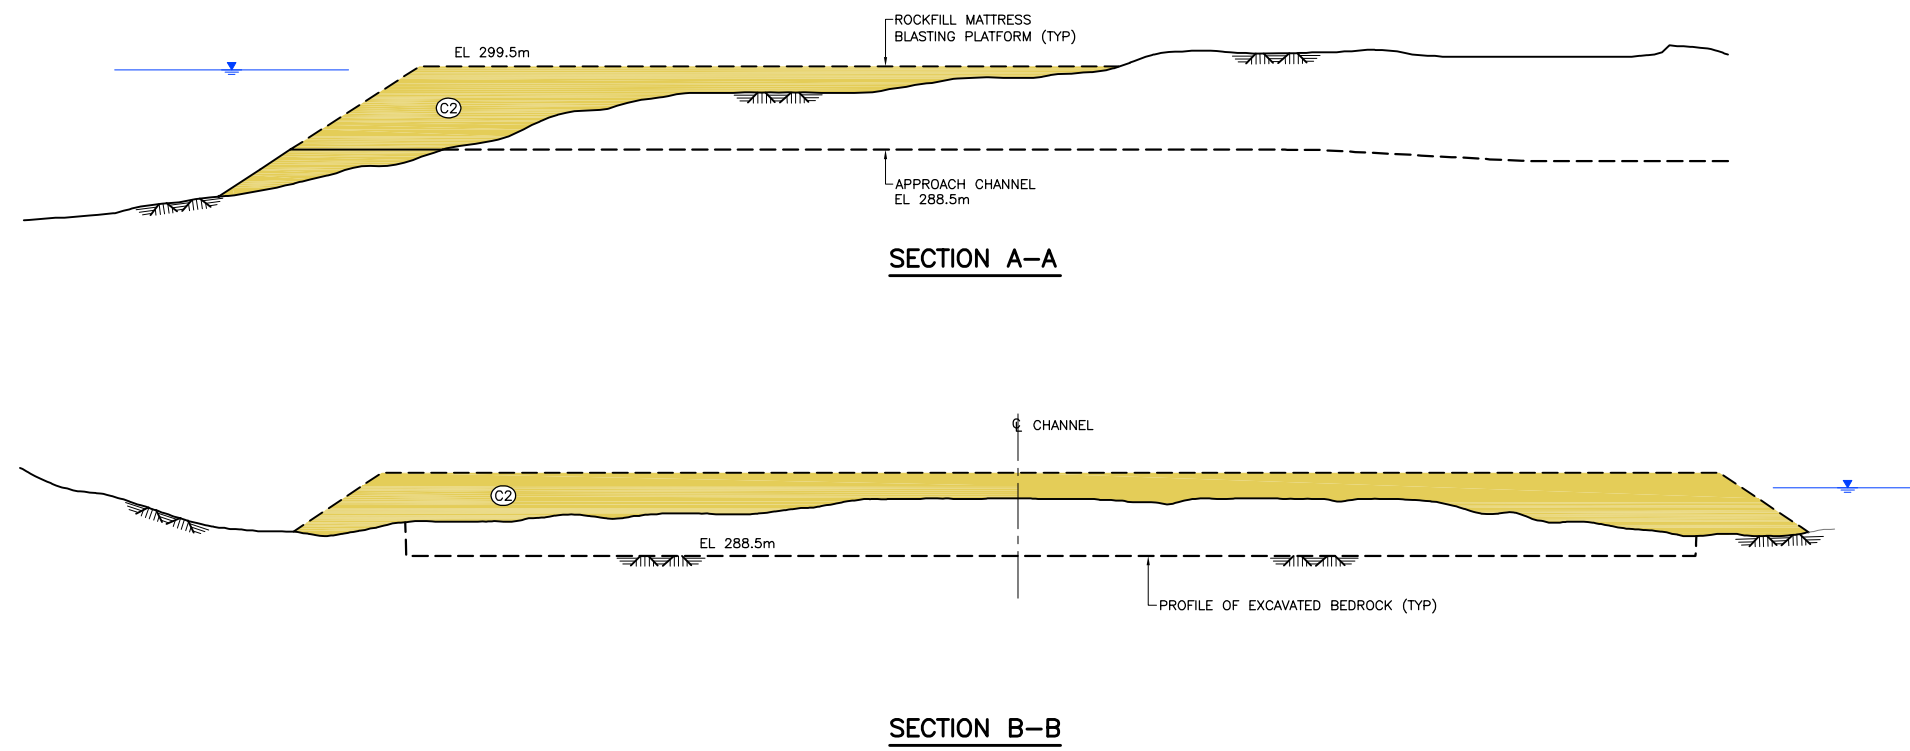
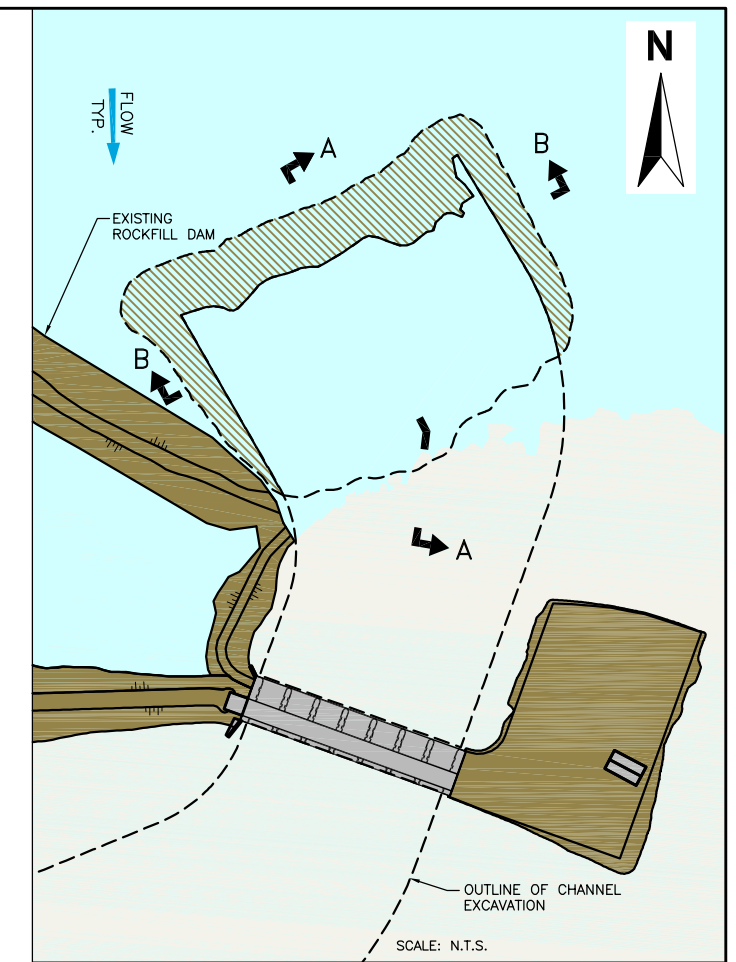
Figure:
3.23
Rev 1

Legend	
	ROCKFILL
	WATER LEVEL
	BEDROCK SURFACE

Rockfill Mattress

Similar to the Original Arrangement excavation of an upstream portion of the approach channel will be conducted in the wet. This work will not take place between April 1 and June 30 of any year. This will require installation of an infill rock mattress to serve as a construction platform from which drill, shoot and excavation operations will be performed (Figure 3.23 Rev1). The infill materials required for the rock mattress will be sourced from the concurrent dry channel excavation operations. Drilling will be undertaken to place explosives to fracture the rock underneath the mattress. Subsequent to the blasting, excavation will start at the outer limit of the rock mattress and work toward the solid rock plug. Rock removal will be performed using equipment such as backhoes and clamshell excavators. The removed rock will be re-used, to the extent possible, in the construction of the earthfill dams and guide berm.

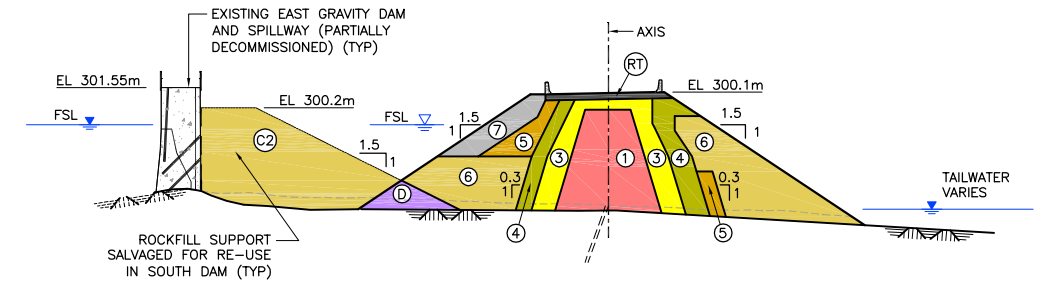
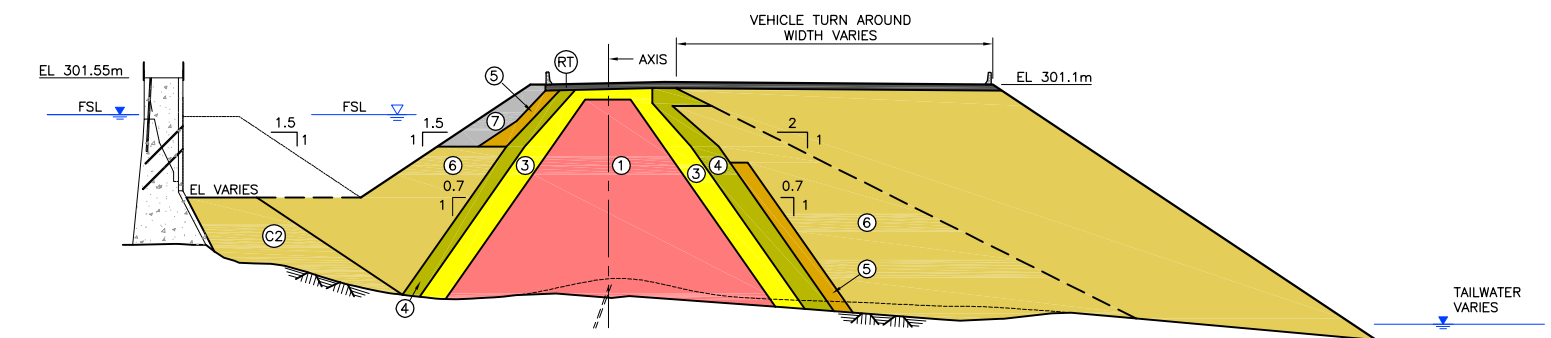
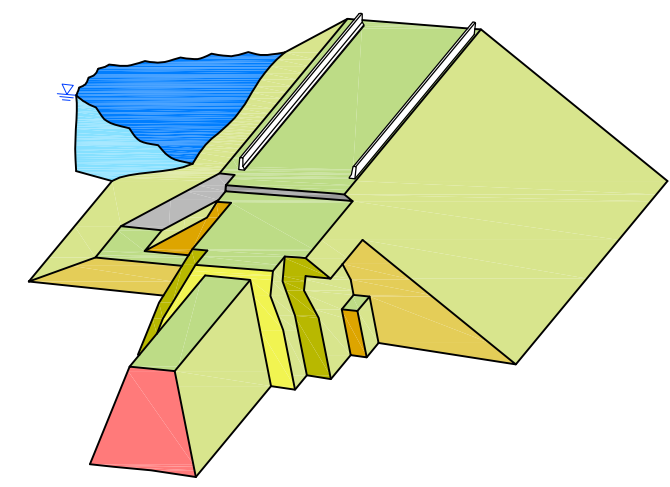
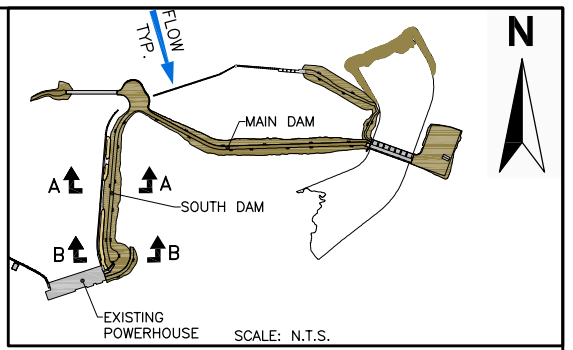
Figure:
3.24
Rev 1

A-A SOUTH DAM AND MAIN DAM

B-B SOUTH DAM AT TURN AROUND

**EARTHFILL DAM (ISOMETRIC)
(SOUTH AND MAIN DAM)**

Earthfill Dams - Sections

The earthfill dams will be zoned earthfill embankments, each consisting of an impervious core with granular and crushed rock filters and outer rockfill shells (Figure 3.24 Rev1).

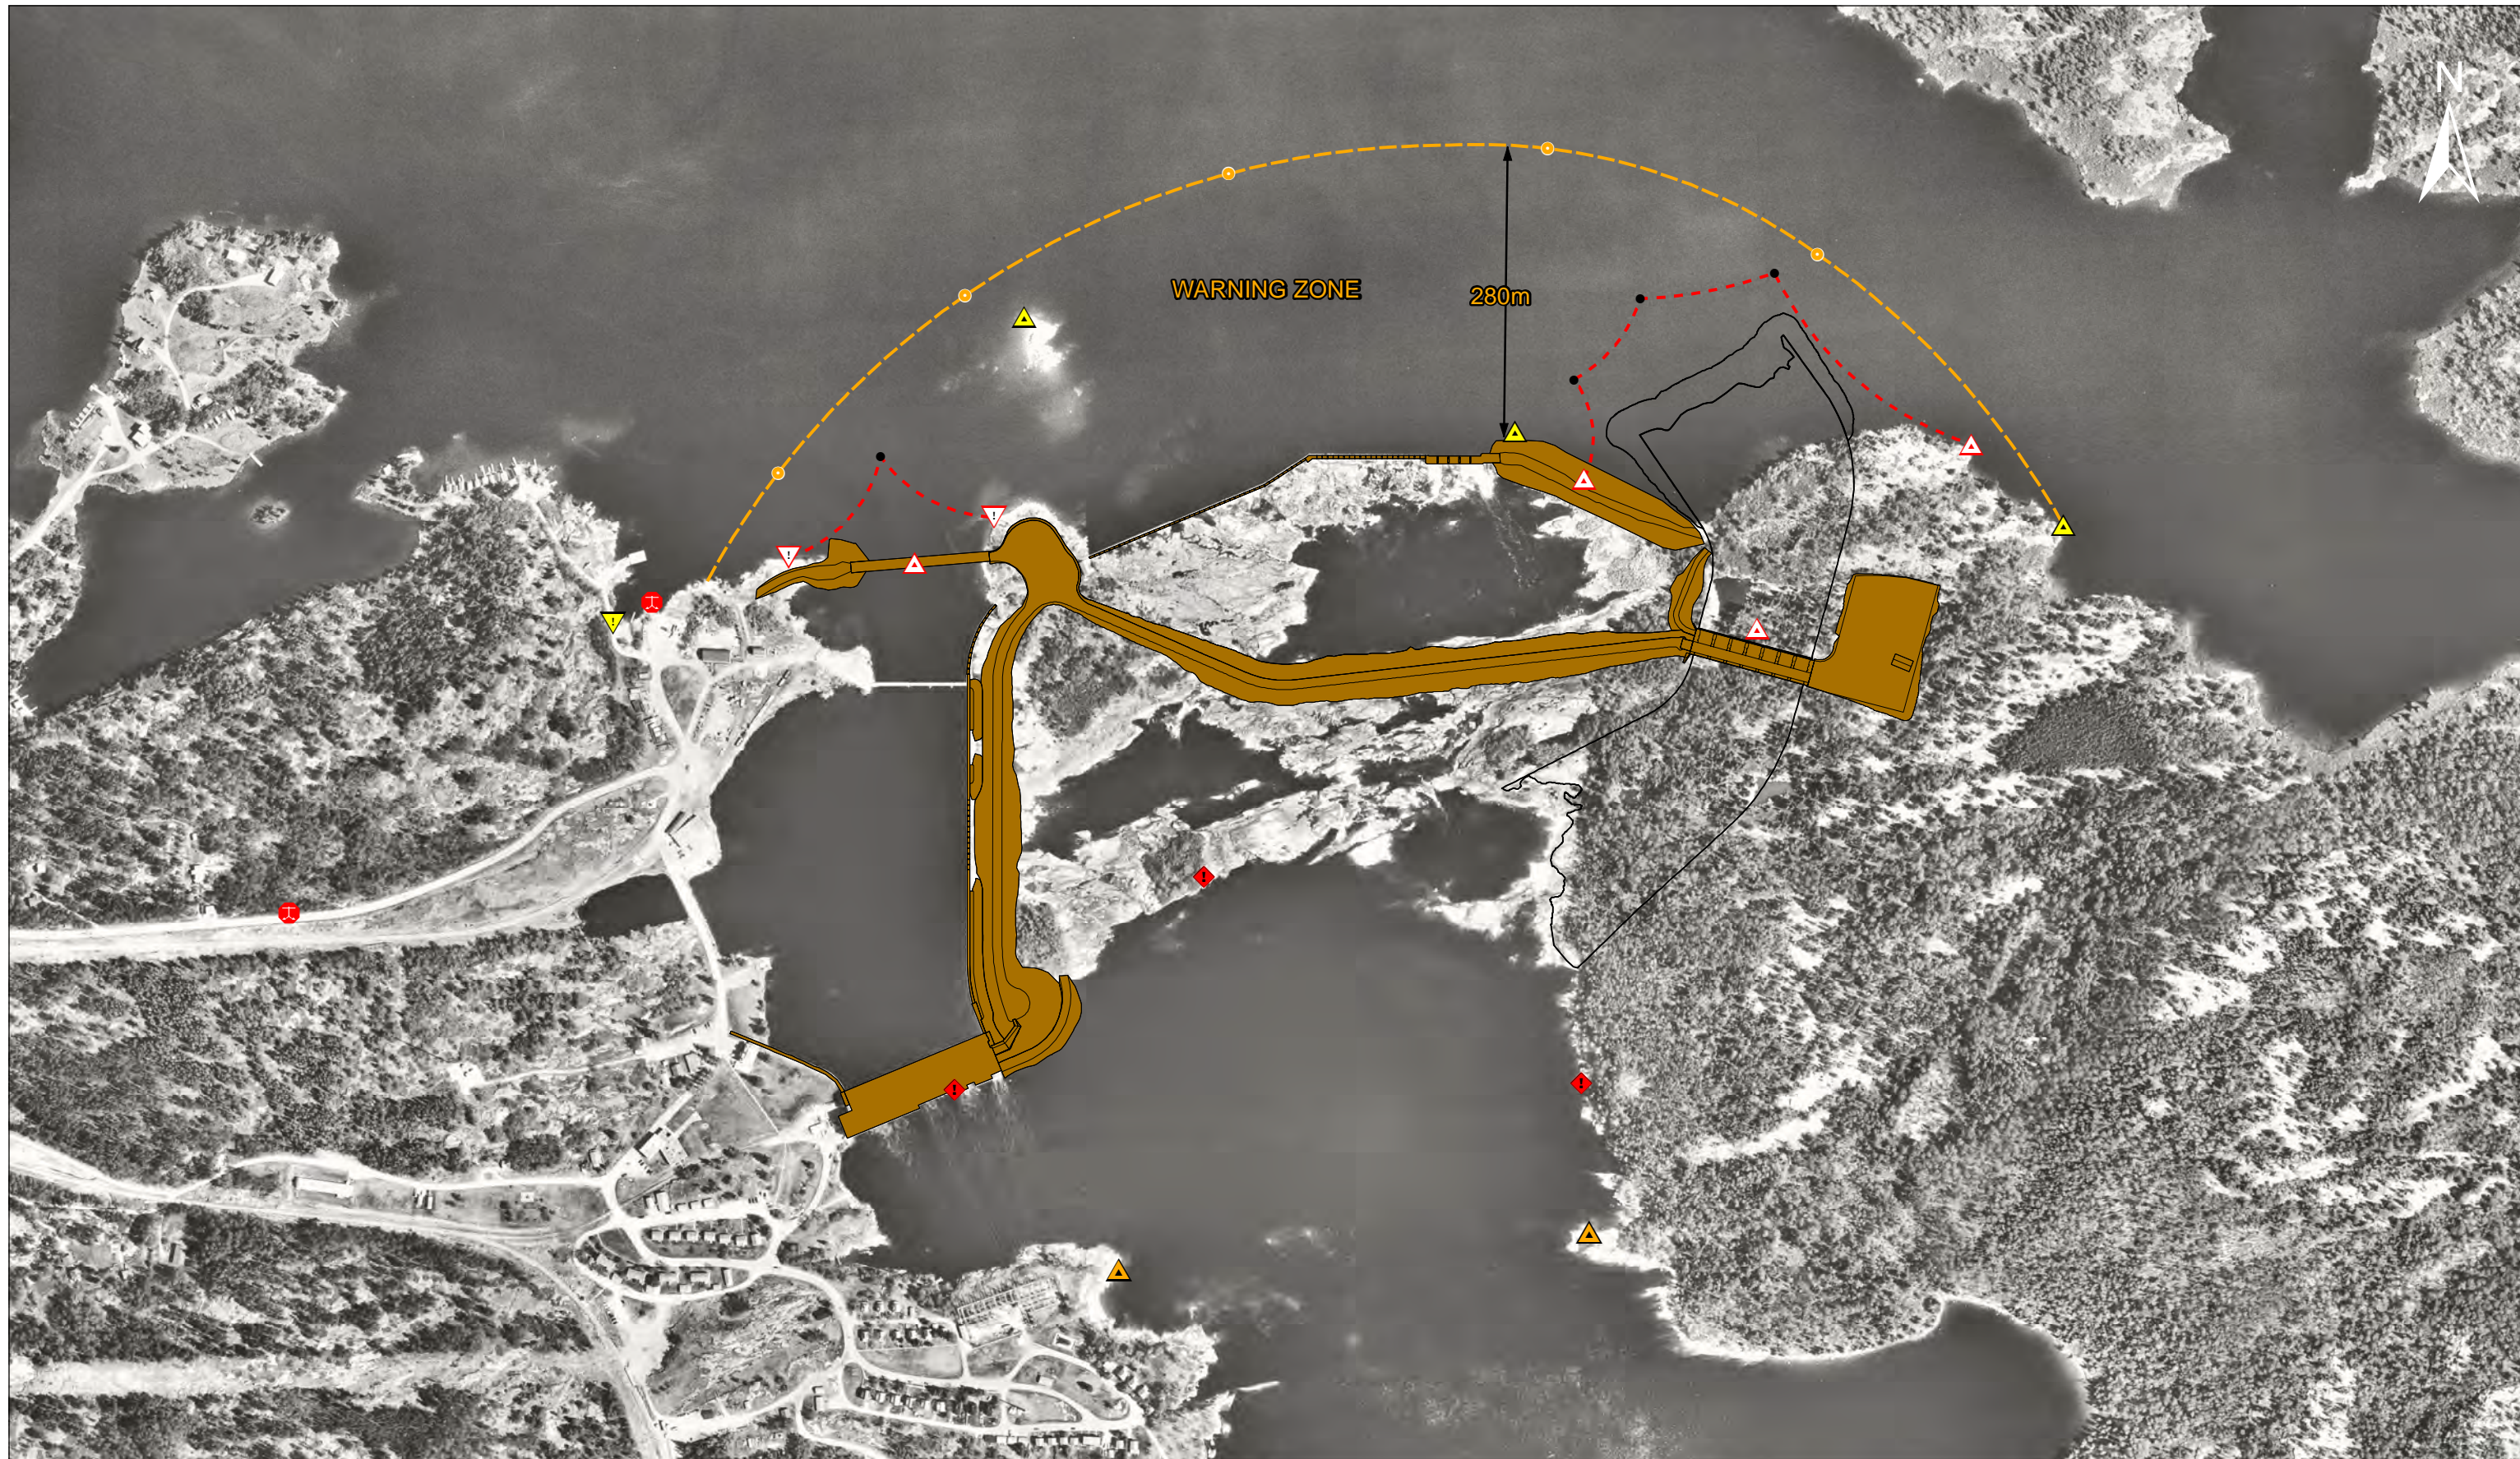
Coordinate System: UTM NAD 1983 Z14	DATA SOURCE: Manitoba Hydro, KGS Group	Legend		New Buoys	Boom	Pointe Du Bois Spillway Replacement Project	Preliminary Navigable Waters Public Safety Measures	Figure: 3.27 Rev 1
		DATE CREATED: 06 JULY 2012	CREATED BY: KGS Group	New Warning Sign and Use Designated Portage Route Sign New Upstream Danger Sign New Downstream Danger Sign New Downstream Danger Sign and Use Designated Portage Route Sign	Existing Danger Sign Existing Warning Sign Boat Launch Closed Sign	Warning Zone

As discussed in the EIS, measures will be undertaken to comply with the Navigable Waters Protection Act. Safety booms, buoys and signage will be deployed to prevent inadvertent access to dangerous areas. Figure 3.27 Rev1 provides a concept of the navigable waters public safety measures that will be employed.

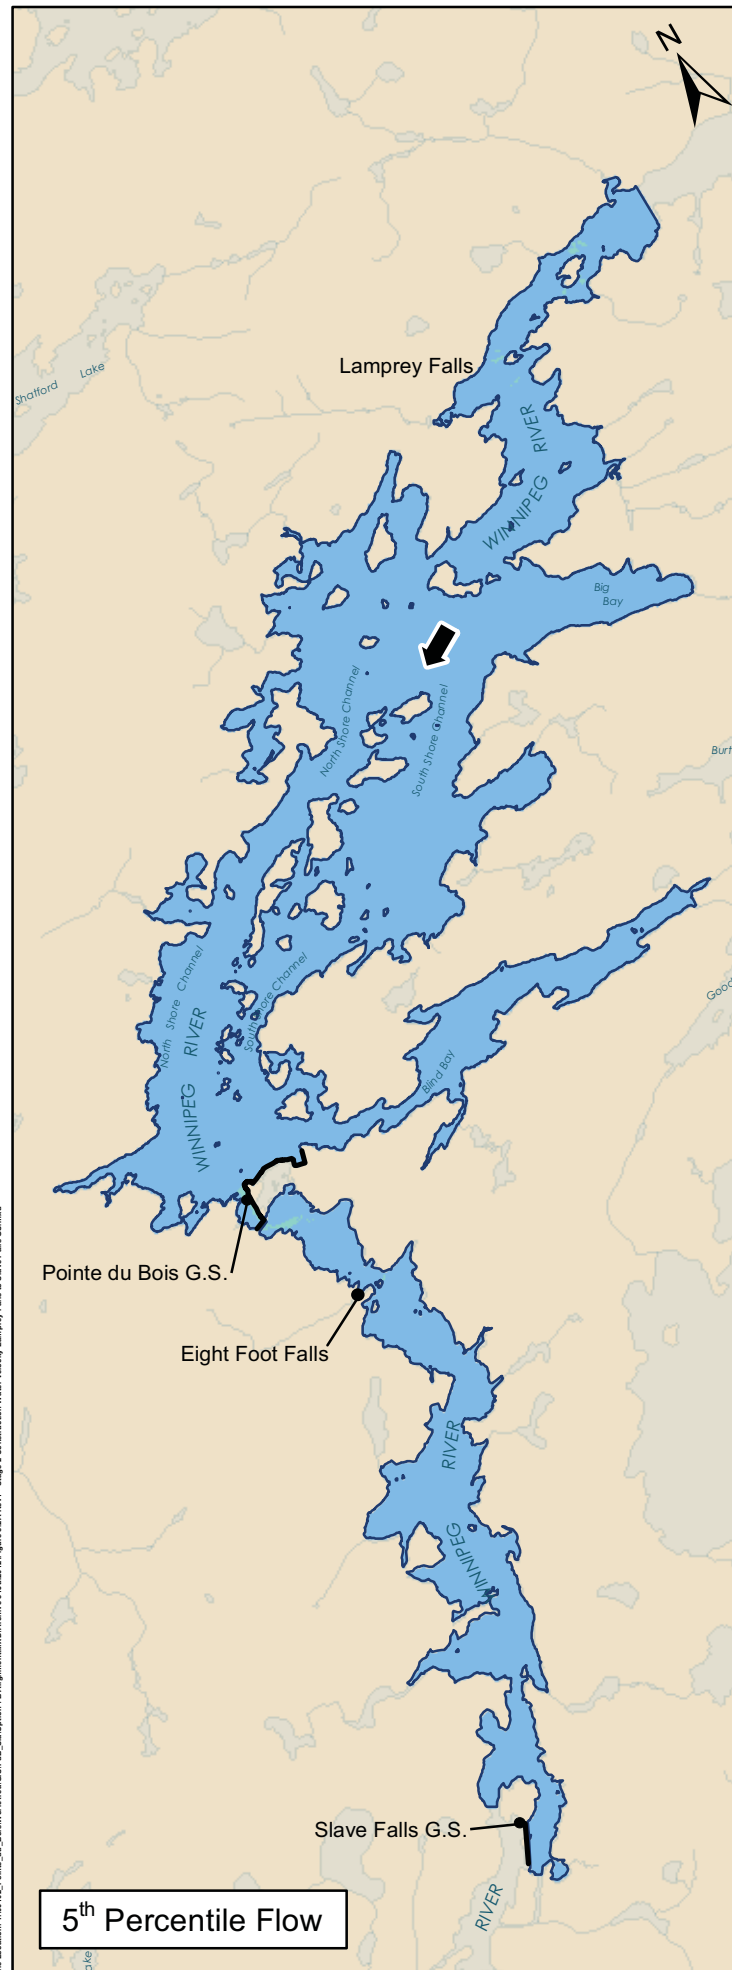
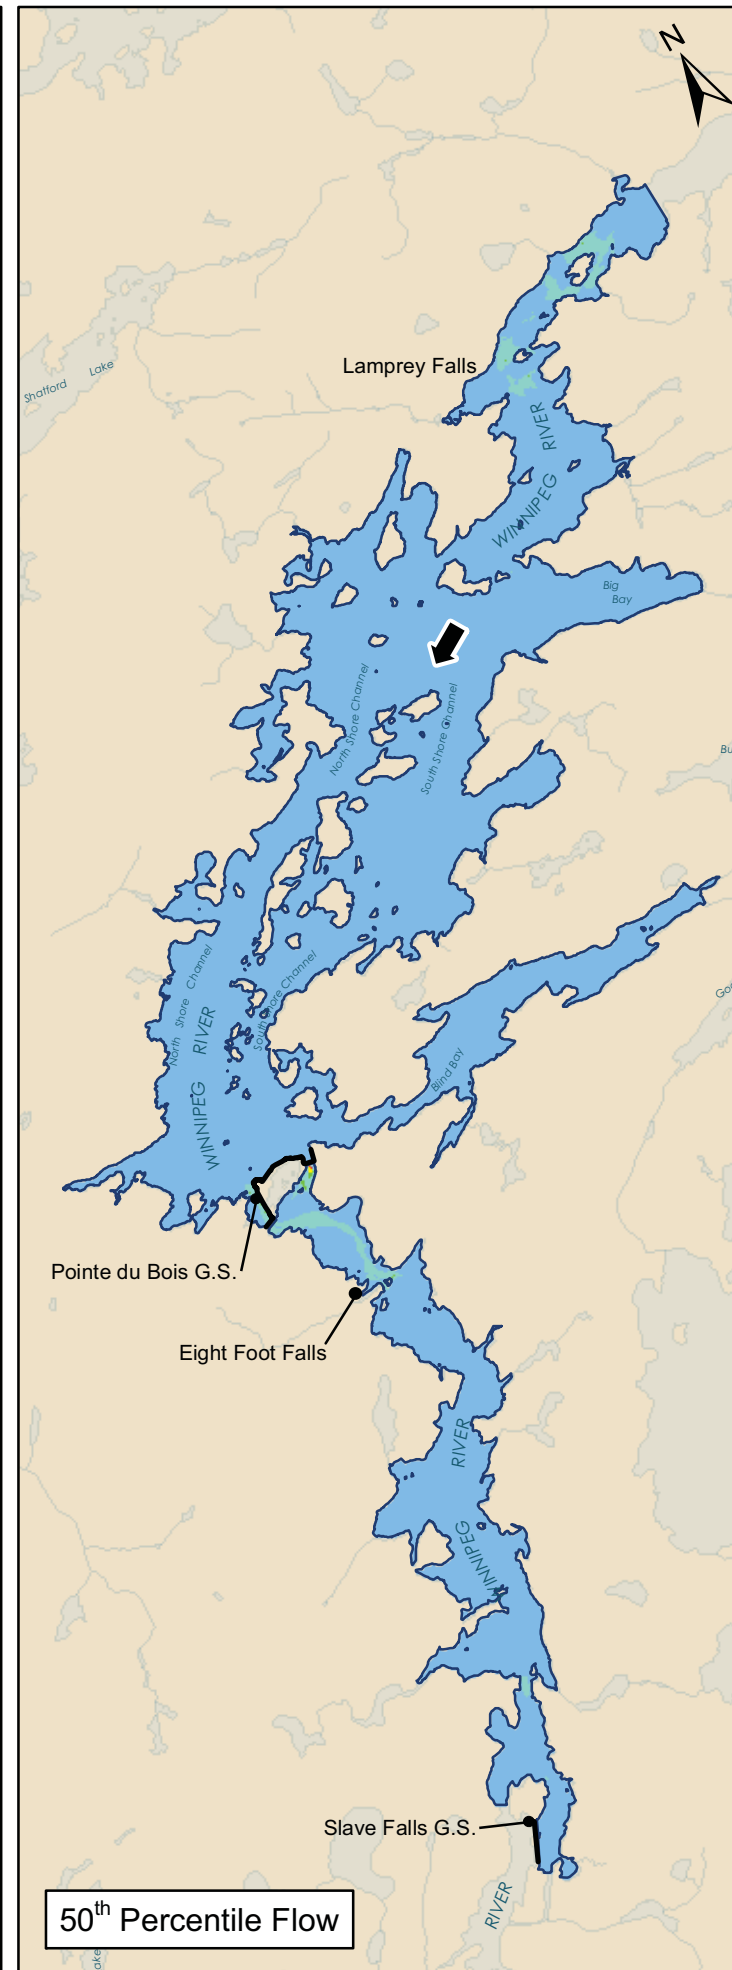
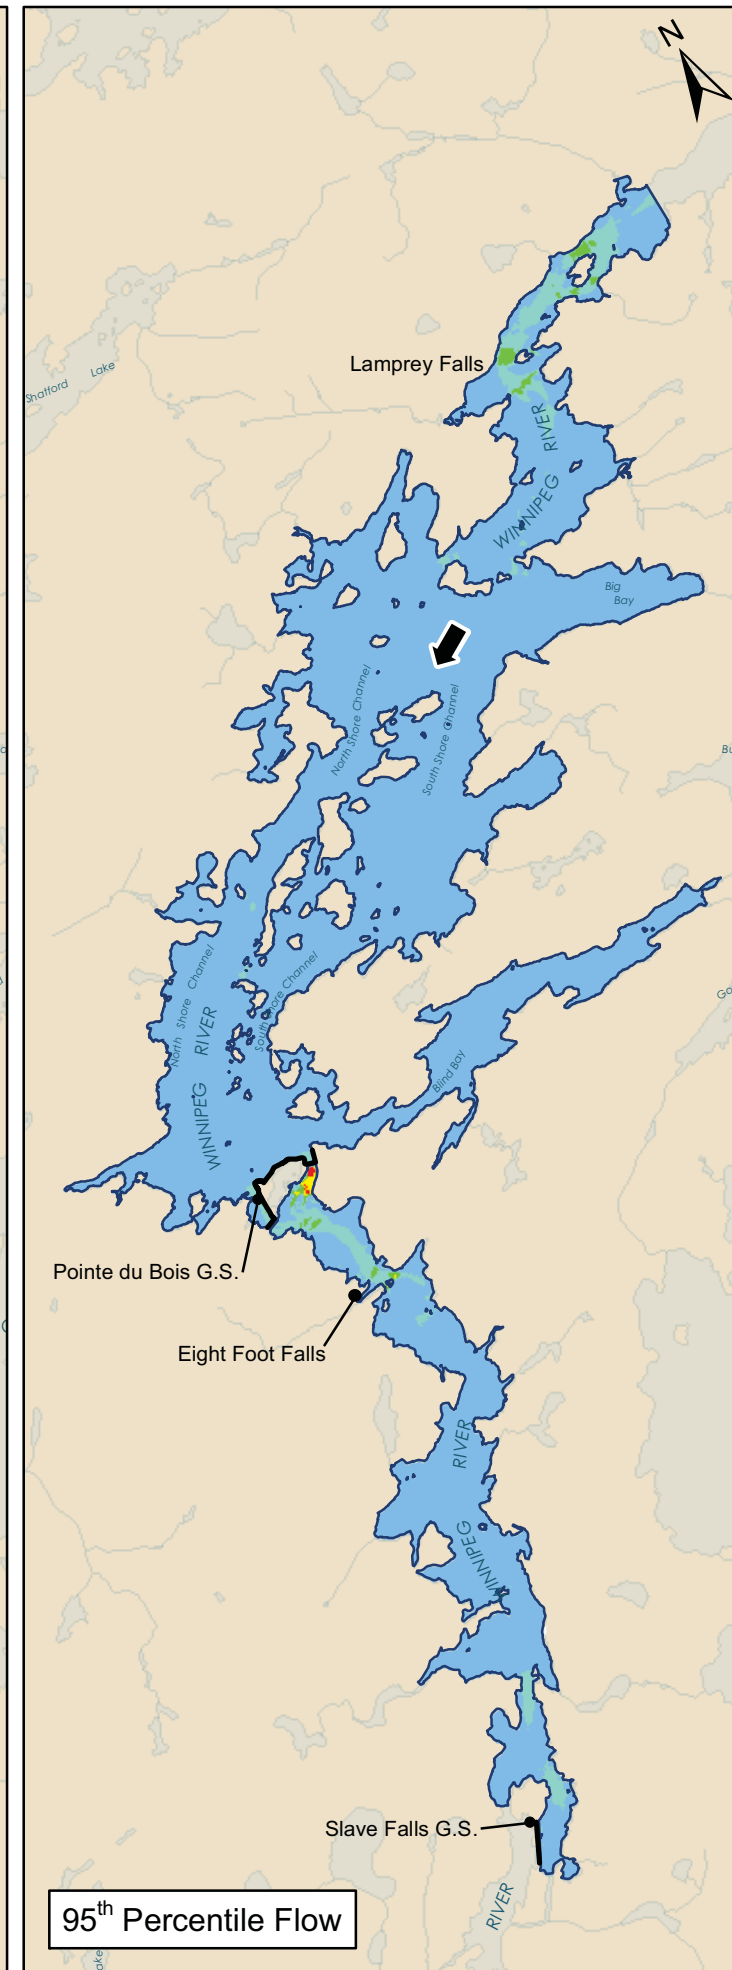
5th Percentile Flow

50th Percentile Flow

95th Percentile Flow

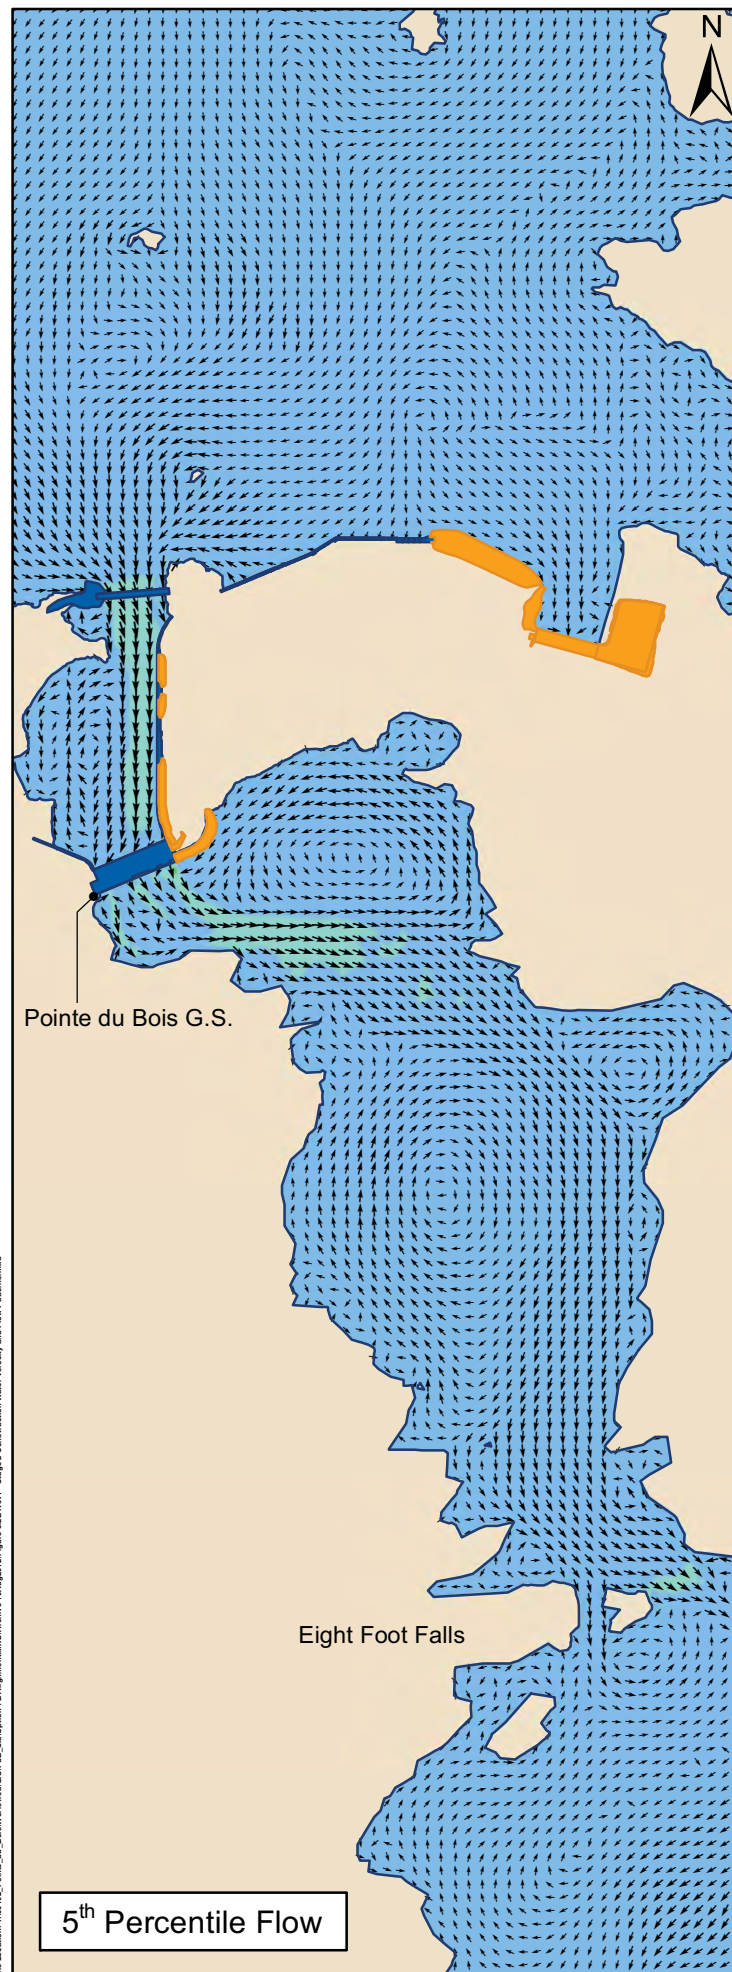
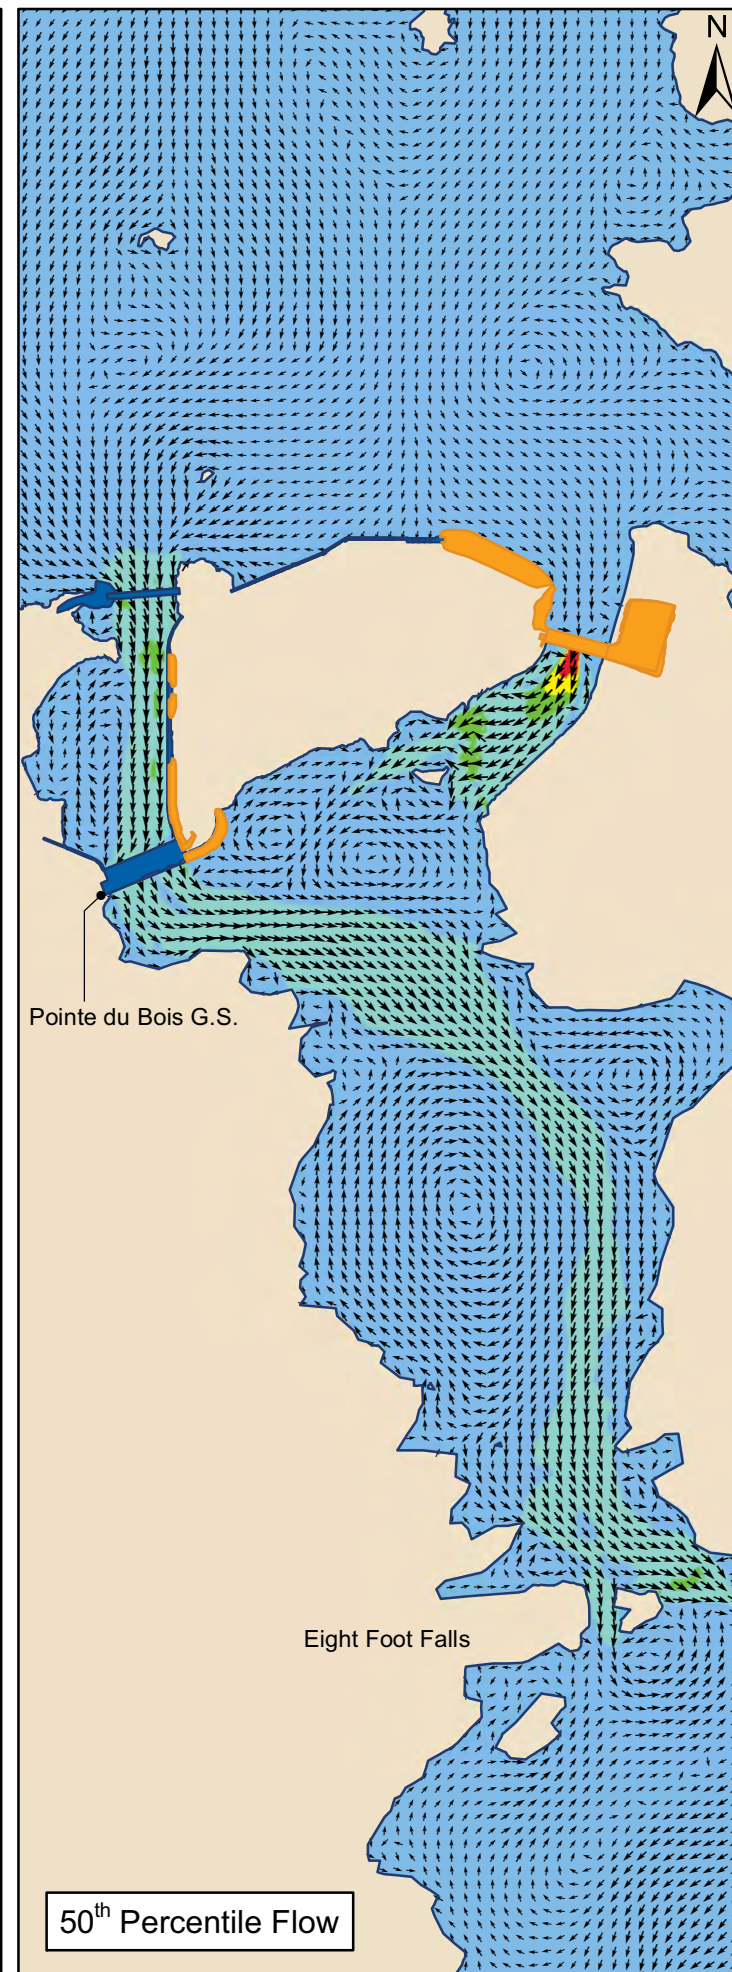
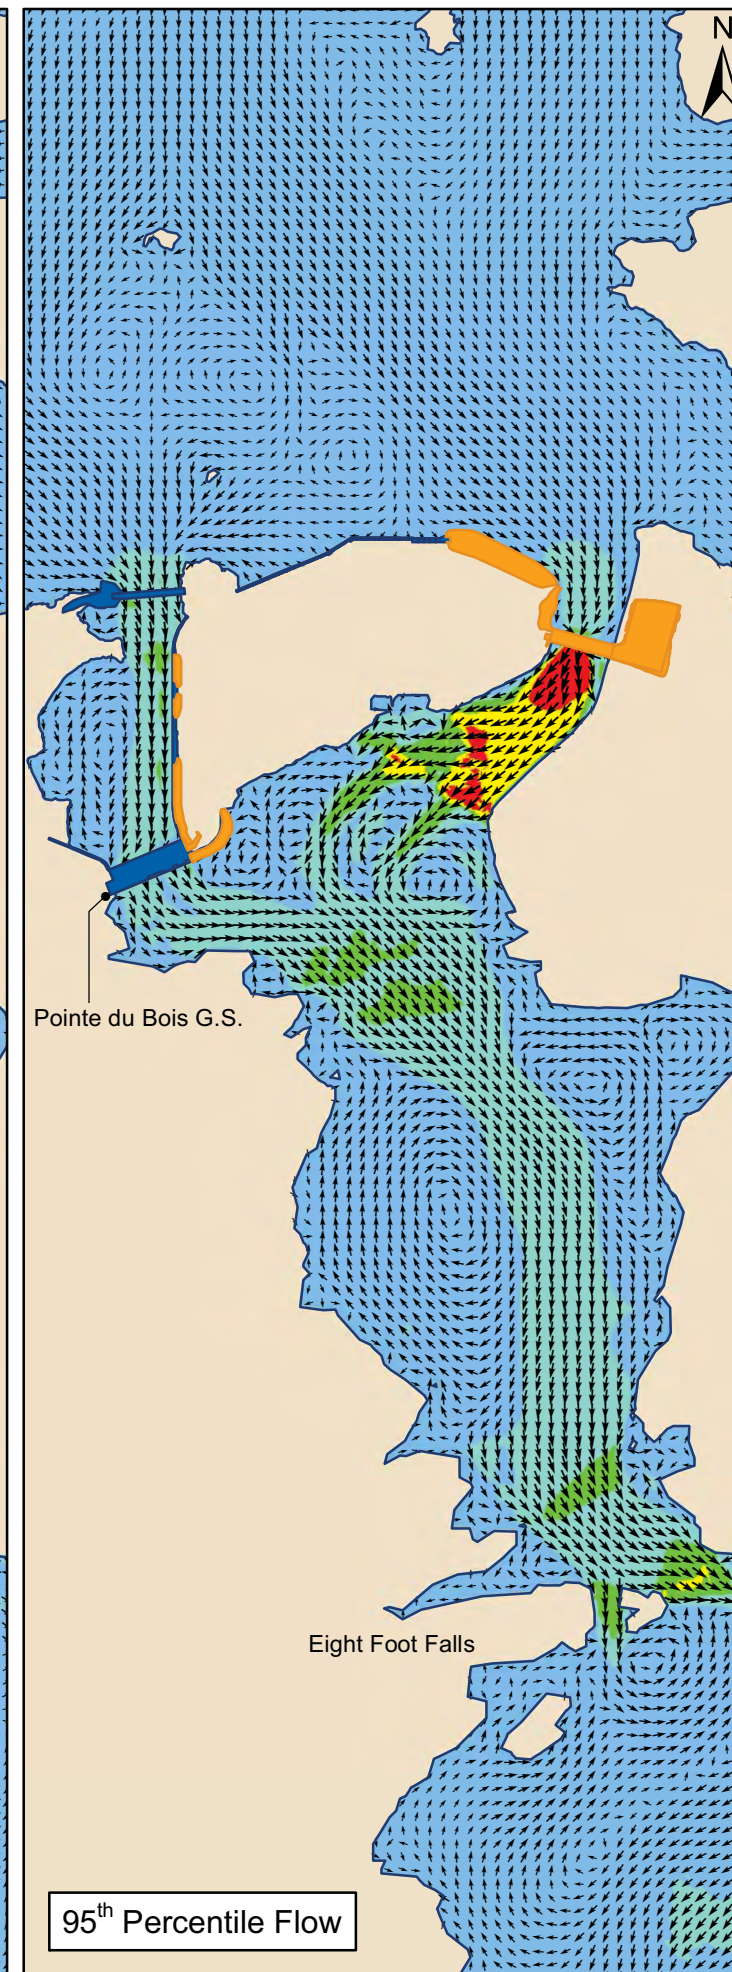
Velocity Vectors NTS
Generating Station (G.S.)

5th Percentile Flow

50th Percentile Flow

95th Percentile Flow
