Manitoba Hydro

Pointe du Bois Spillway Replacement

Alteration

August 2012

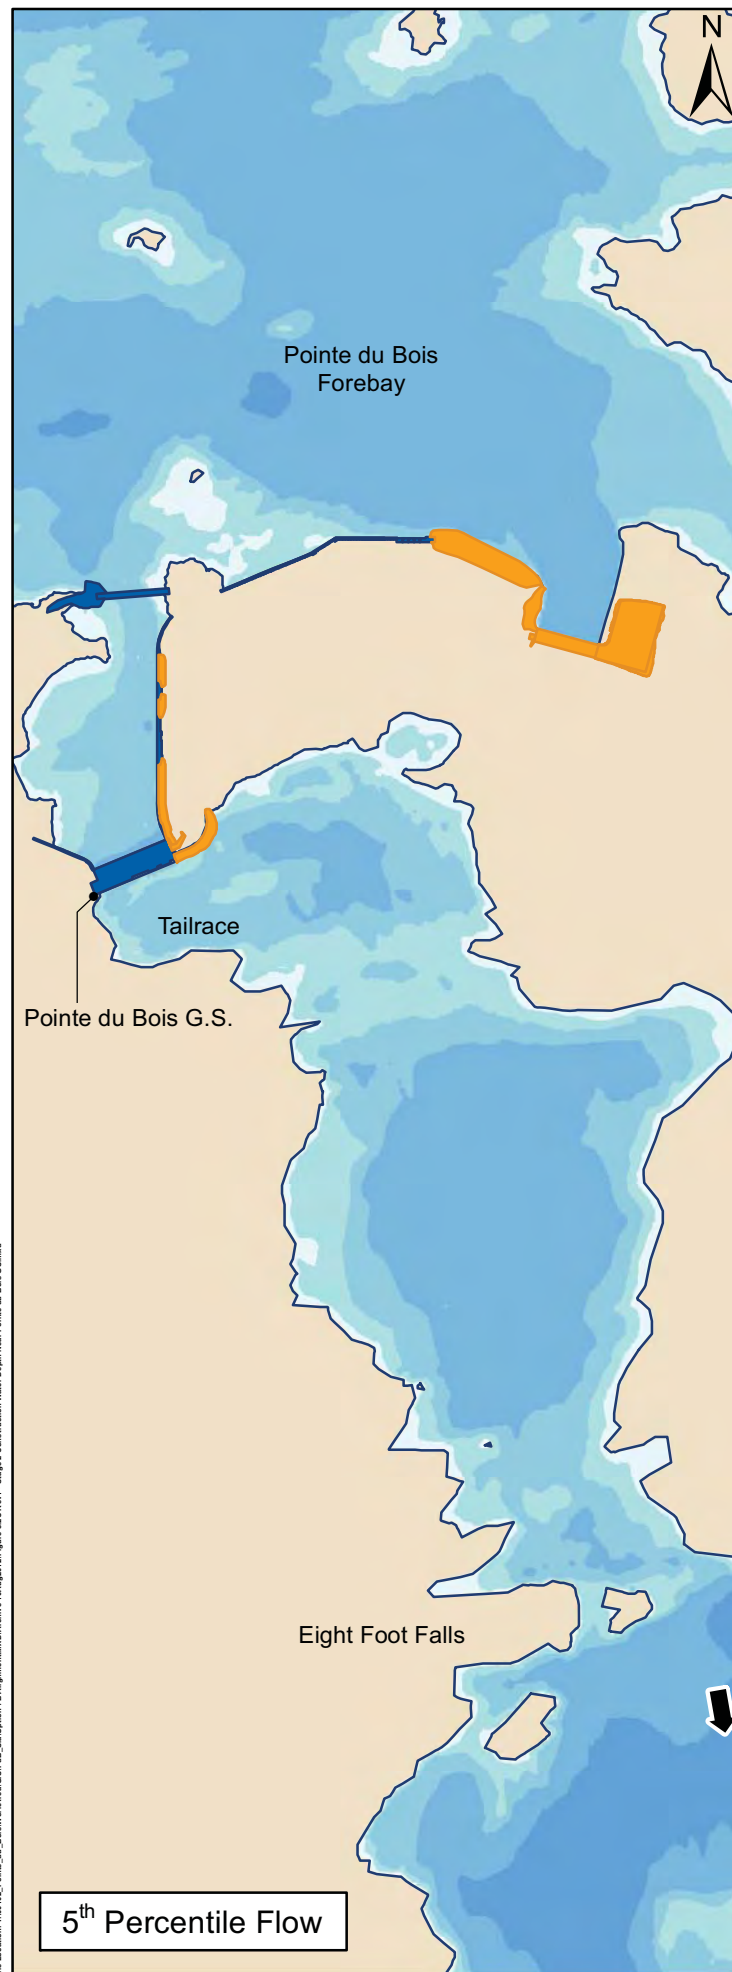
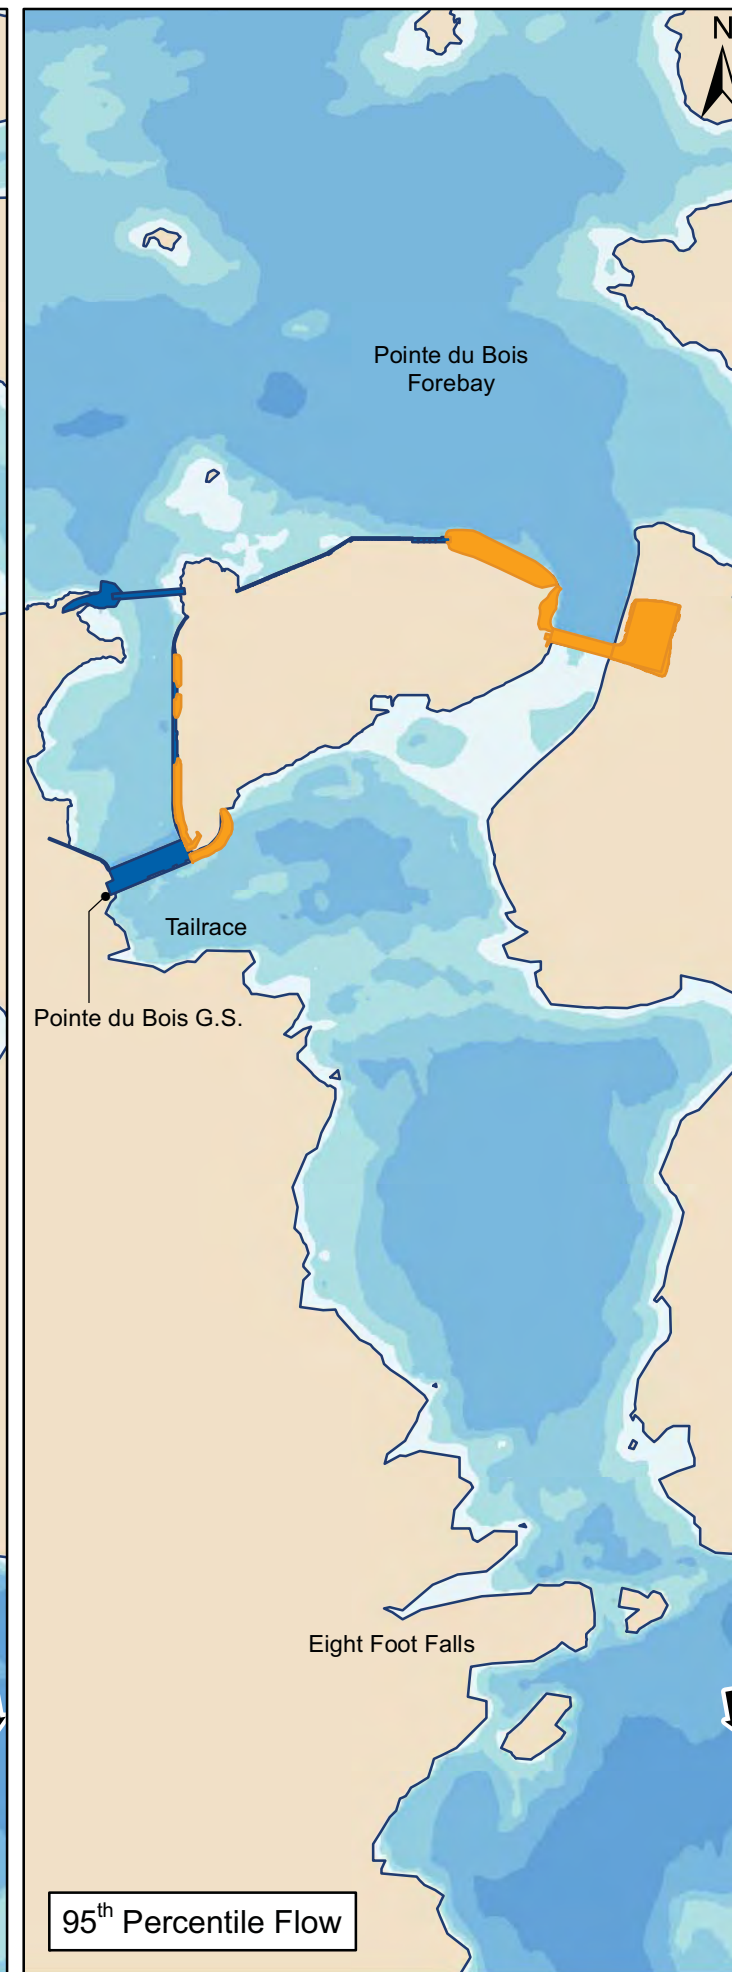
- 0 - 2
- 2 - 5
- 5 - 10
- 10 - 30
- Greater than 30

Direction of Flow
Generating Station (G.S.)

5th Percentile Flow

50th Percentile Flow

95th Percentile Flow

Depths at some locations near the bottom of the spillway shelf will be 2.5 m shallower than existing condition as flows will be directed down the new spillway discharge channel rather than across the spillway. Depths in a localized area in the tailrace channel near the spillway discharge increase about 0.5 m. Depth increases will be reduced compared to the Original Arrangement.

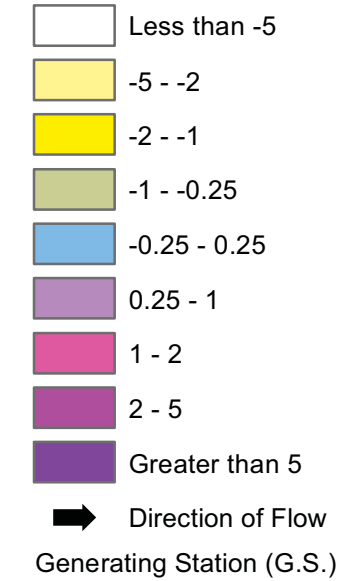
Velocity Change [m/s]

Stage 2 Construction Estimated Velocity Changes
Existing Conditions vs Revised Arrangement

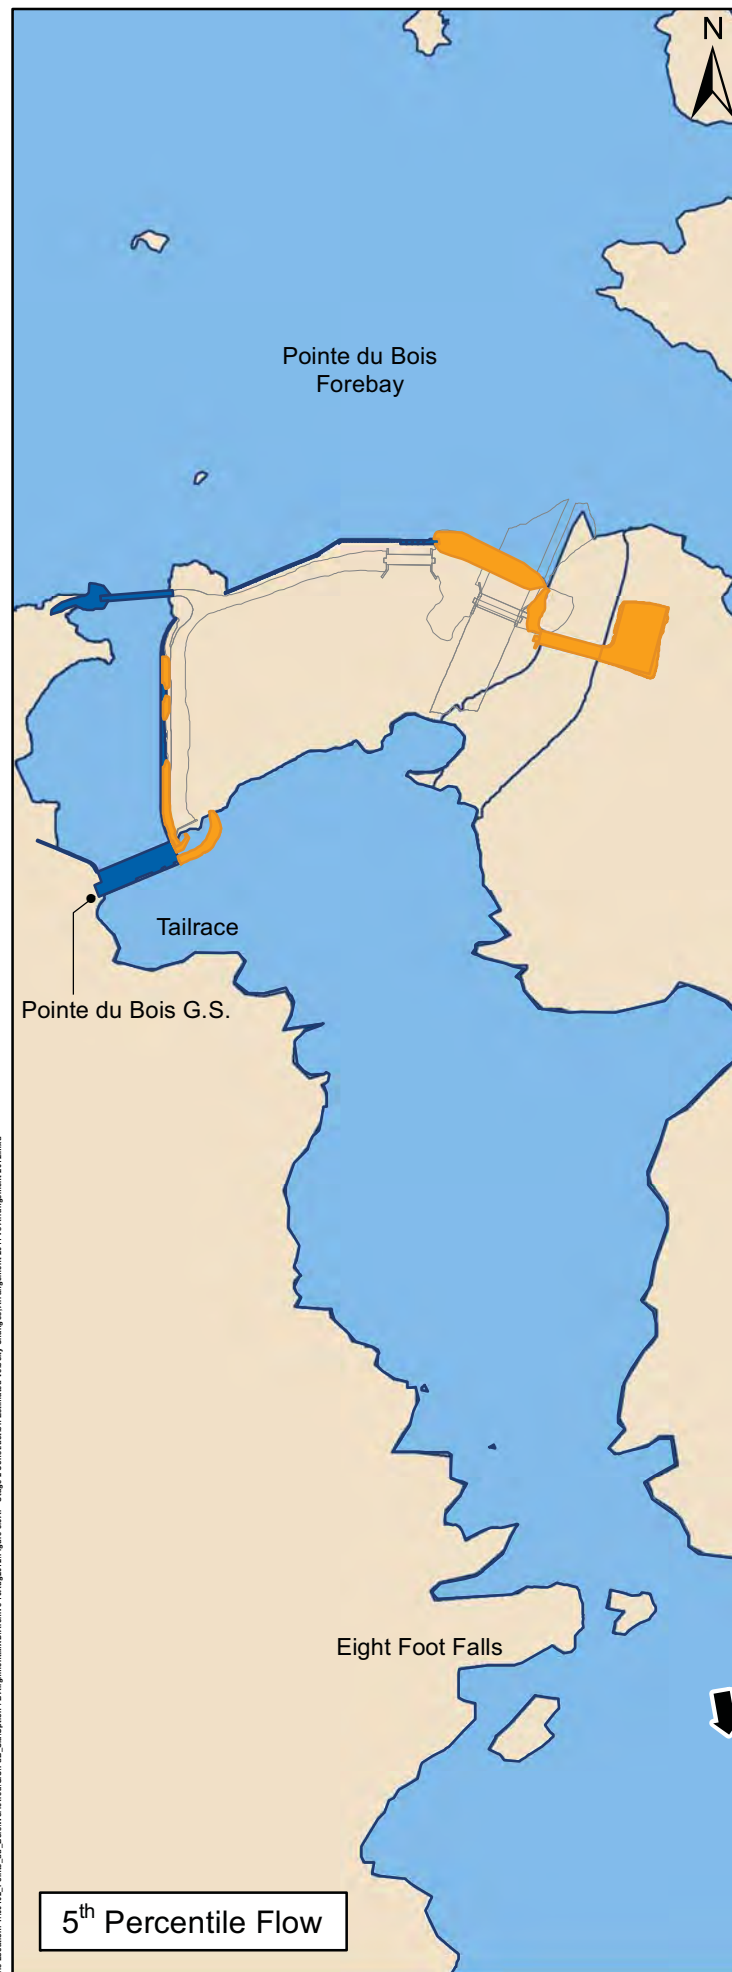
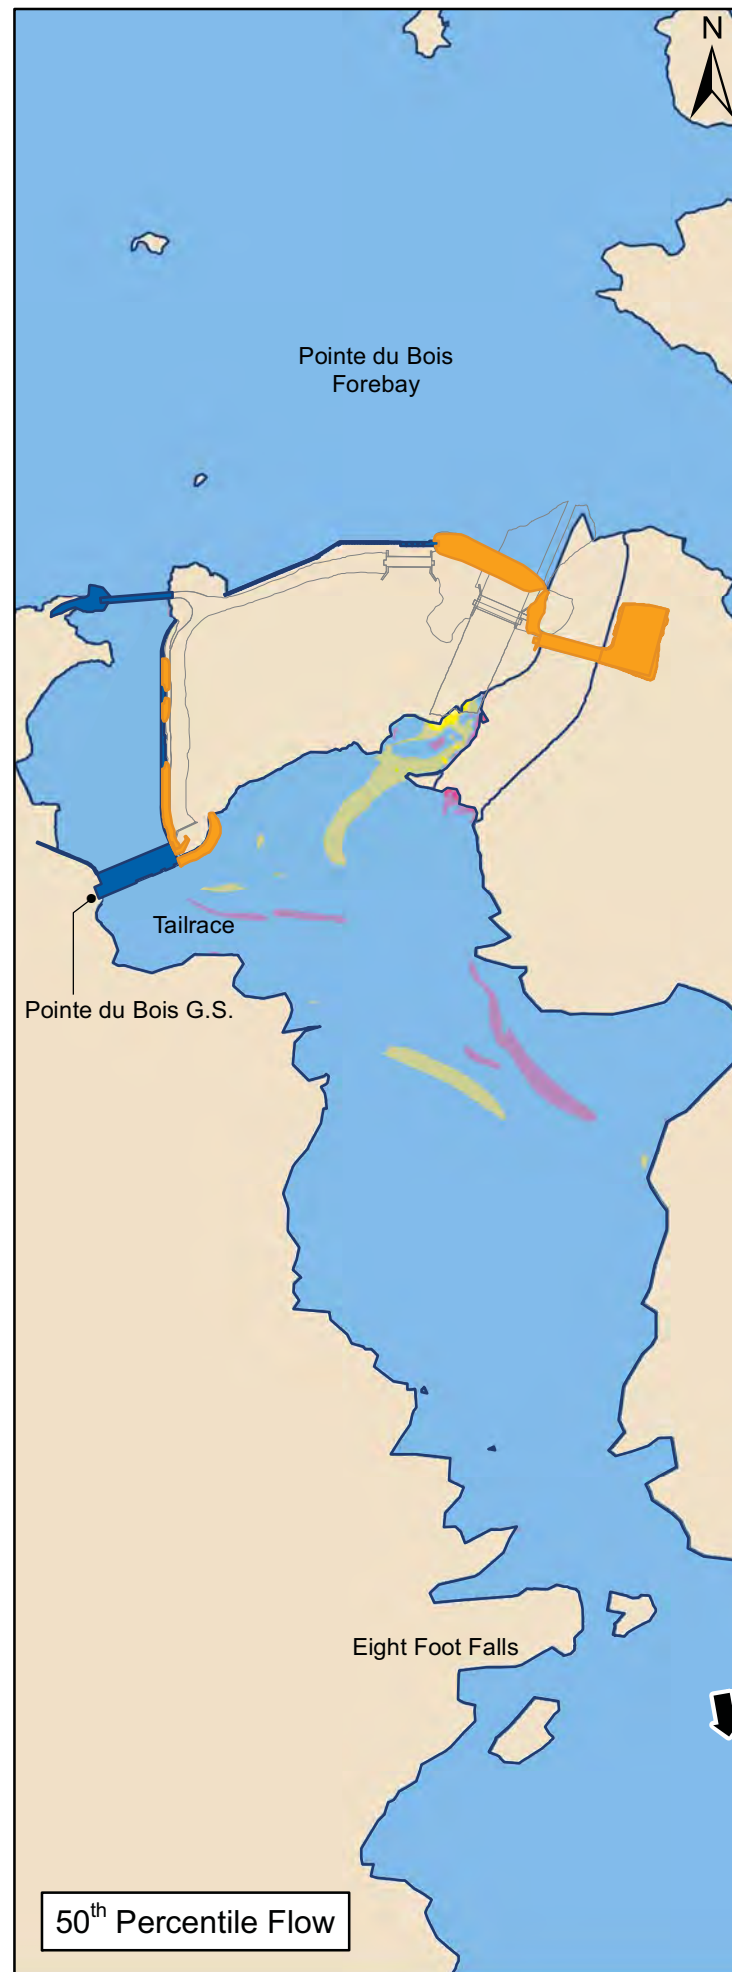
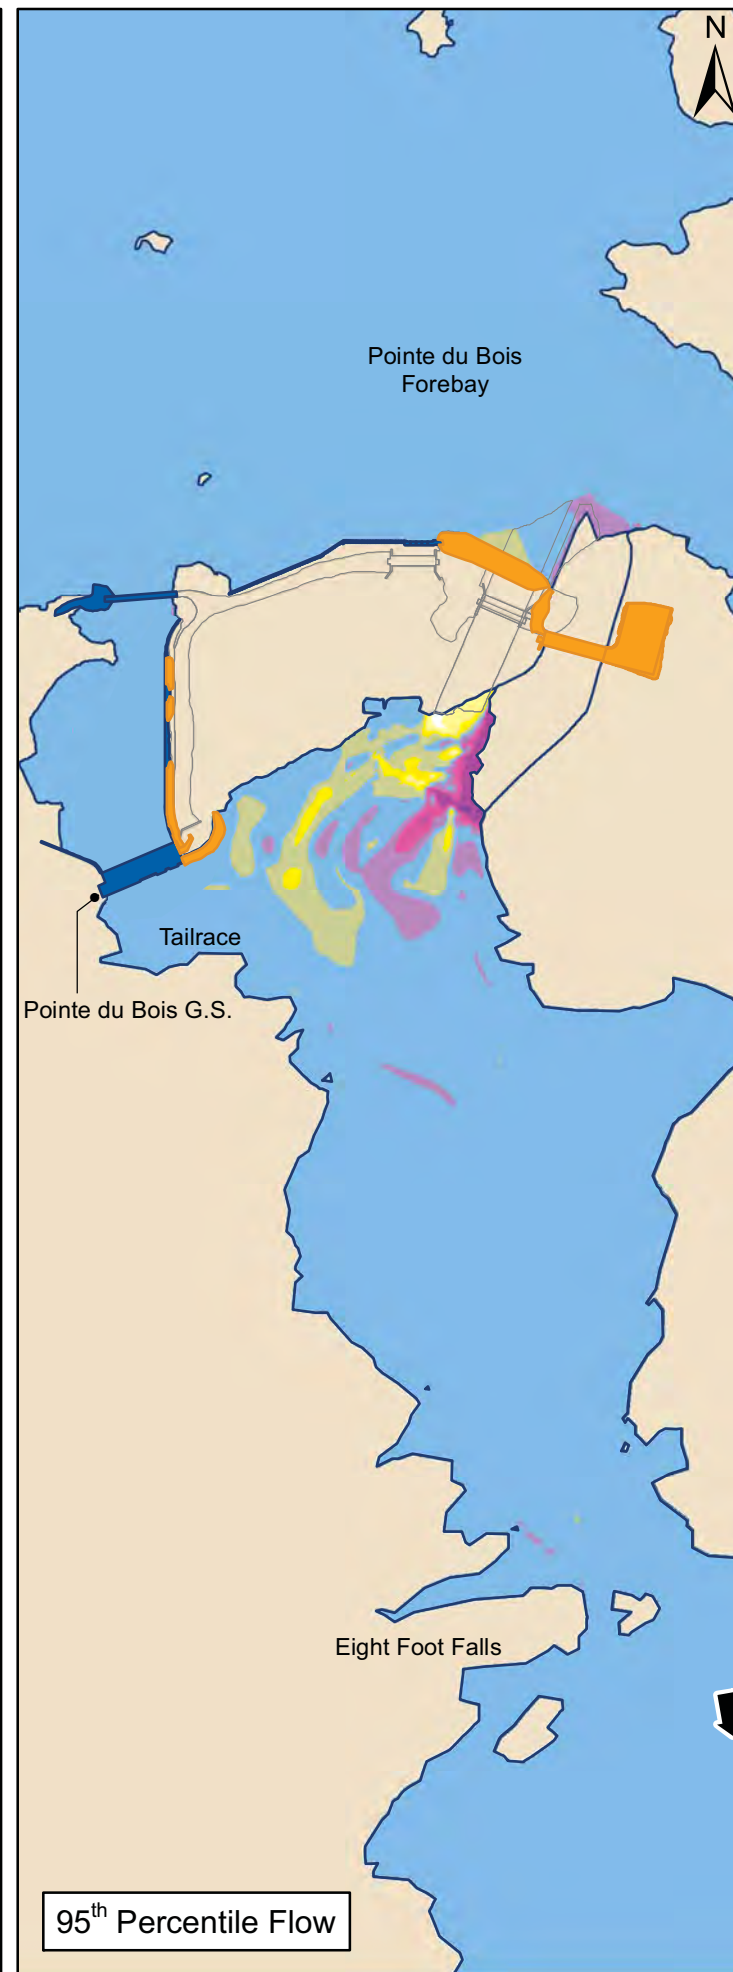
Figure:
8.3Ai

Stage 2 Construction Estimated Velocity Changes
Original Arrangement vs Revised Arrangement

During Stage II construction, flows in excess of the powerhouse capacity will be passed through the new spillway. Water velocity changes upstream of the approach channel and existing spillway will be similar for both the Revised Arrangement and the Original Arrangement. Water velocities, flow patterns and depths during Stage II construction are shown in Figures 8.2A Rev1, 8.2B Rev1 and 8.2C Rev1. The estimated change to water velocities between existing conditions and Stage II construction (Revised Arrangement) is shown in Figure 8.3A Rev1. The estimated change to water velocities during Stage II Construction from the Original Arrangement and the Revised Arrangement is shown in Figure 8.3Ai.

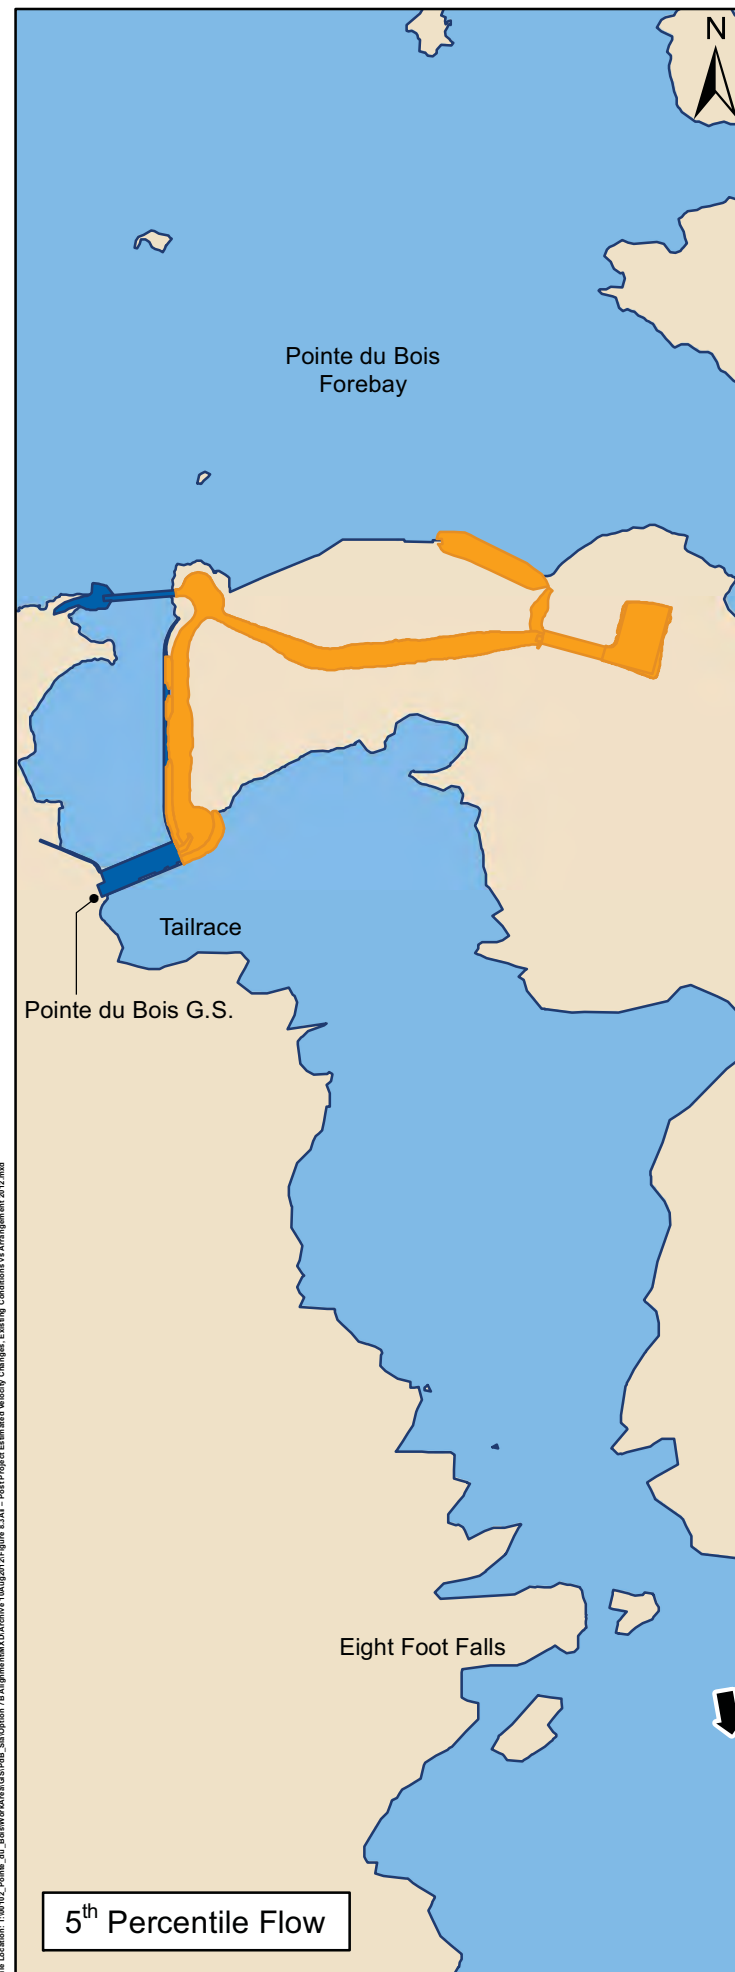
Figure:
8.3Aii

Post Project Estimated Velocity Changes
Existing Conditions vs Revised Arrangement

During the operational phase of the project, estimated water velocities and flow patterns for 5th, 50th and 95th percentile flow conditions are the same as conditions during Stage II construction, with the exception of the new forebay area between the existing spillway and the new main dam. Water velocities, flow patterns and depths under post project conditions are shown in Figures 8.2Ai, 8.2Bi, and 8.2Ci. The estimated changes to velocities as a result of the Revised Arrangement are shown in Figure 8.3Aii. The estimated change to water velocities from the Original Arrangement and the Revised Arrangement are shown in Figure 8.3Aiii. Velocities in the new forebay area will be up to 5 m/s lower, as water depths increase up to 10 m after impoundment.

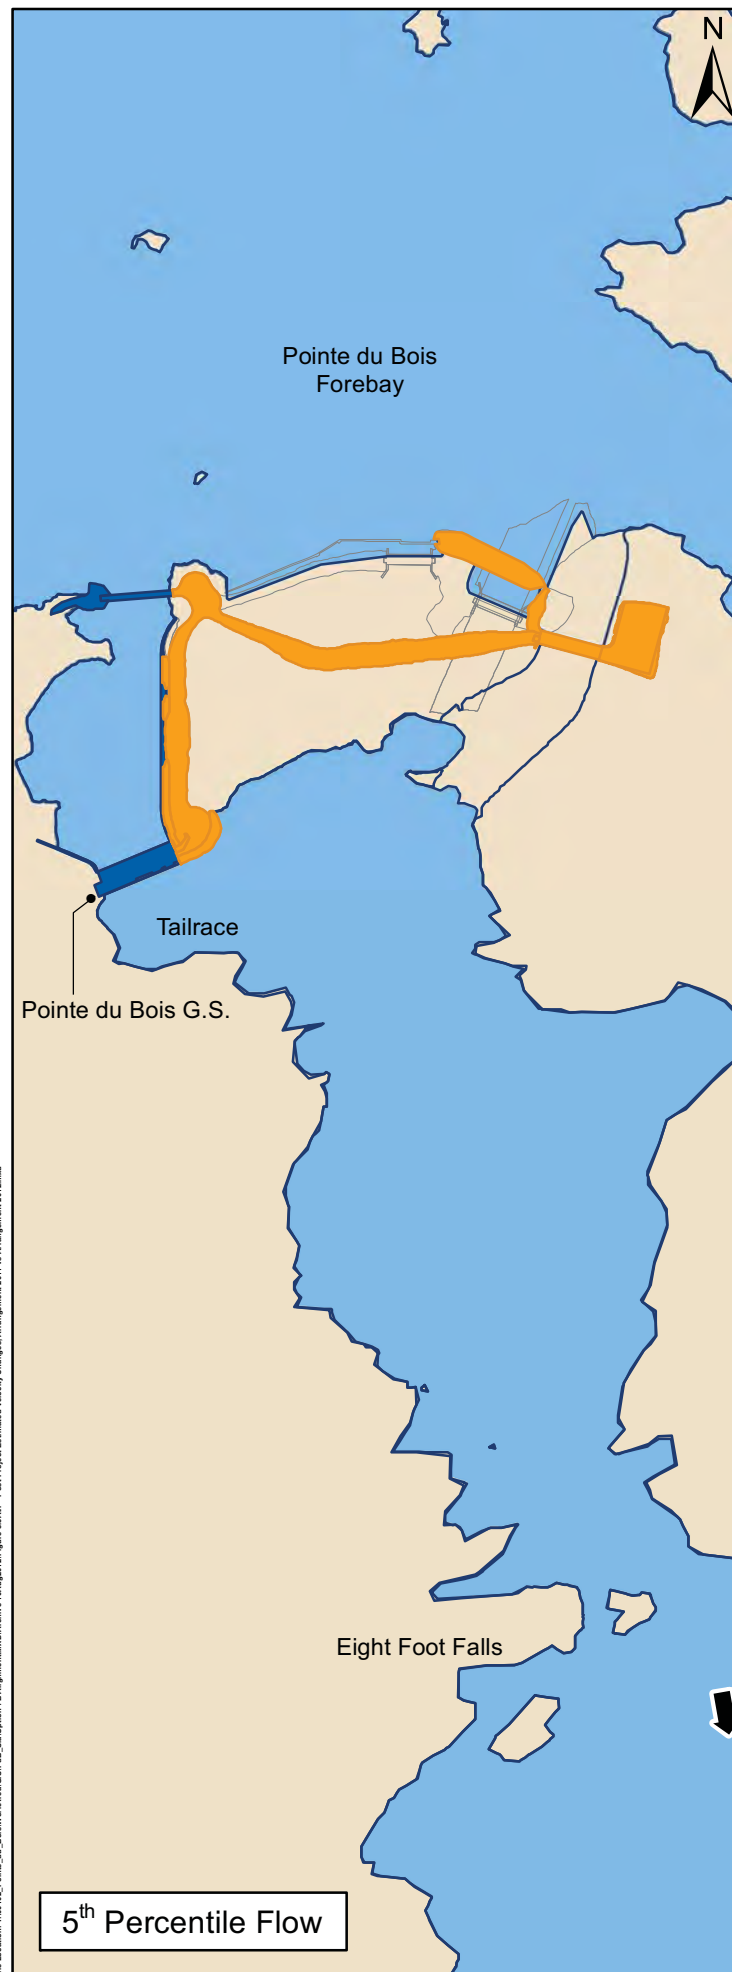
Figure:
8.3Aiii

Post Project Estimated Velocity Changes
Original Arrangement vs Revised Arrangement

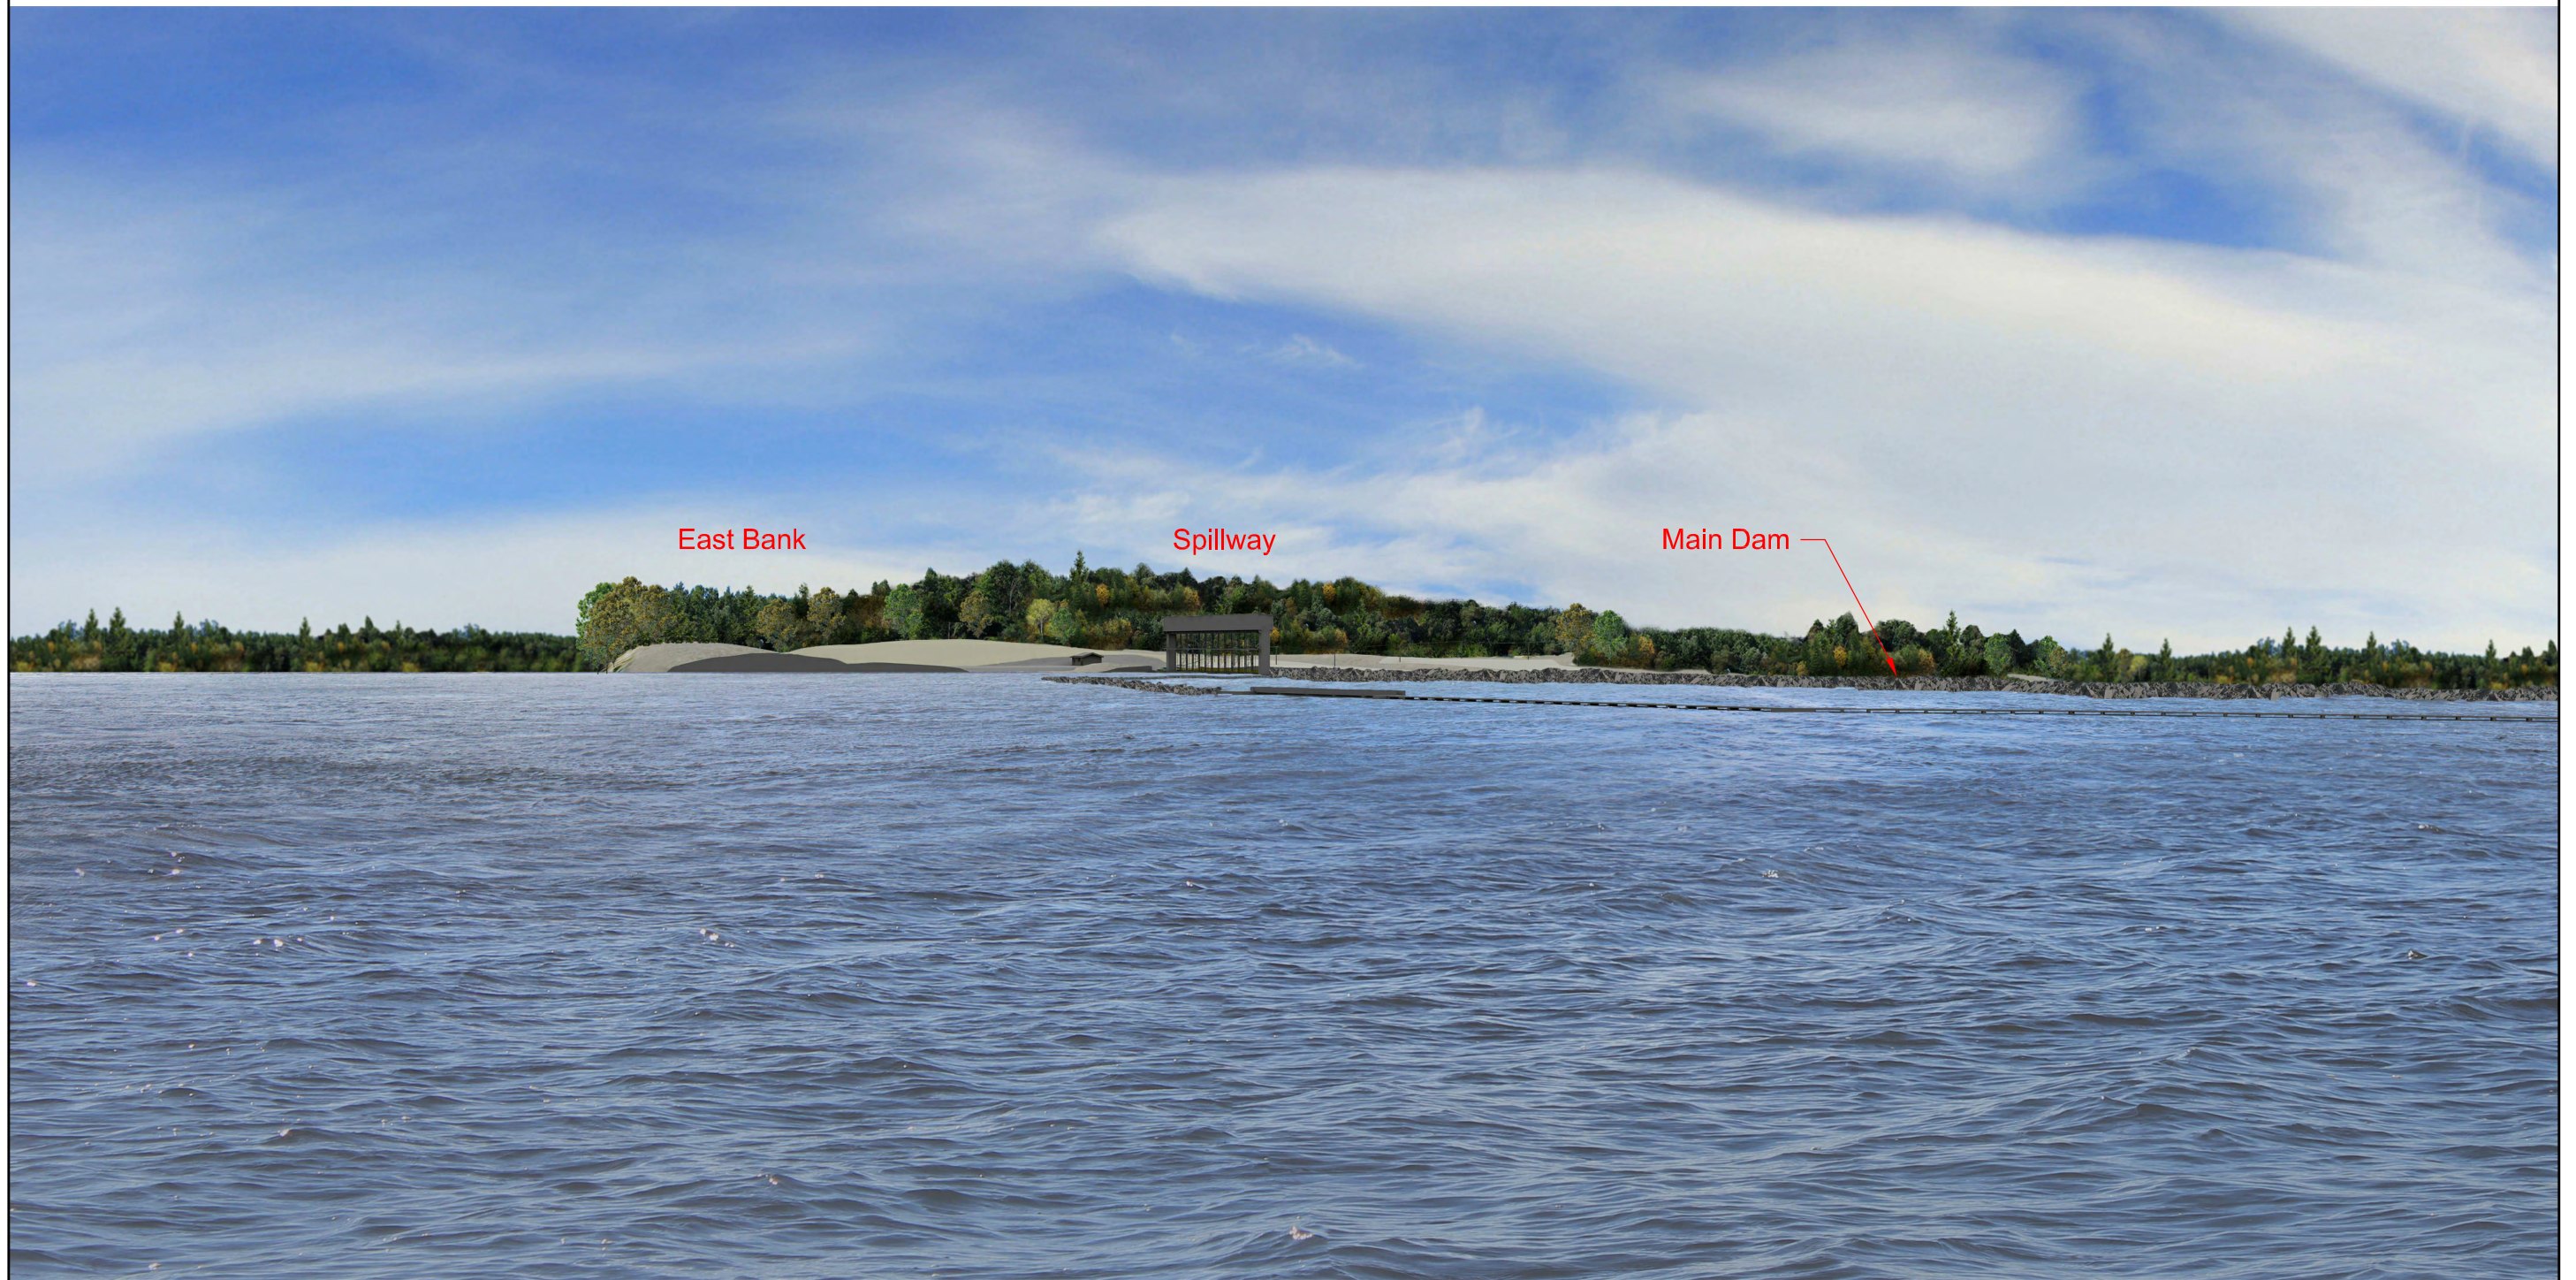
DATA SOURCE: Manitoba Hydro, KGS		<p style="text-align: center;">Pointe du Bois Spillway Replacement Project</p>	
	DATE CREATED: 06 JUL 2012	CREATED BY: KGS GROUP		<p style="text-align: center;">Artistic Rendition - View of Spillway Facing Downstream</p>
	REVISION No. VERSION 2.0	REVISION DATE: 13 AUG 2012		
			Figure: 8.11A Rev 1

Artistic renditions of the completed project are provided in Figures 8.11A Rev1 and 8.11B Rev1.

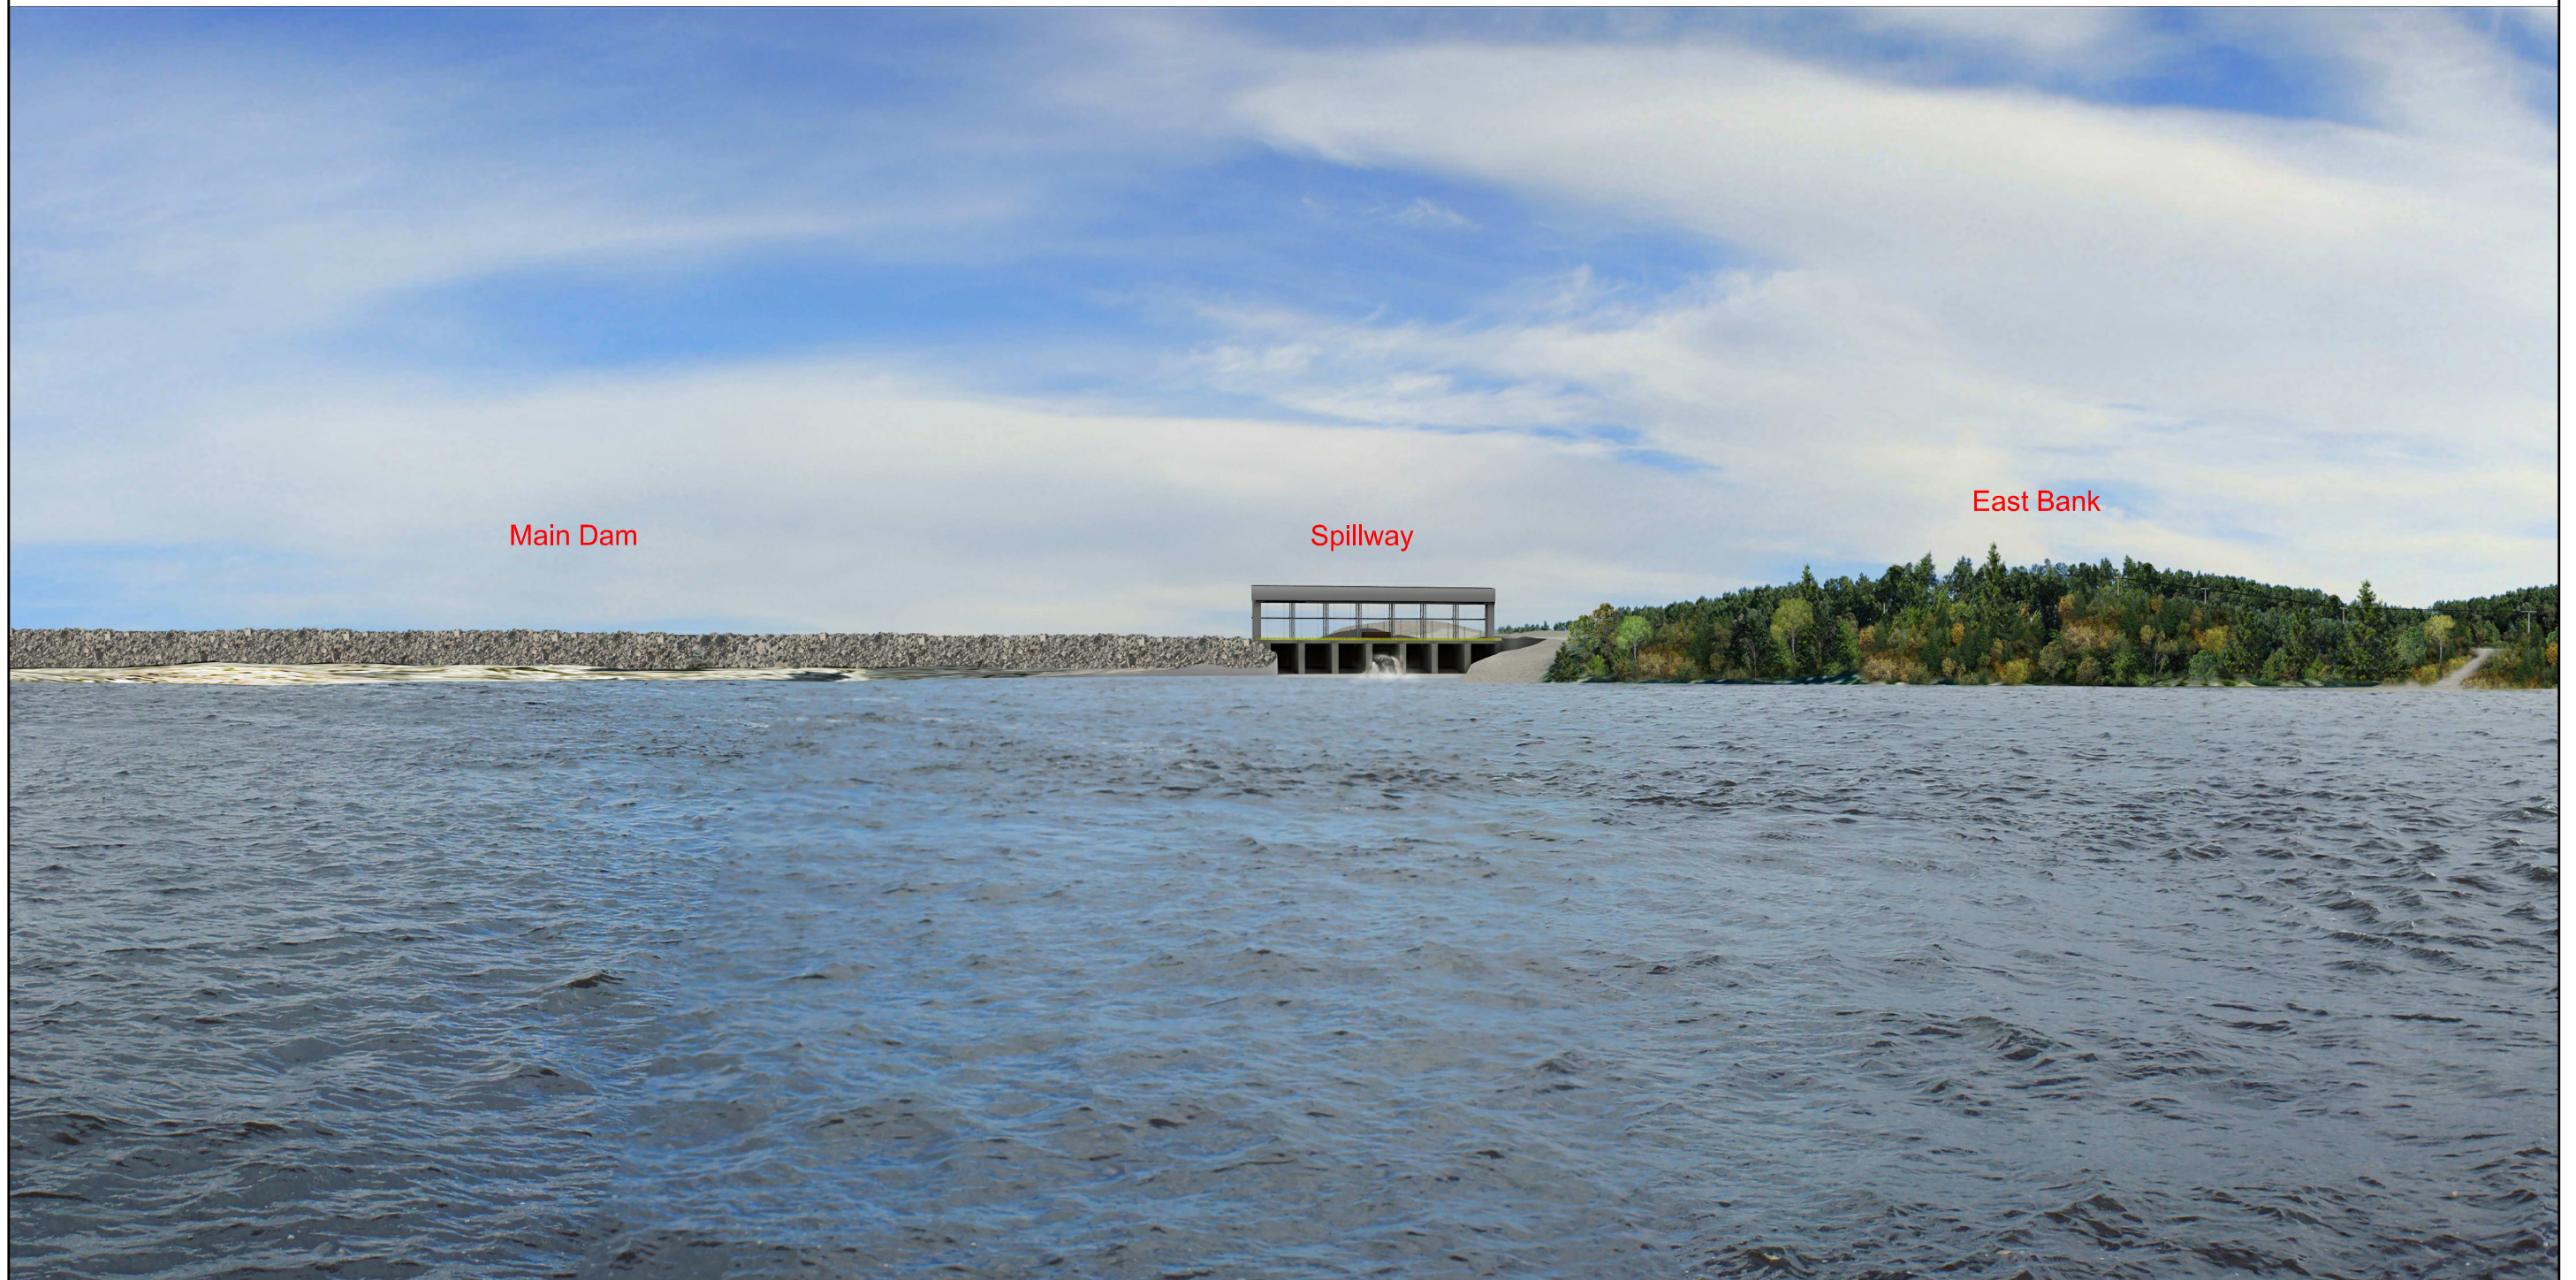
DATA SOURCE: Manitoba Hydro, KGS		<p style="text-align: center;">Pointe du Bois Spillway Replacement Project</p> <p style="text-align: center;">Artistic Rendition - View of Spillway Facing Upstream</p>	Figure: 8.11B Rev 1
	DATE CREATED: 06 JUL 2012	CREATED BY: KGS GROUP		
	REVISION No. VERSION 2.0	REVISION DATE: 13 AUG 2012
